Structural Inspection Report

'The Barn', at the rear of 8 High Street,

Prospect Yard, Kirton in Lindsey, Lincolnshire, DN21 4LU

Job No: 08:121

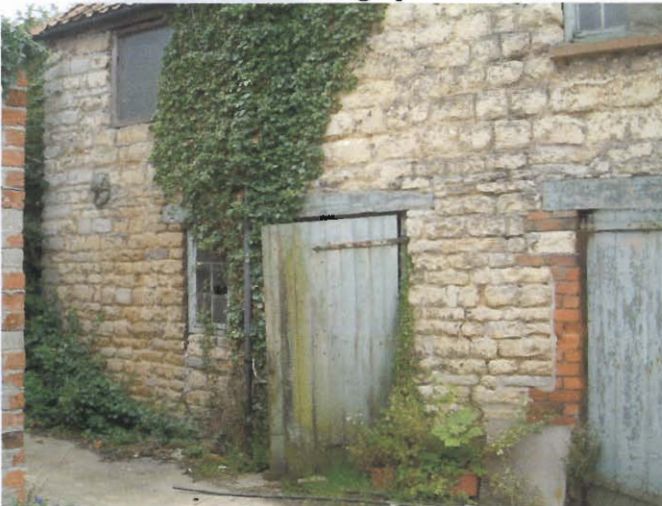
- 3.1.1 On the north elevation of the barn (Plates 1 & 2), there was undulation in the clay pan tile roof and widespread distortion, particularly in the central section (as can be seen in Plate 6). There was also damage to individual tiles and visible settlement in the roof line. Below the left hand side of the left hand ground floor window, there was a 3-4mm wide vertical crack; this had occurred within previous mortar repairs, although these had longstanding origins. The major part of this elevation was of stone construction and whilst this was noted to be generally in a reasonable condition, the lime mortar joints were noted to be of a very friable nature. At the left hand edge of the window frame there was a 10-15mm wide separation crack and above the timber lintel (which formed both the door and window head member) the walls were bowed outwards. A patteress plate had been installed at this location, but with the lack of any localised damage at this point, it would appear that this distortion had historical origins and movement did not seem to be significantly progressive in nature. Above the lintel the wall was covered with climbing shrubbery that inhibited close inspection. Between this and the next door position, there was a longstanding vertical crack that propagated from ground level to a point approximately 2.0 metres up the wall. The width of this crack was somewhat difficult to assess due to mortar erosion, but again it had longstanding origins. The wooden lintel above the second door was distorted towards the central position and the presence of another patteress plate was noted above the door. The presence of past mortar repairs was again noted, but as previously there were no obvious signs of significant recent movement. At the junction of the right hand quoin brickwork with the stone there was a slight separation crack, which had manifested itself through past albeit longstanding mortar repairs. Significant vegetation growth from the joints was noted above the right hand door reveal and at high level, below the gutter line. Above the left hand reveal on the next door (second from the right and accessing Room 2) there was a further patteress plate over the stone lintel. There was further evidence of past mortar repair in the stonework joints and a patch of dampness over the left hand door reveal, but no obvious signs of any significant re-cracking. To the left over the first floor window over there was some outward bulging in the stonework wall and indeed some distortion around the patteress plate, but

Plate 1 Front (north) elevation of the Barn (left hand side).

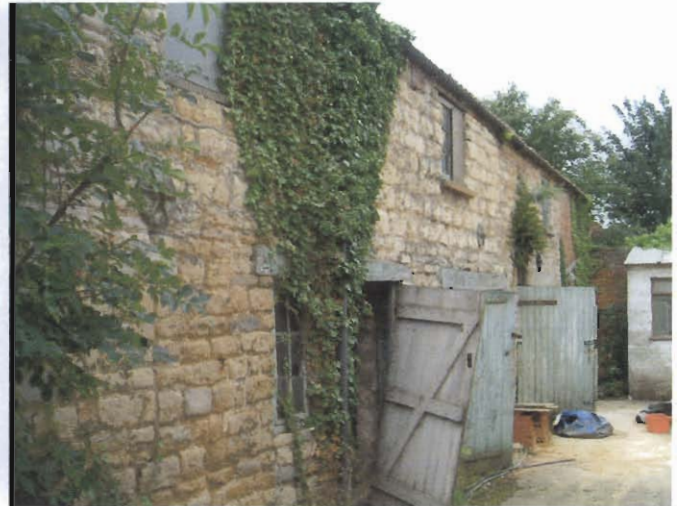
there was no obvious significant cracking that might be associated with any recent movement. In the brickwork section to the right hand end of the building, there was efflorescence at low level below the ground floor window and some erosion. Climbing shrubbery again obscured part of the wall elevation at this point, but there were no further obvious signs of structurally significant cracking or distortion. The timber window framing and doors were generally in a poor state of repair.

Plate 2 Front elevation of the Barn (as viewed from the north-east).

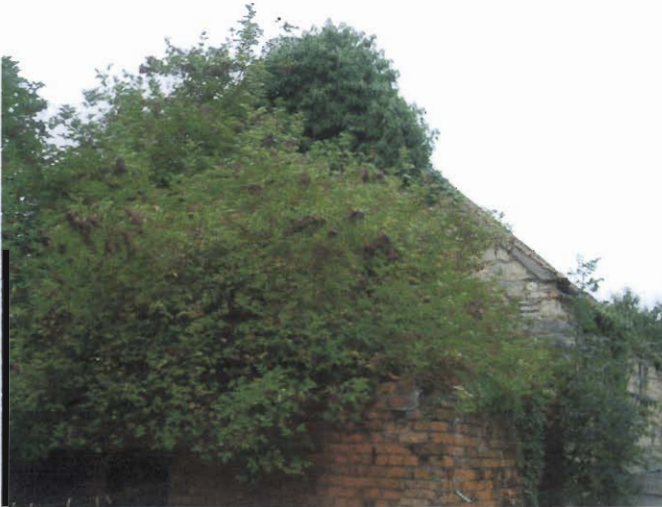
- 3.1.2 On the east elevation of single storey barn (Plate 3), there was heavy ivy growth which again inhibited close inspection. Within the passageway (Plate 4), it was apparent that the ground was built-up against the building and there were several self-set trees growing against the building. Generally the stonework (even where visible through the shrubbery) appeared to be in reasonable condition with no obvious signs of structurally significant cracking) but there was erosion in the mortar joints. Above the brick infilled door position, the erosion in the joints was heavier.

Plate 3 East Elevation of the barn (obscured by vegetation).

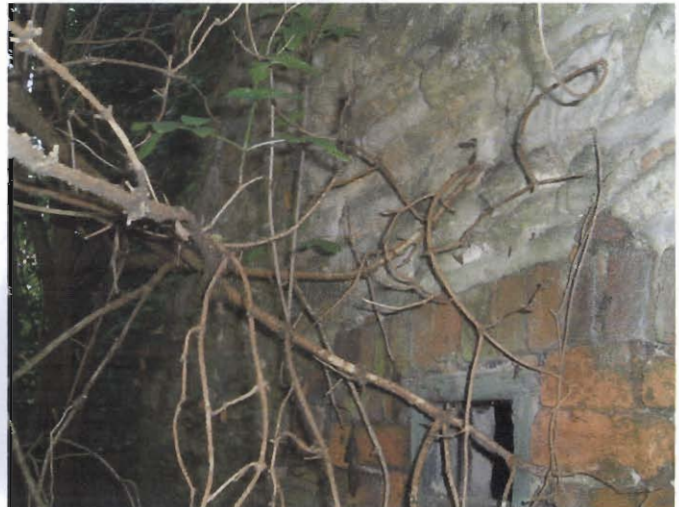
Plate 4 East Elevation of the barn (at low level within passageway).

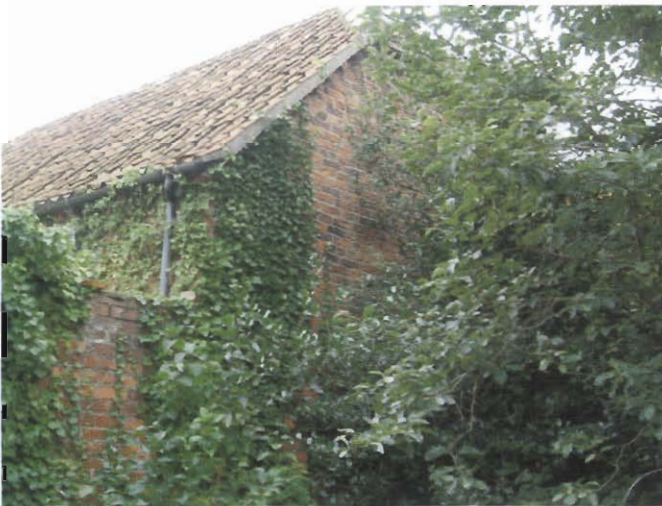
- 3.1.3 On the west elevation of single storey barn (Plate 5), large parts of the brickwork were obscured by ivy growth and other vegetation. Where visible, the brickwork was again weathered and eroded, but there were no obvious signs of structurally significant cracking or distortion. A holly tree (5-6 metres high) and a further deciduous variety (approximately 7 metres high) were noted at distances of approximately 2 metres and 2-3 metres from the building respectively.

Plate 5 West Elevation of the barn (again partially obscured by vegetation).

- 4.5 We recommend that the trees and shrubs around the building (including those within the neighbouring property) are maintained as part of any ongoing management scheme for the property. Although these trees do not appear to have been a major contributor to past movement in the building, they nevertheless lie within the influence zone of the foundations. If these

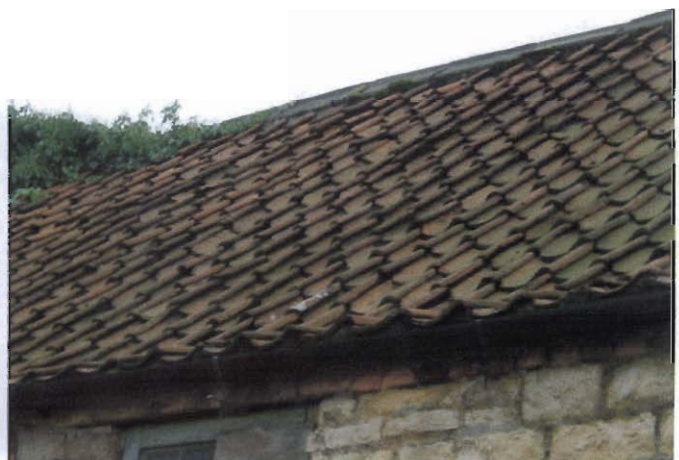
Plate 6 Undulation/distortion in the roof tiles.

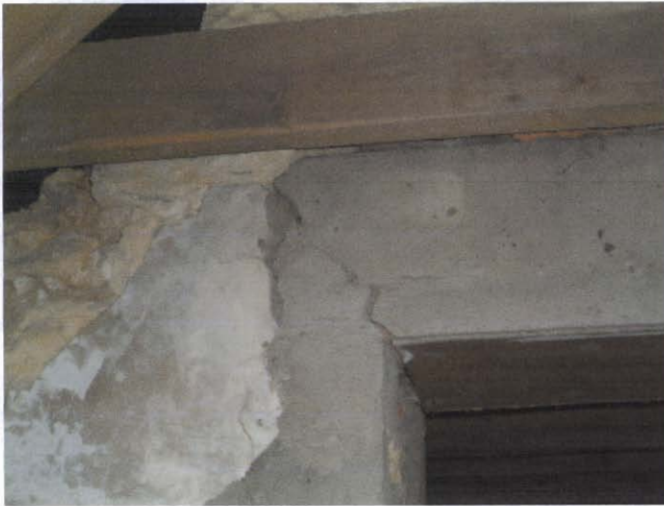
Plate 7 Cracking above the door reveal between the first floor rooms (through previous repairs).

- 4.3 For those cracks identified as being in excess of 2-3mm in width, we recommend that these should be stitched using proprietary resin injected repair ties (e.g. 'helibars'), prior to any decoration work. The separation cracking at interfaces with gable, masonry cross walls and in the worst cases over door heads should be tied using 30 x 5 x 1200 (min) galvanised straps. The observed cracking elsewhere within the building is in our opinion of lesser importance and is also essentially of an historical nature and would only be classified in the BRE Digest 251 (Assessment of damage in low-rise buildings) as category 1 or 2 (very slight to slight) and therefore aesthetic in nature. Consideration should therefore only be given to cosmetic repair only, for such items (and lintel replacement with localised rebuilding as necessary in the worst cases). Wall inclusions and indeed the several lintels were noted to be of timber construction. Independent of the need for replacement of the latter under perceived strength shortfalls or rot/insect attack, they should be removed as part of the refurbishment of the property where possible. If they were to be retained internally and simply plastered over, then introduction of heating into the new dwelling could lead to thermal volumetric change, which would in turn likely damage the new decorations. Widespread re-pointing will also be required externally; this will also involve the replacement of the more eroded or damaged stone/brick units. The gable walls should be securely tied to the roof rafters and new floor members via 30 x 5 x 1200 (min) galvanised straps at approximately 1500mm centres

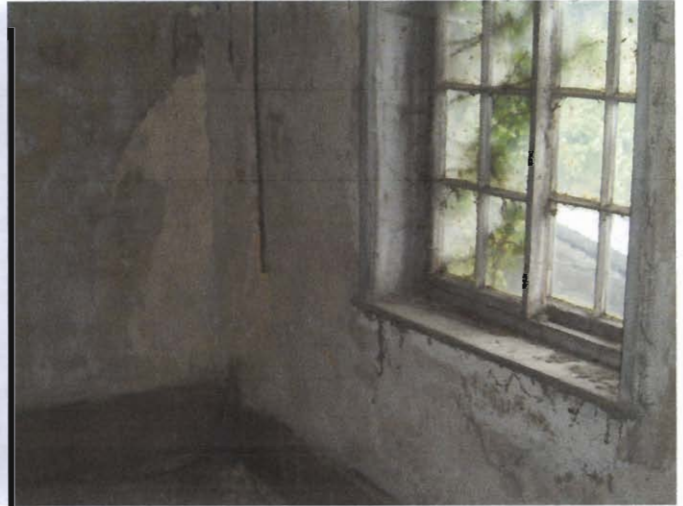
down from the raised tie level before diminishing to hairline width at the mid door height level. To the right hand side of this wall adjacent to the rear wall junction there were a series of diagonal cracks, generally up to 3-4mm in width but there was a single crack assessed as being approximately 10mm in width. Below this section of wall the plaster was partially exposed revealing friable joints beneath. The blockwork rear wall (built some fifteen years ago) was generally in good condition although some of the perpend joints had not been filled, but wall plate strapping was in place (presumably installed in advance of proposed renovation works). On the ground floor internal (north) wall there was perished plaster with some exposed brickwork. There was some cracking within the masonry joints, but the exact width was difficult to establish. On the north facing first floor wall there was a pair of longstanding 1-2mm diagonal cracks at the right hand edge adjacent to the gable return wall (Plate 8). There were no further obvious signs of structurally significant cracking or distortion.

Plate 8 North-west corner of the first floor landing area.

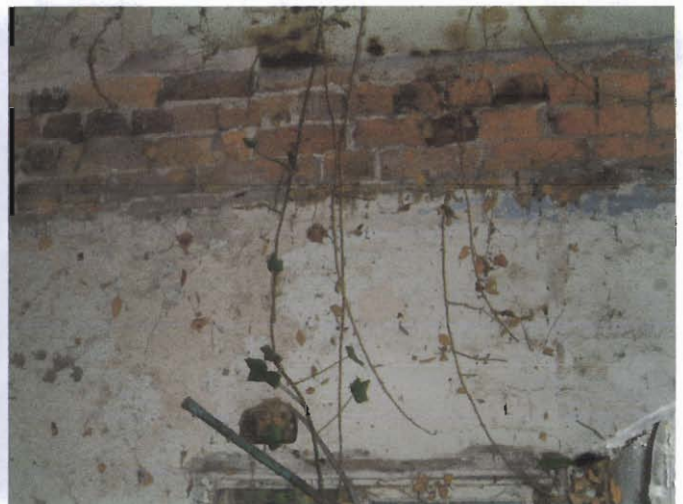
Plate 12 Vegetation inundating the openings on the western gable.

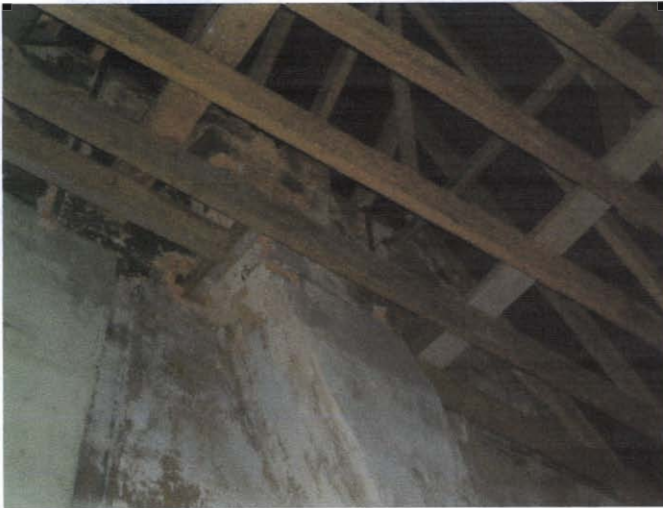
Plate 13 Exposed roof timbers as viewed from ground floor level.

- 4.4 It is our belief that a specialist timber consultant should be appointed to examine the condition of the roof timbers, wall plates and floor members in order to ascertain which timbers can be reused in the proposed renovation, the need for repairs or remedial work as necessary. The effects of rot, fungal or insect infestation will naturally have a weakening effect on the structural members over the years and from visual inspection, it appeared that some of the timbers might be affected. It is also highly likely that window/door framing (as appropriate) will have to be replaced, although specific advice on this matter is outside the scope of this particular report.

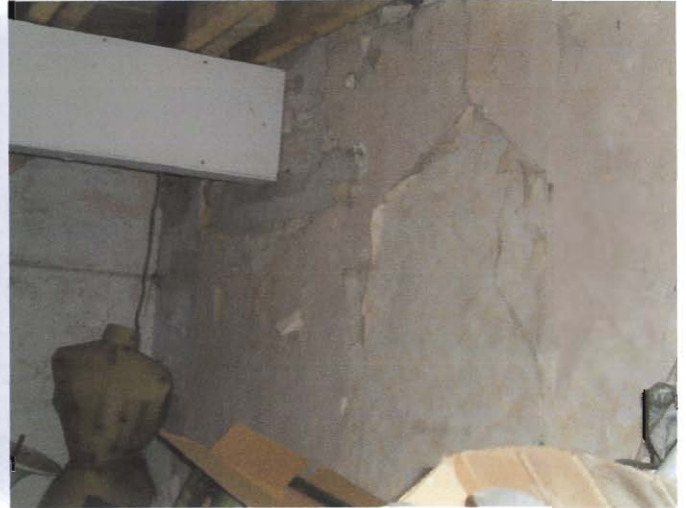
Plate 14 Room 2 (west wall)

- 3.2.2 Inspection of Room 2 revealed a 3-4mm wide separation crack at the junction with the buttressing wall and a 4-5mm ostensibly vertical crack in the mid section. On the east wall perished plaster was again noted and there was a 1mm vertical crack adjacent to the door below a patch of repair blockwork. There were no further obvious signs of structurally significant cracking, but viewing was partially obscured by the presence of stored materials.

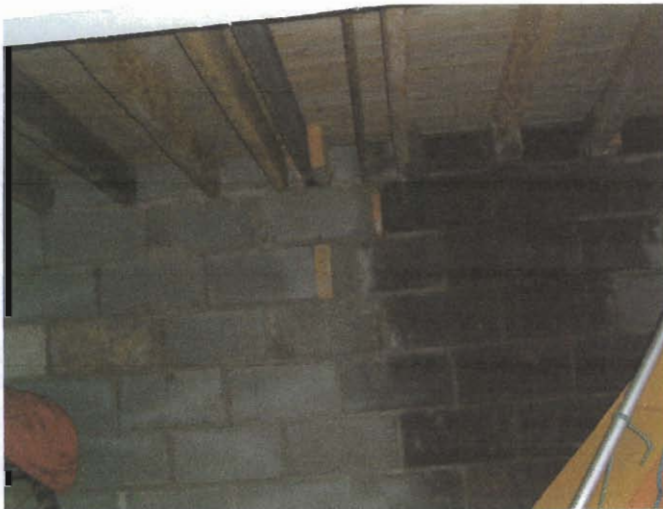
- 3.2.3 Inspection of Room 3 revealed areas of patched blockwork repair with some slight separation cracking at the junctions with the original masonry. On the front wall there was loss of mortar in the joints to each side of the door reveal. The western internal wall had been partially reconstructed in blockwork at high level, but this would seemingly be associated with the installation of the support beam. The blockwork rear wall (lining leaf) was again seemingly in good condition, but there was a patch of dampness (as viewed in the room over and visible in Plate 15 – see later) which will require further investigation. The solid floor again comprised a tiled finish.

Plate 15 Damp staining in the rear wall of Room 3.

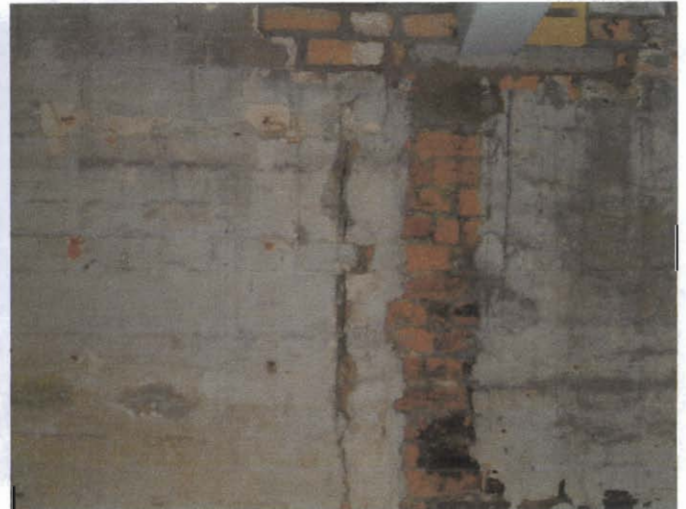
Plate 16 Vertical crack in the west (internal) wall of Room 4.

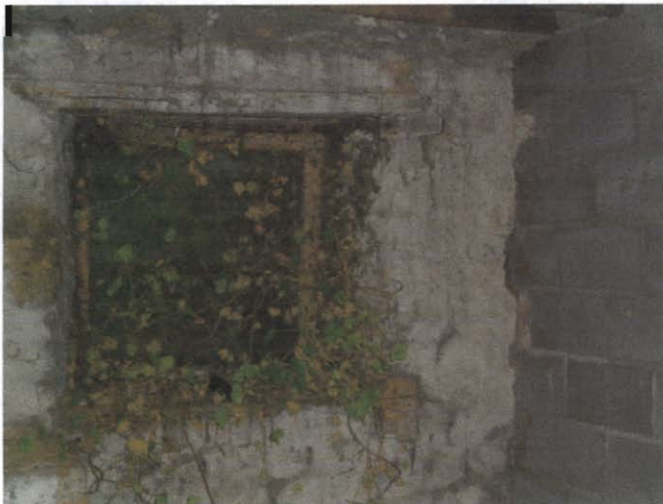
junction with the reveal. Above the top right corner of the right hand window there was 1mm wide crack that propagated upto the ceiling over and in places had developed voids and below the same opening there was substantial mortar loss from the joints. Substantial vegetation growth through the window opening itself was noted. On the west wall there was a 4-5mm wide vertical crack in the wall to the left of the beam position (Plate 16 refers). At the beam bearing position the wall had been locally re-built. At the junction with the rear wall the masonry has been 'toothed in' and there were no obvious signs of any structurally significant cracking. On the front wall there was substantial loss of mortar below the right hand side of the window (as viewed). Above the line of the feeding trough there was a further vertical crack, but the level of erosion was such that the width was difficult to assess. There was also cracking and distortion in the right hand door reveal, particularly at low level.

Plate 17 Growth of vegetation through the window of Room 4 (East Wall)

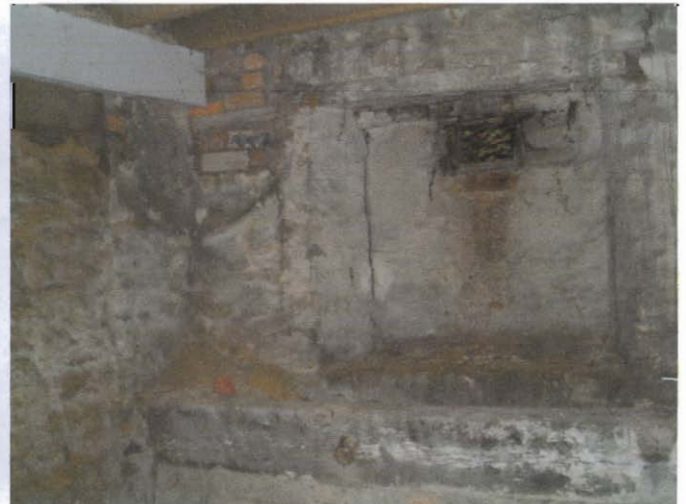
Plate 18 East wall of Room 4 (front section)

- 3.2.4 Inspection of Room 4 revealed a floor comprising a concrete and tile finish that undulated in places. On the external end wall (east side), there was a void in the stonework and consequent loss of lintel bearing above the right corner of the left hand window as viewed. At low level there was a brick built animal feeding trough arrangement where mortar loss was prevalent. A 10mm wide separation crack had also developed at the left hand frame
