TREE REPORT

090610

Plot East of 12 Mill Lane
Kirton in Lindsey
North Lincolnshire

10th June 2009

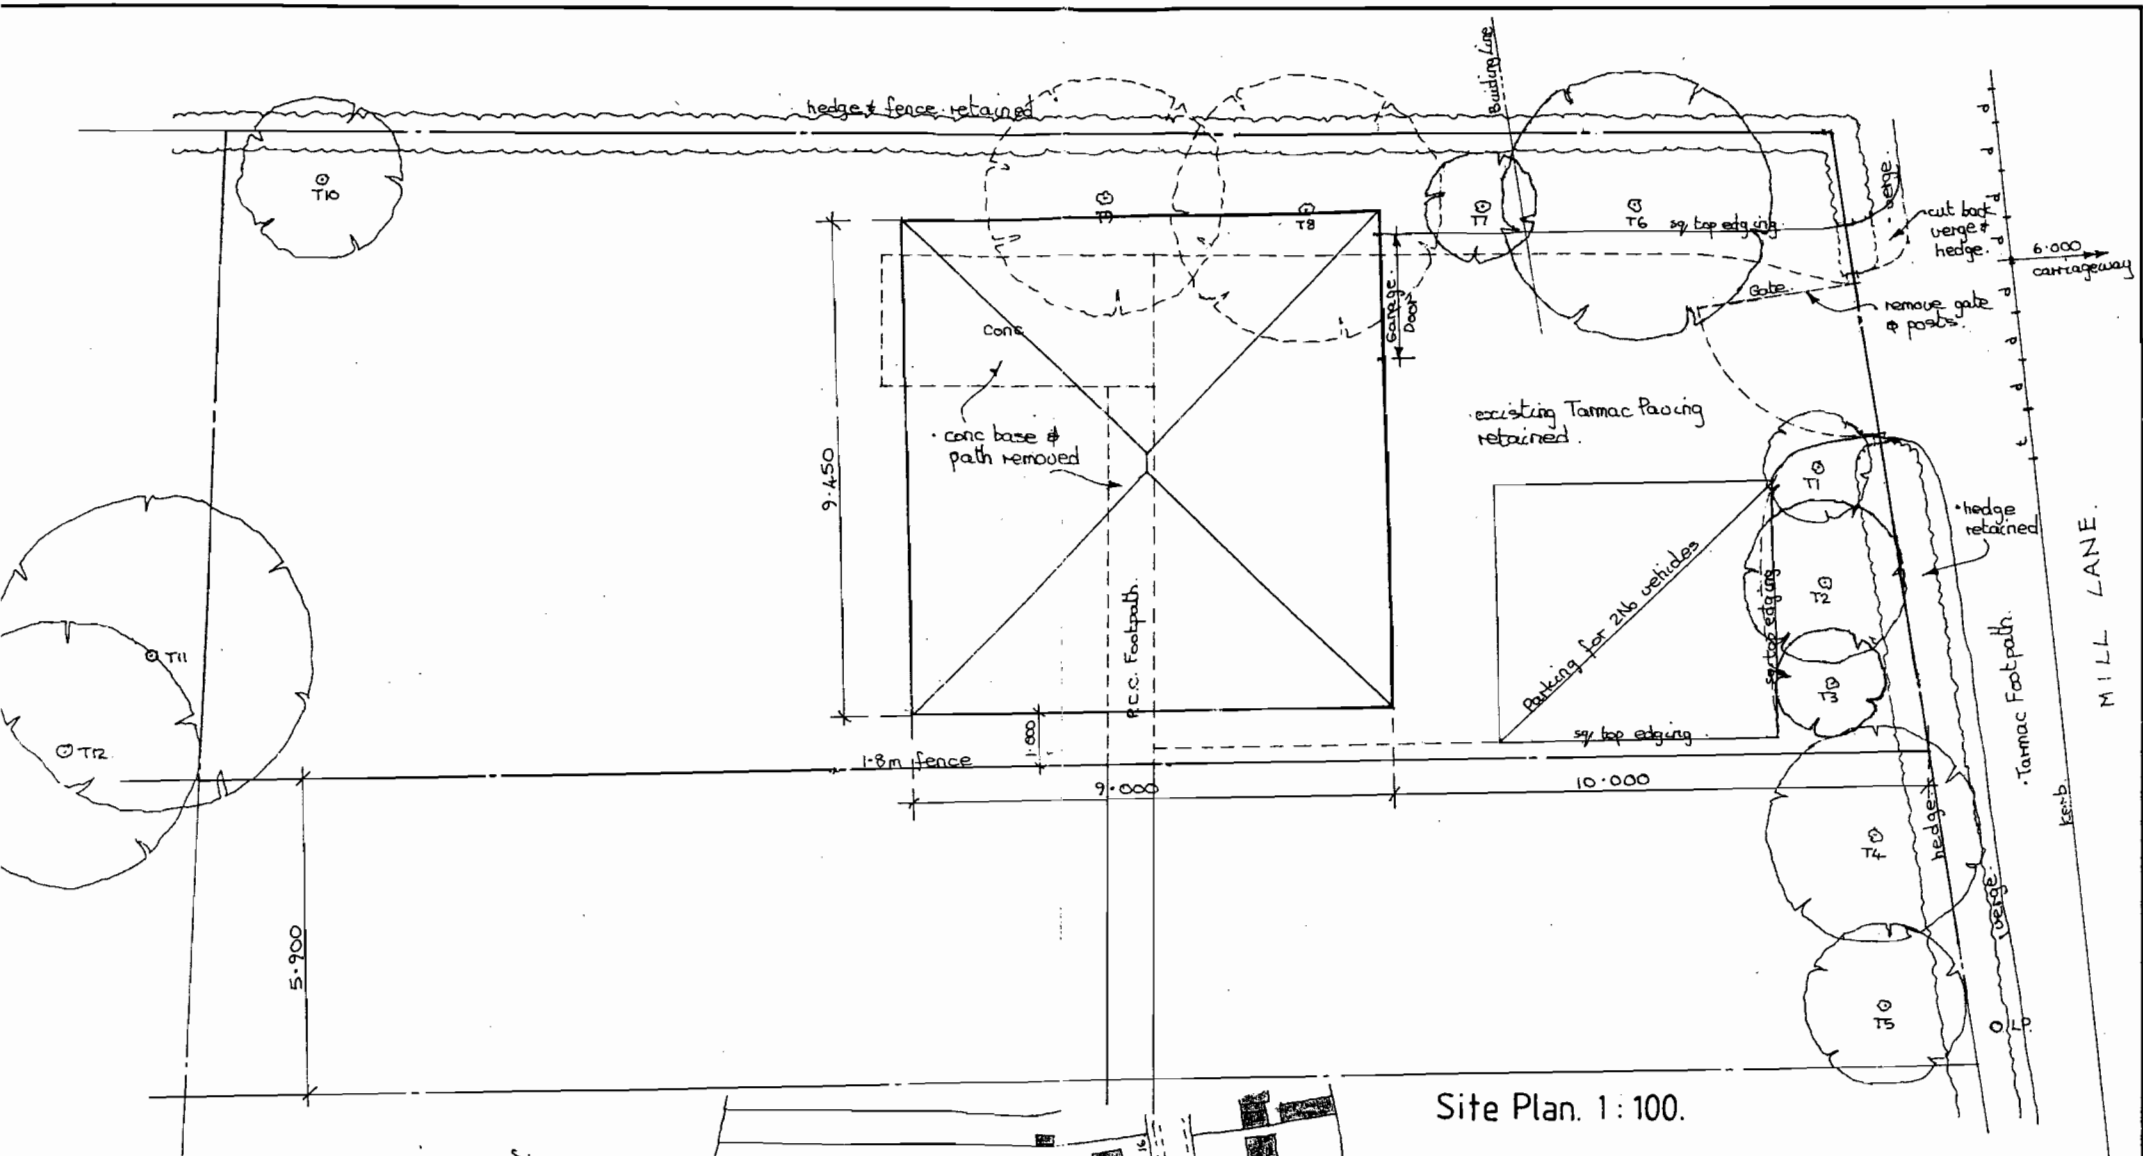
Site Plan. 1:100.

| T11 | Crab Apple | o/s site |
