## TREE CONDITION SURVEY AND REPORT

**1 FRANKLAND CLOSE  
WRAWBY  
BRIGG  
NORTH LINCOLNSHIRE  
DN20 8RU**

3.1	<b>T1 Beech</b>	<i>Fagus sylvatica</i>		
	Age Class	Fully mature		
	Condition	Physiological - Good	Structural - Fair/Poor	
	Height	21m	DBH	1065mm @ 1.2m

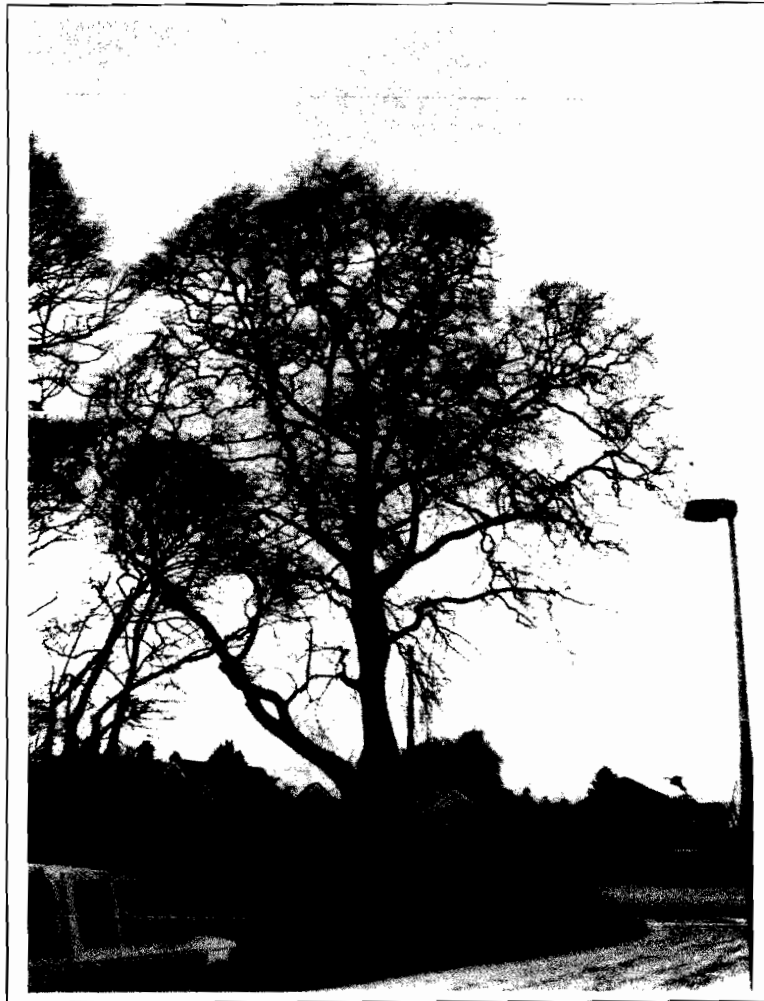
**Figure 1** - General view of the tree viewed looking west.  
The trees to the left of the picture grow in the grounds of the Old Vicarage.

The crown is a large, domed structure with a relatively even profile, except for the southern quarter comprising the major limb. The crown spread to the east is less extensive due to a competing sycamore which stood around 10m away. Its stump remains protruding from the turf. The main branch structure is in good overall condition and is evenly distributed. The only visible defects are where small cavities have formed following the death of minor secondary branches. The central crown contains dead wood up to 75mm in diameter. The outer canopy is fully furnished with small twigs which remain healthy. Buds have formed ready for the new growing season and can be clearly seen all round the crown through binoculars. There is no evidence of any decline such as twig dieback or crown thinning.

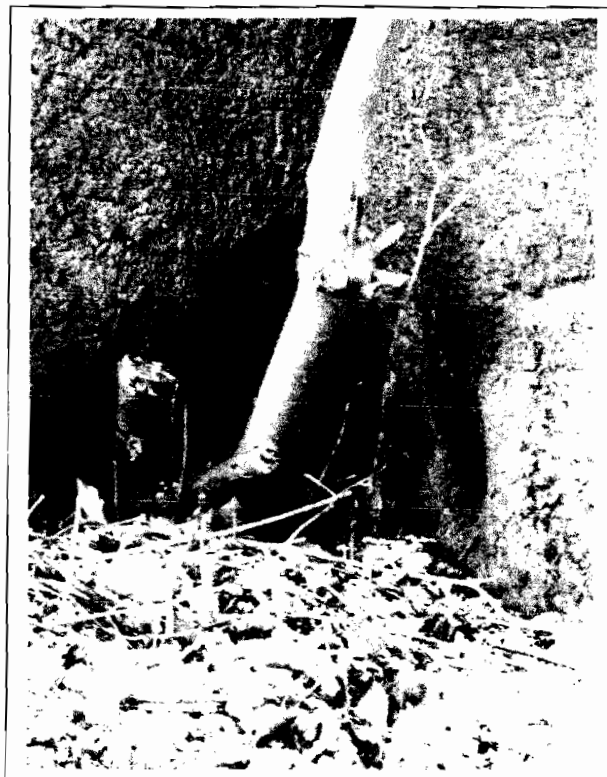
The tree has a large trunk base supported by stout root buttresses in all directions. The root collar and lower trunk base exhibit no evidence of perennial fungal fruit bodies. The trunk contains a void at ground level between two well-formed buttresses on the east side, the entrance of which is partially obscured by a holly sapling. I probed the extent of the cavity from the entrance of the void between the buttresses using a metal rod. It extends horizontally to approximately 0.5m from the aperture at its greatest. The extent of the decay is more pronounced in the north-eastern quarter of the trunk base. The timber has visibly hardened and become compartmentalised to the south of the void. The rot does not extend further than 50% of the trunk diameter at ground level. As an additional diagnostic exercise, I conducted an ultrasonic decay detection test in a north-south direction across the trunk at 1.2m above ground level. The test confirms that it remains sound at this level and above.

**Figure 2** - Close-up view of the basal cavity on the east side of the trunk with the holly sapling growing from the aperture.

The tree stands on a patch of ground which appears at first sight to be a public open space in local authority ownership. It was left in the ownership of 1 Frankland Close by the developers. The road construction cut into the bank, giving the tree a more elevated stance. Root material will have been removed during both this process and the subsequent landscape works to round off the profile of the verge. It is possible that damage caused during these operations has prompted the decay to develop.

The beech is fully mature and I estimate its age to be around 140 years from the diameter measurement I have taken. It remains in good physiological health despite the alteration in soil levels it suffered at the time of the development. The tree has continued to make active shoot growth across the entire crown since then, confirming it has compensated for any root loss by regenerating new growth below ground. It exhibits no symptoms of decline and the dead wood contained within the central canopy is of normal size and quantity for a beech of this age class. Most of its structural parts also remain in good condition but I am compelled to reduce its grading to Fair/Poor on account of the depth to which the basal cavity extends. However, the surrounding buttresses are sound and the tree continues to make active new wood on all sides of the base. This new growth will remain unaffected by the decay which has been compartmentalised in the absence of an aggressive fungal pathogen.

- 6.1 Reduce the major limb extending from 2.5m on the south side of the crown by 40%, reshaping to suitable secondary shoots. The work will also help safeguard the adjacent power line and should be completed within the next 6 months.
- 6.2 Clean out all dead wood above 15mm diameter. The work should be completed during the same operation as reducing the limb on the south of the crown.
- 6.3 Regularly review the condition of the tree every 3 years.

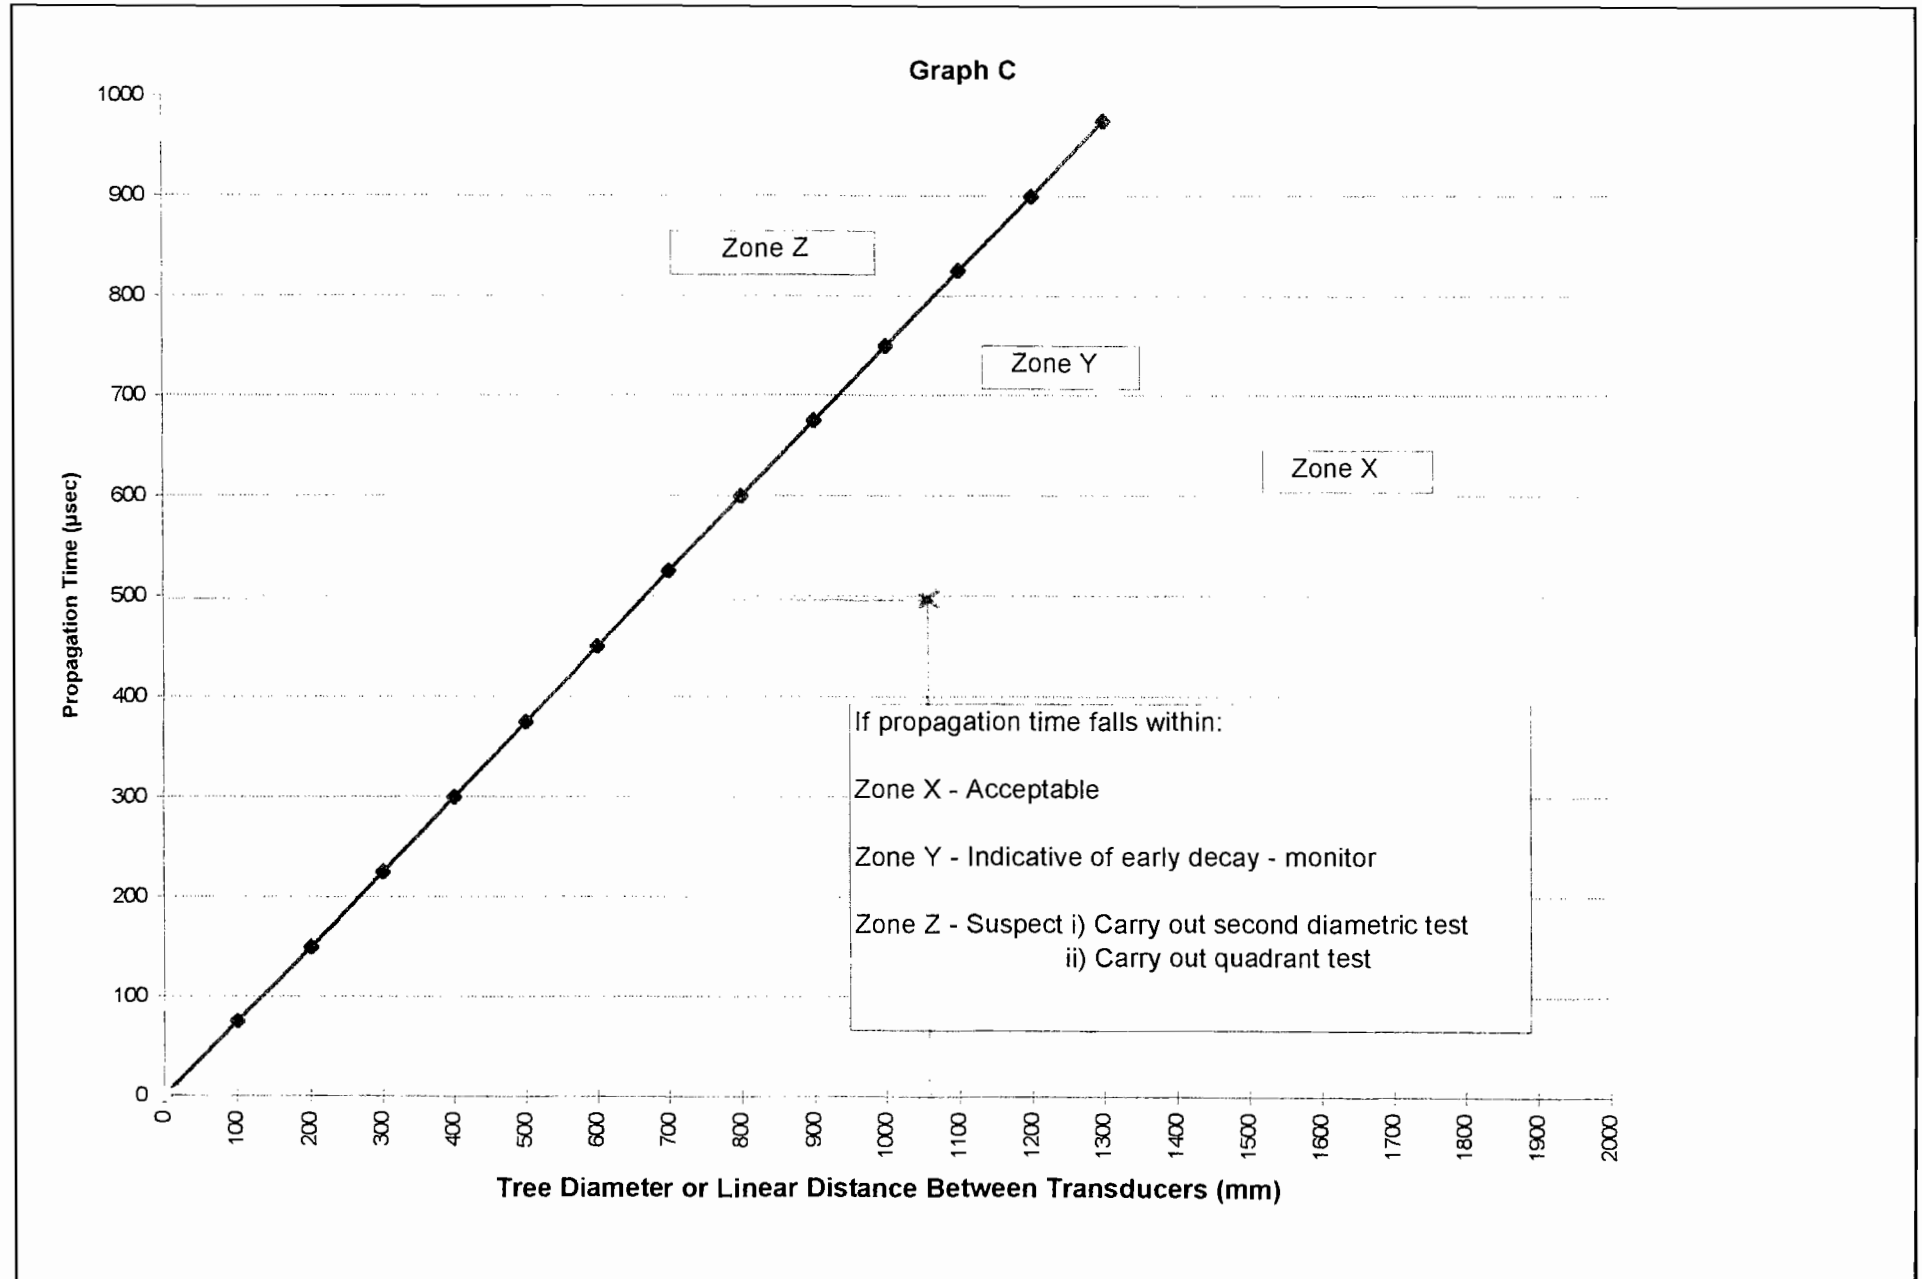
Tree Diameter (mm) v Propagation Time (usec) - Diametric Testing (Transducers @ 180°)

Age class	Fully mature	
Diametric test points	Height	- 1.2m above ground level
	Polarity	- North/South
Trunk diameter at test points	- 1065mm	
Readings		
Anticipated reading if trunk sound	- 533 $\mu$ sec (microseconds)	
Actual reading	- 498 $\mu$ sec

The result shows that the timber between the test points remains sound and free from decay. The decay has formed a roughly conical cavity which is offset within the north-eastern quarter of the base and does not extend up into the centre of the trunk. The graph overleaf plots the exact trace of the ultrasonic pulse.
