## STRUCTURAL APPRAISAL

**'The Groves',  
Trentside,  
Amcotts,  
North Lincolnshire  
DN17 4AX**

# SIMPKINS KENNY LTD

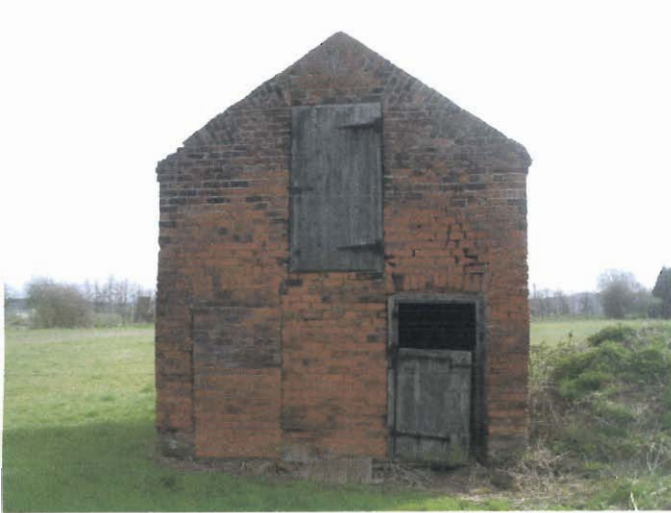
3.1.1 Inspection of the west elevation of the barn (Plate 1) revealed heavily weathered brickwork in the central section at first floor level with erosion of the mortar joints. Above the doorway in particular, the wall was heavily voided and in the soldier coursing there was a missing unit. At the right hand edge of the building (as viewed), there was particularly heavy weathering. A longstanding crack was noted in the heavily weathered sill and the timber door and framing was noted to be rotten. The right hand side doorway had been infilled at some time in the past and there was separation crack along both vertical junctions, with substantial mortar loss. To the left of the soldier coursing there was a 3-4mm wide separation crack. Above the left hand side of the first floor opening there was a 2-3mm diagonal crack that propagated upto the line of the roof slope. There was a similar crack (assessed as being 2mm in width) at the right hand corner.

Plate 1 West elevation of the tow storey Barn.

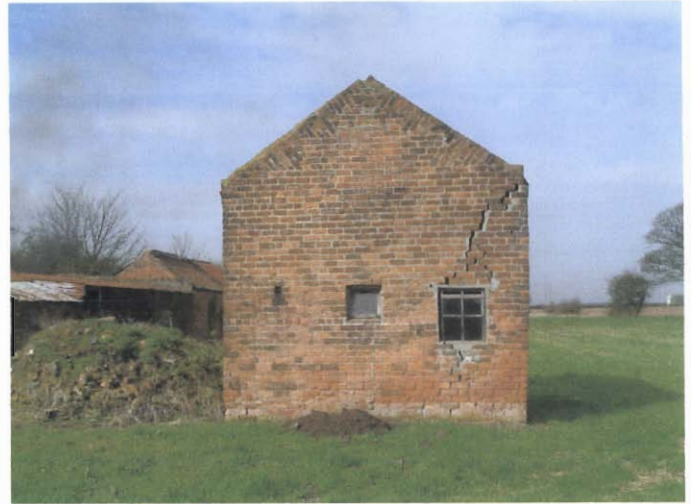
3.1.3 On the east elevation of Barn (Plate 2) there was a significant diagonal crack, symptomatic of past rotational movement above the left hand window (Plate 3

Plate 2 East elevation of the tow storey Barn.

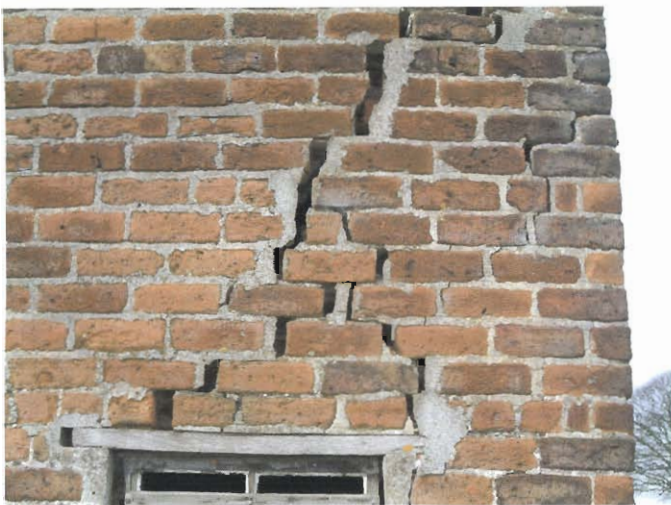
refers). The crack was assessed as being approximately 25mm in width at the window head and propagated to a width of some 50mm at the eaves level. Above the right hand corner of the same window there was a 15mm inwardly propagating crack that linked with the main crack and a second crack (upto 10mm in width) running in parallel. The crack had been re-pointed at some time in the past, seemingly without success although there was no obvious evidence of significant recent movement. The timber lintel over the window was distorted and had moved by some 25mm on the left hand bearing (as viewed), which correlated with the crack width at this location. Below the left hand window there was a further (and seemingly related) 5mm ostensibly vertical crack that opened to approximately 15mm in width at the window sill height. To the left of this position there was a further 2-3mm crack at low level. Both above and below the central window, there was a 2-3mm wide crack, but this did not seem to extend significantly down to the foundations. Both window frames were rotten. At the bottom left hand corner of the building, there was a 2-3mm wide longstanding crack and the surrounding brickwork was heavily weathered. At the apex, there was a missing brick unit. Trial Pit 1 (Plate 17) had been excavated adjacent to this elevation. The foundation had a corbel outstand of 15-20mm with a formation at 600mm below ground level. At the formation the soil still appeared to comprise top soil.

- 4.2 With reference to the points raised in section 3.0, we are of the opinion that there has been some past rotational movement in the barn building, which is particularly evidenced by the crack patterns on the east elevation of the barn and the presence of pattress plates tying the building in a north south direction. Whilst the movement appears ostensibly to be of historical origin corroborating the owner's anecdotal evidence, the level of observed movement on the east wall was significant (being greater than 25mm in width, it would be classified in the BRE Digest 251 (Assessment of damage in low-rise buildings) as category 5 (very severe damage)). It is our opinion that an underpinning scheme is adopted for the support of the barn walls. The extent of this work will depend upon the soil conditions encountered and the architectural detail for the proposed refurbishment (which is unknown at this time). For the remainder of the buildings (and subject to the recommendations below), whilst the foundations are seemingly founded within the clays underlying the top soil, the depth is relatively shallow and would therefore should also be underpinned (to the appropriate depth and width). If these buildings are to form part of any two storey accommodation scheme in the future then we would recommend that the new structure should comprise an internal leaf of blockwork founded on an internal *quasi* raft foundation, which would also form the ground floor slab (incorporating a damp-proof membrane and insulation in accordance with the modern building regulations). The loads from the new roof, first floor and the blockwork would be transferred directly into this element (cantilevered from an eccentric integral ground beam) and thus relieving the load from the original walls. The original walls would then be tied to the new masonry leaf as part of the re-construction. It is also understood that there may be a potential

Plate 3 Substantial cracking on the east wall (external view).

- 4.3 With the exception of the larger cracks on the east elevation of the two-storey barn, where localised rebuilding will be required, for all cracks identified as being in excess of 2-3mm in width, we recommend that these should be stitched using proprietary resin injected repair ties (e.g. 'helibars'), prior to any decoration work and minor localised re-building will be required for the damaged arch. The separation cracking at masonry walls interfaces should be tied using 30 x 5 x 1200 (min) galvanised straps. The observed cracking elsewhere within the buildings are in our opinion of lesser importance and is also essentially of an historical nature and would only be classified in the BRE Digest 251 (Assessment of damage in low-rise buildings) as category 1 or 2 (very slight to slight) and therefore aesthetic in nature. Consideration should therefore only be given to cosmetic repair only, for such items (and lintel replacement with localised rebuilding as necessary in the worst cases). Wall inclusions and indeed the internal lintels were noted to be of timber construction. Independent of the need for replacement of the latter under perceived strength shortfalls or rot/insect attack, they should be removed as part of the refurbishment of the property where possible. If they were to be retained internally and simply plastered over, then introduction of heating into the new dwelling could lead to thermal volumetric change, which would in turn likely damage the new decorations.

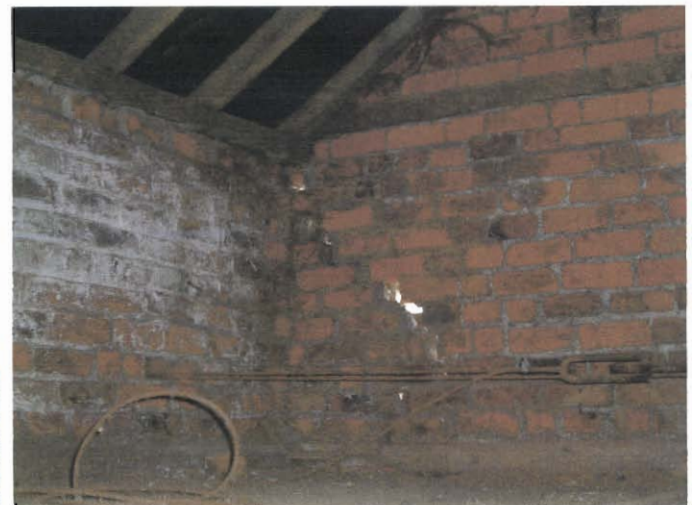
3.1.5 Inside the barn, there was no access to the first floor (and the floors timbers themselves showed signs of rot), but a limited 'head and shoulders' inspection of the first floor area revealed a traditional timber roof construction, which although distorted was seemingly in reasonable condition bearing in mind the relative exposure to the elements. It should also be noted that with sarking felt in place (visible in Plate 5), re-roofing must have taken place in the more recent past. From Plate 4, it can be seen that the large crack noted on the outside of the building was

mimicked internally and daylight was clearly visible through the fissure. The window and door framing timbers (Plate 5) had succumbed to the effects of rot/insect infestation over the years. At ground floor level, the walls had been painted at some time in the past, but had mostly flaked away. On the west wall there was a 5mm separation crack at the left hand side of the infilled door opening brickwork. On the right hand side as viewed there was a 10-15mm wide separation crack; both of these had seemingly longstanding origins. To the right hand side of the hook position, there were a series of outwardly propagating cracks (upto 5mm in width in the worst cases). The timber lintel over the door was distorted. On the south wall there was heavy erosion in the brickwork and the mortar joints, particularly at low level, which could be attributed to the soil and rubble banked against this wall externally. At the junction with the east wall there was slight separation cracking, but no further obvious signs of structurally significant distress. On the east wall (Plate 6) the crack patterns again replicated the external observations and there was further minor cracking in the flaking paint finishes with further signs of erosion at low level. Occasional timber inclusions within the wall were noted. On the north wall there was further erosion at low level and some missing brick units. Towards the right hand side of this wall, there was a 3-4mm wide inwardly propagating diagonal crack with a second minor crack above. Both of these had apparently longstanding origins.

Plate 4 Substantial cracking on the east wall (internal view).

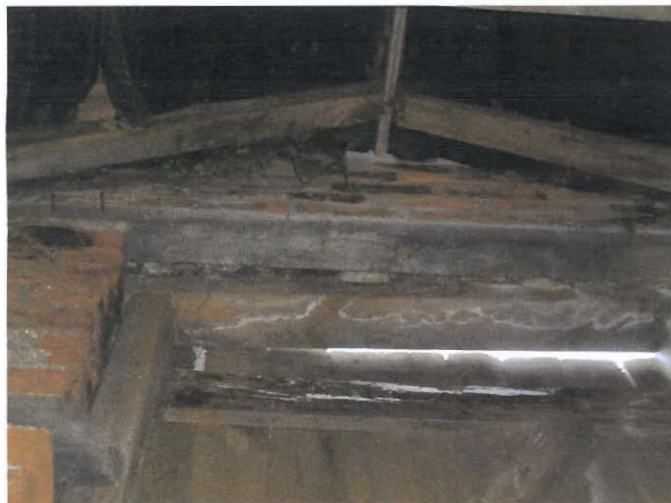
Plate 5 Roof structure over the western gable wall of the barn.

- 4.6 It is our belief that a specialist timber consultant should be appointed to examine the condition of any roof and floor timbers, wall plates and other timber inclusions, if they are to be retained, in order to ascertain the need for repairs or remedial work as necessary. The effects of rot, fungal or insect infestation will naturally have a weakening effect on the structural members. It is also necessary to replace existing door and window framing which have succumbed to the effects of rot and damage from the elements over the years, although specific advice on this matter is outside the scope of this particular report.

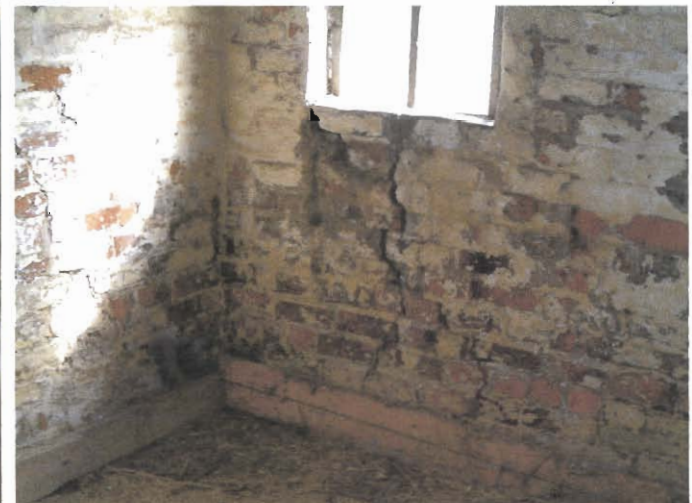
Plate 6 Cracking at ground floor level on the east gable of the barn.

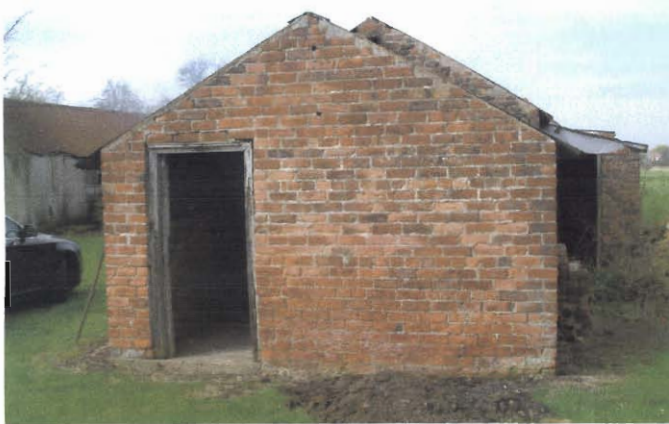
3.2.1 On the eastern wall of Building 2 (Plate 7), there was an inwardly propagating 5mm wide diagonal crack at the top right hand corner of the door opening and a similar but handed 3mm crack above the left hand side. With a 3mm horizontal bed joint crack at this location also, it would appear that the damage was associated with lintel deficiency. At the apex (on the forward gable section) there was a 2-3mm wide ostensibly horizontal crack. Towards the right hand corner (as viewed) there was a 2-3mm wide diagonal crack just below the roof slope that quickly diminished to hairline in width and at low level, there was an inwardly propagating 1mm wide crack. The remainder of the brickwork was weathered with some friable individual brick units that will require replacement. On the backward gable there was a 5mm wide crack below the left hand slope and a second 2-3mm wide crack towards the left hand edge of the building. Below the right hand slope, the friable brickwork was heavily eroded and there was a 5mm crack towards the right hand

Plate 7 Eastern elevation of Building 2.

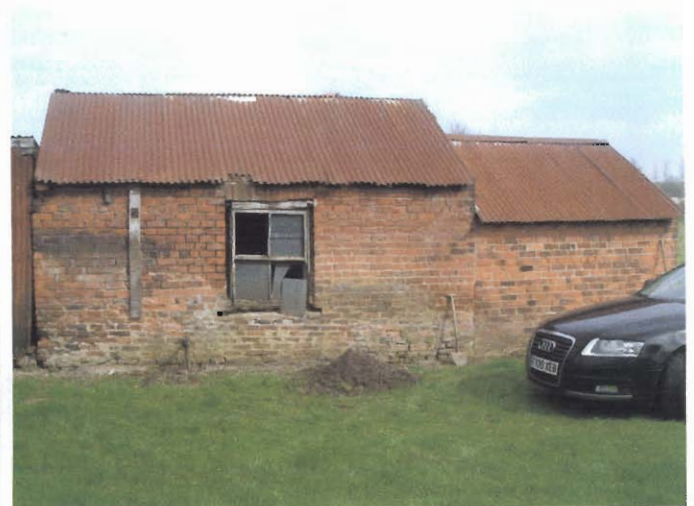
Plate 8 Southern elevation of Building 2.

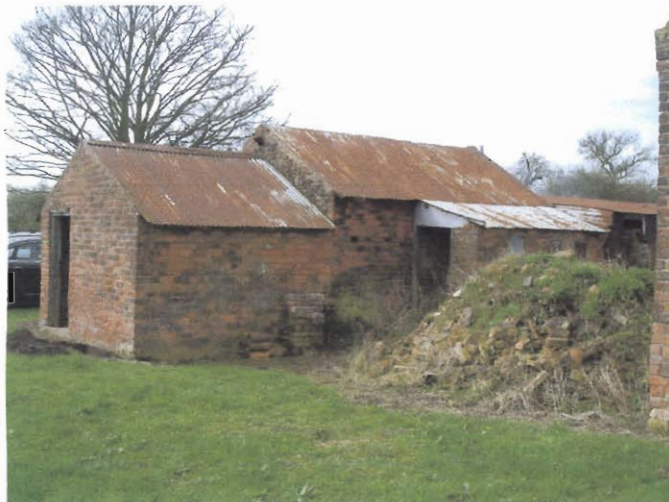
Plate 9 Northern elevation of Building 2.

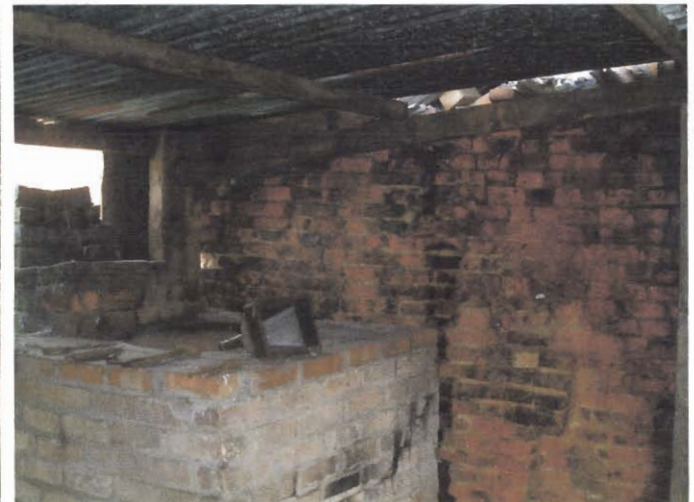
- 3.2.5 In the store on the east side of the building the concrete floor again contained longstanding cracks, but there were no obvious signs of significant undulation. The presence of an animal pen restricted inspection (Plate 10), particularly on the east wall, but on the division wall there was a 3mm diagonal crack above the small opening and a 2mm wide crack propagating from the side. On this same wall, there was a central 1mm wide mainly vertical crack from mid height upto apex level and at the right hand eaves, there were fissures in the friable brick wall. The mortar loss, however, made it difficult to establish any discernable crack pattern. There was cracking above the door (reflecting the external observations), but no further obvious signs of structurally significant cracking or distortion in the remaining walls (where visible).

Plate 10 Western elevation of Building 2 (from within storage area).

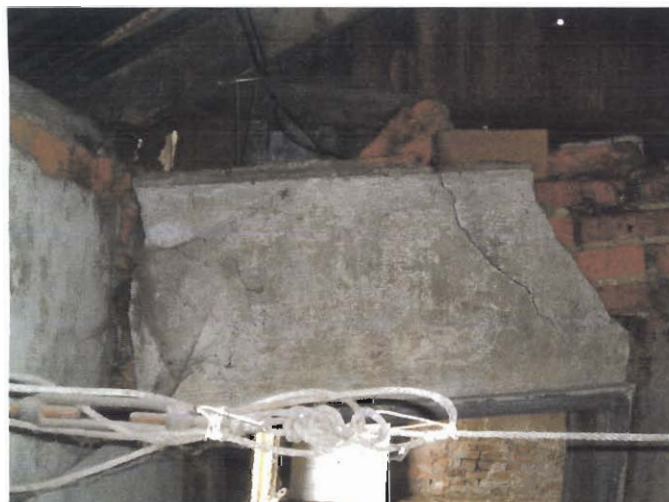
Plate 11 Partially collapsed brickwork panel over the door to the derelict living accommodation (Building 2).

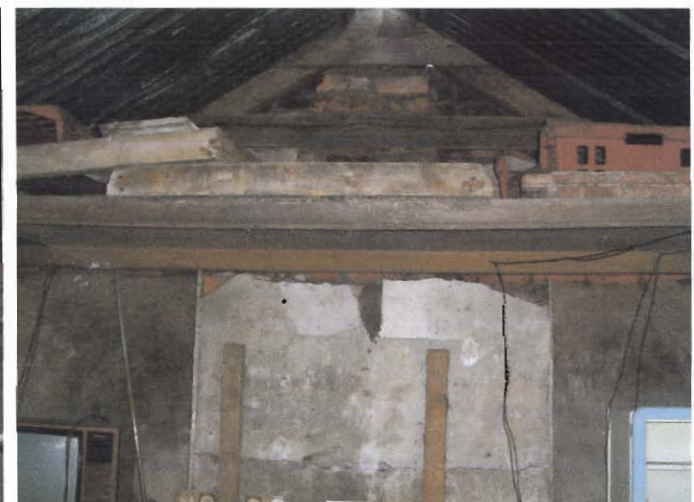
diagonal crack below. On the western wall (Plate 12), the render was heavily boxed, particularly over the fireplace. To the left of the fireplace there was an area of missing render but no further obvious signs of structurally significant cracking. At the junction with the north wall there was a 2-3mm wide separation crack. On the north wall itself the render was damp and boxed once more and was missing in a section below the window position. There was a 1mm vertical crack below the window sill, but this did not significantly propagate down towards ground level. There was a further area of damaged render above the top right hand corner of the window and a hole had developed to the right of this position.

Plate 12 Roof construction over the east wall of the derelict living accommodation (Building 2).

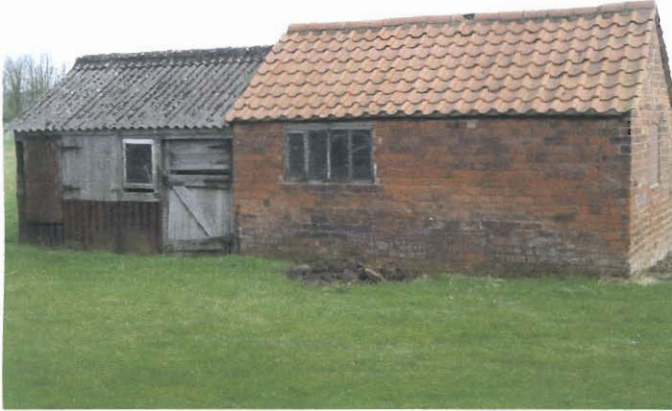
3.3.1 Inspection of the west elevation of Building 3 (Plate 13) revealed some past re-pointing below the bottom left hand corner of the window. There was some undulation in the clay pantile roof ridge line and one of the central ridge tiles was broken. The brickwork was generally fire-cracked and slightly weathered. Some erosion in the joints had taken place (even in those joints that had been re-pointed), but there were no obvious signs of structurally significant cracking in the brickwork on this elevation. The attached shed on the north side of the building (constructed in corrugated sheeting and timber), is to be demolished as part of the proposed renovation works and has not been inspected under the scope of this report. Trial Pit 4 (Plate 18) had been excavated adjacent to this elevation. The foundation had a corbel outstand of 60mm with a formation at 400mm below ground level. At the formation the soil still appeared to comprise moderately stiff clay.

Plate 13 Western elevation of Building 3.

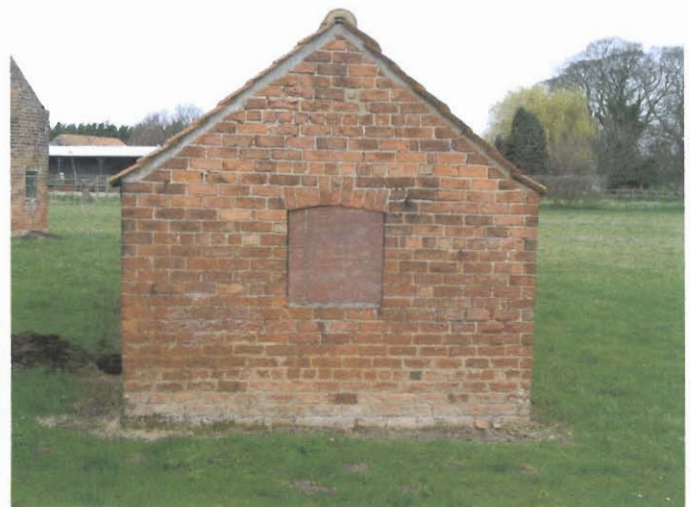
3.3.2 On the south gable elevation of the building (Plate 14) there were a pair of forked 3mm cracks propagating from the right hand top corner of the window opening. Below both the left and right hand bottom corners of the same window position, there were inwardly propagating diagonal cracks; these were both assessed as being approximately 2mm in width. The brickwork had been re-pointed at low level and some general erosion was again evident. There were, however, no further obvious signs of structurally significant cracking or distortion.

Plate 14 Southern elevation of Building 3.

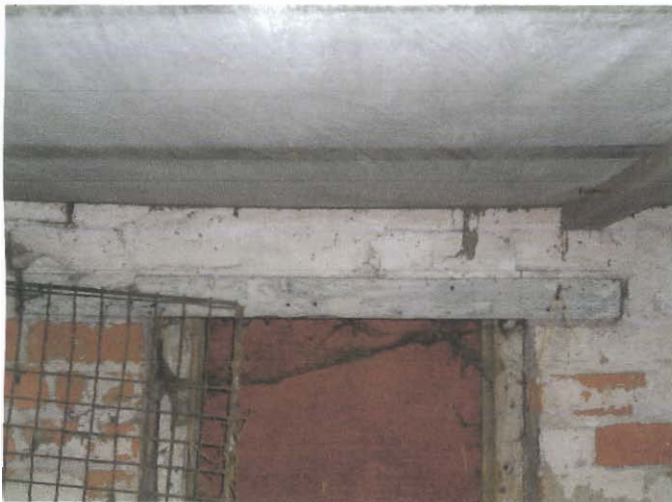
Plate 15 Roof panelling over doorway to Building 3.

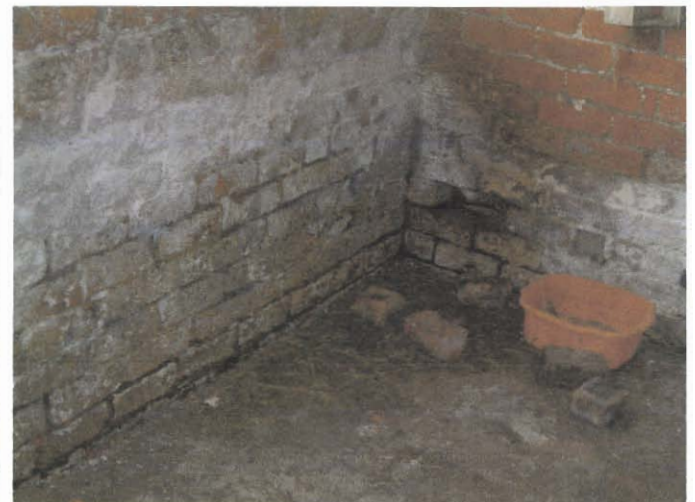
- 3.3.4 Internally there was separation cracking at the edges of the concrete floor (Plate 16) and the walls were damp at low level with heavy mortar loss from joints in places. On the south wall there was a 10mm wide inwardly propagating crack above the left hand corner of the timber lintel over the window and a similar 2mm wide crack above the right hand corner. On the northern wall there was a missing brick unit at low level to the left hand side of the door as viewed. In the remaining walls there was staining related to ingress of damp over the years, but no further obvious signs of structurally significant cracking or distortion. The ceiling was underdrawn in fibrous type boarding which could possibly have an asbestos content.

Plate 16 Low level dampness within Building 3
