**STRUCTURAL REPORT
ON OUTBUILDINGS AT
MANOR TOP FARM
SAXBY ALL SAINTS
LINCOLNSHIRE**

**FOR MR S H BROWN
C/O EDWARDSON ASSOCIATES**

PROJECT REF:- NW/DJY/JF/32765-Rp001

JANUARY 2012

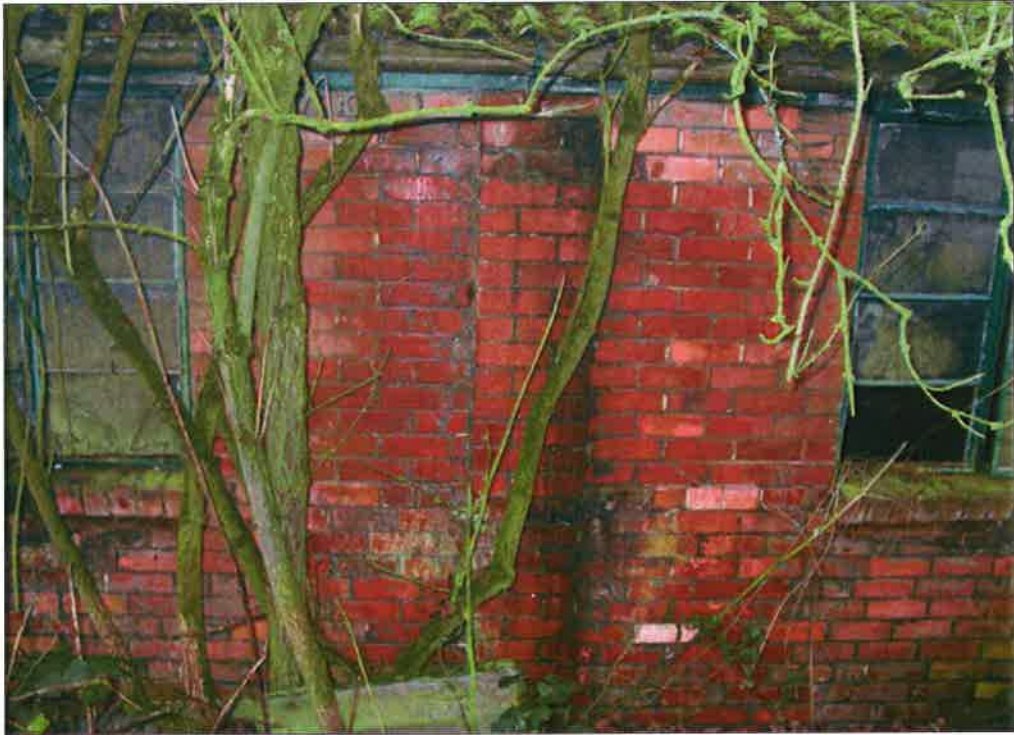
Photograph No. 1

- 3.2 Externally there are a series of saplings and young trees growing directly adjacent to the building which, although not causing any foundation movement, are damaging the gutters (Photograph No. 1).

- 4.1 The cracking apparent to the building is not a result of ground movement but is due to a corrosive expansion of built in steel elements, most particularly the window frames and the bearing plates for the roof trusses.
- 4.2 The rusting of these elements has been exacerbated by the lack of effective gutters over many years.

- 5.3 The young trees causing damage to the gutters should be removed.
- 5.4 The metal windows should be renewed and any other rusting steel built into the wall either removed or de-rusted and treated.

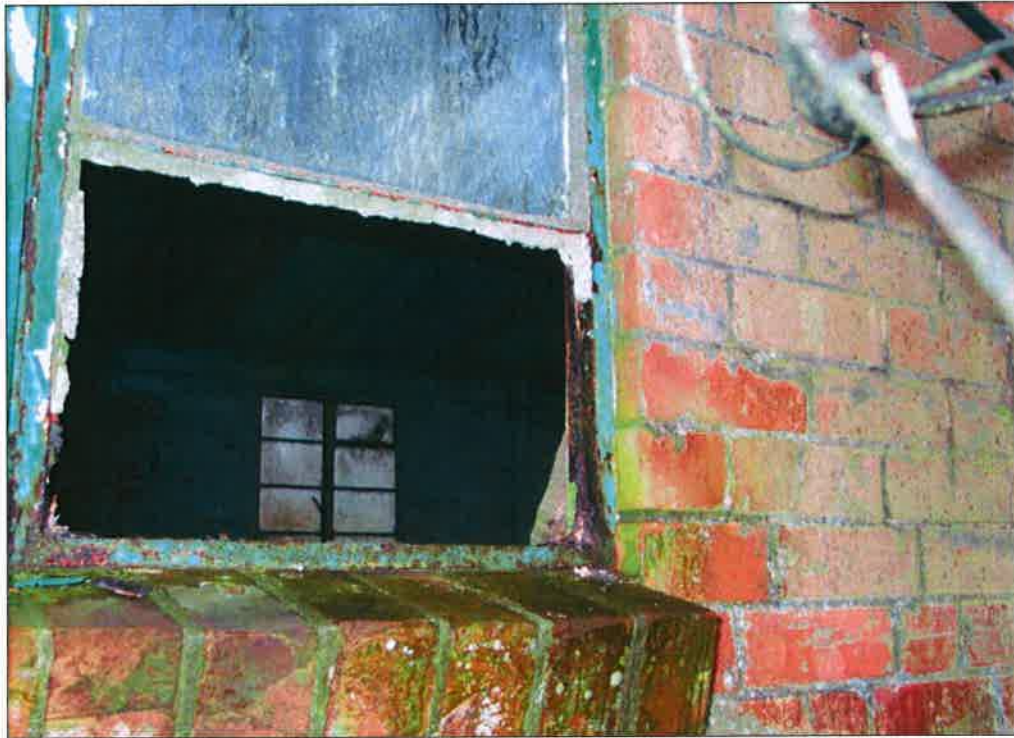
Photograph No. 2

- 3.3 The brickwork walls are reasonably plumb and the coursework approximately level.
- 3.4 The window frames are of the steel type, probably galvanised originally, but which are now heavily corroded (Photograph No. 2).

- 3.5 These window frames have been built in as the building was constructed, with the result that there are no gaps at the junction of the steelwork and brickwork.

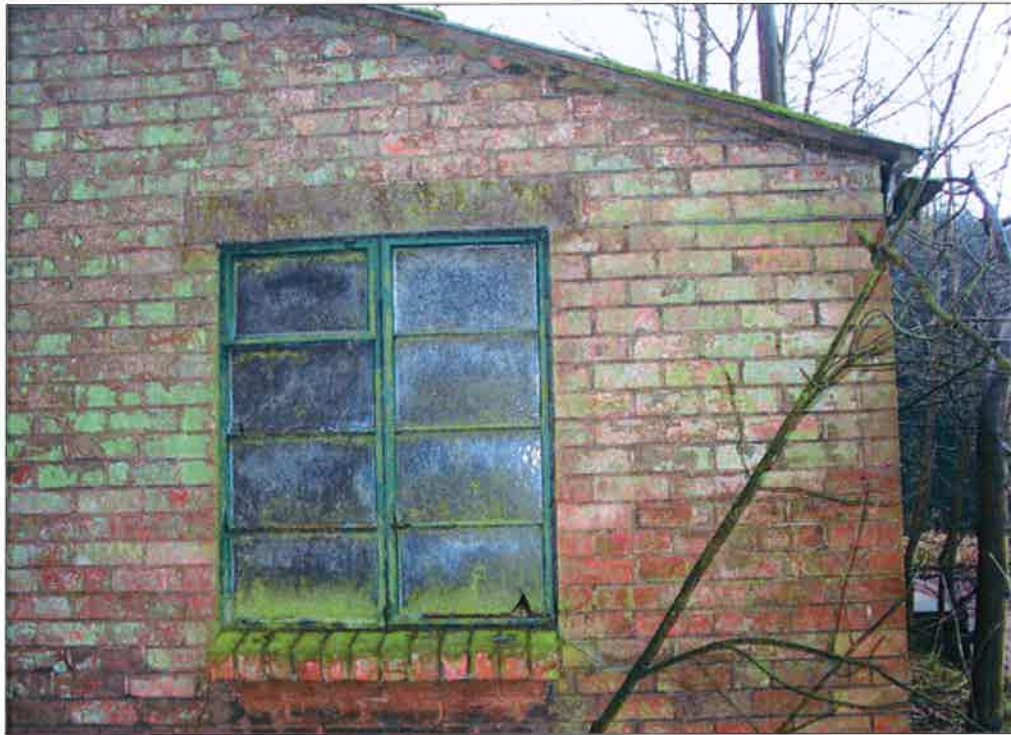
Photograph No. 3

- 3.6 To the north gable elevation there is some 2mm horizontal cracking to the brickwork mortar course extending from the top corners of the windows to the external corners (Photograph No. 3).

- 5.5 All cracked and severely weathered mortar joints should be raked out to a minimum depth of 30mm and be repointed with a mortar which will give some degree of flexibility such as a 1:1:6 (lime) or plasticised mortar. Any cracked, broken or severely weathered bricks should be cut out and new units, of a similar pattern and material, be built in using a mortar similar to that as used in the repointing. When work is carried out adjacent to the damp proof course, great care should be taken to ensure that no damage is done to it or that no mortar bridges across it.

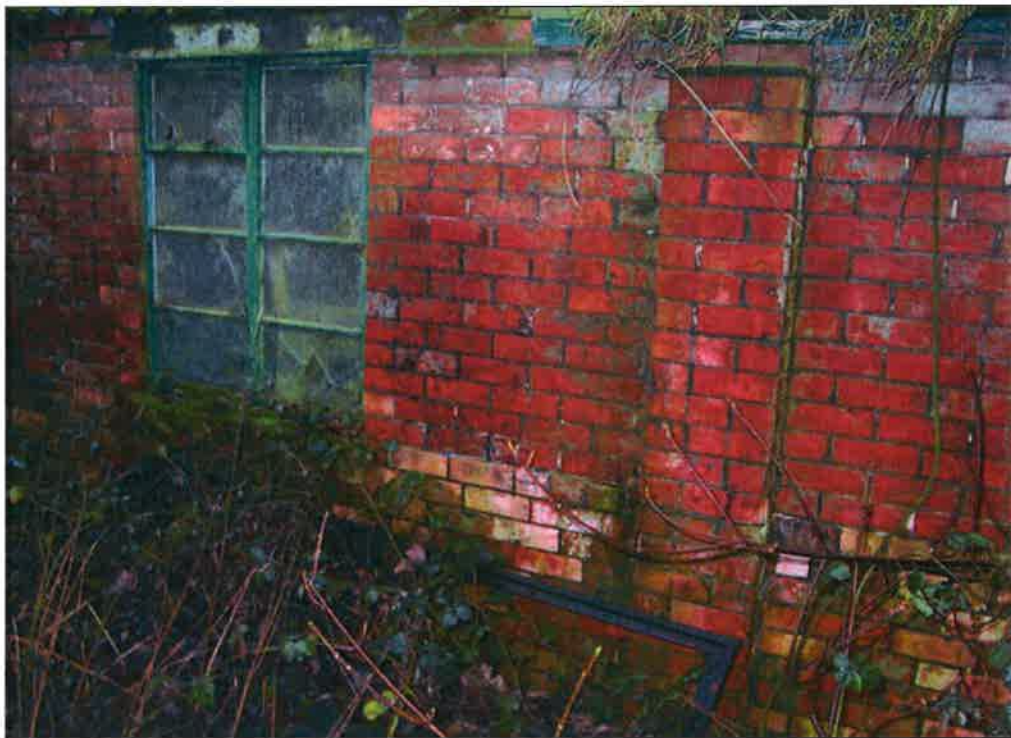
Photograph No. 4

- 3.7 To the east side elevation 1-2mm horizontal cracks extend through the mortar courses from the bottom corner of the window to the bottom corner of the neighbouring window (Photograph No. 4).

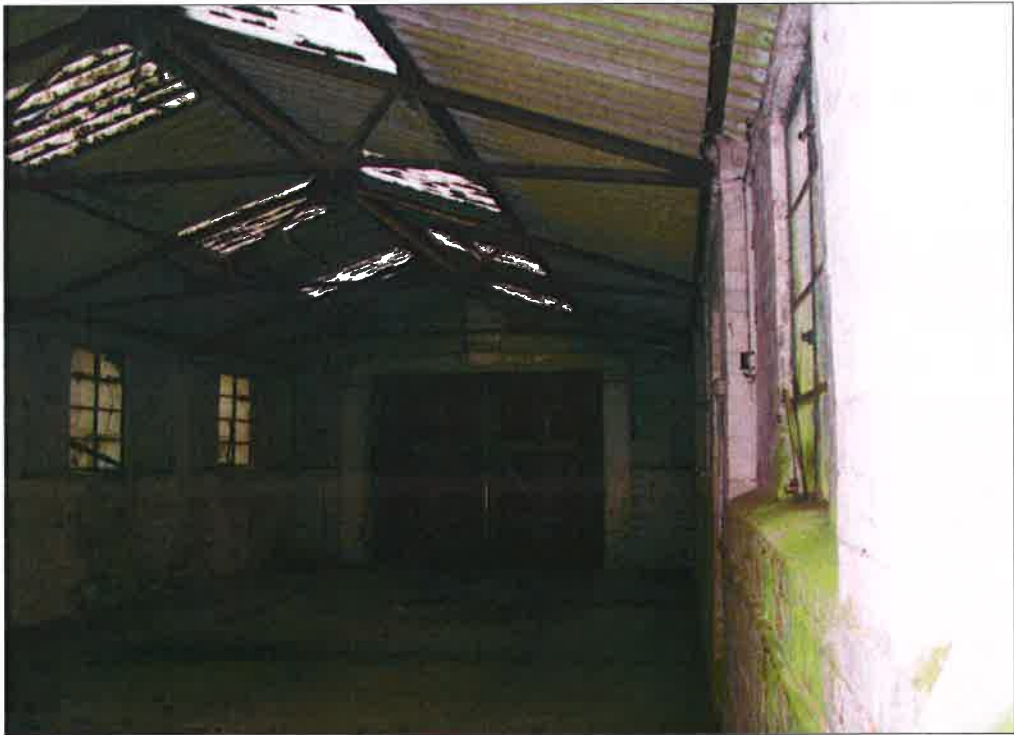
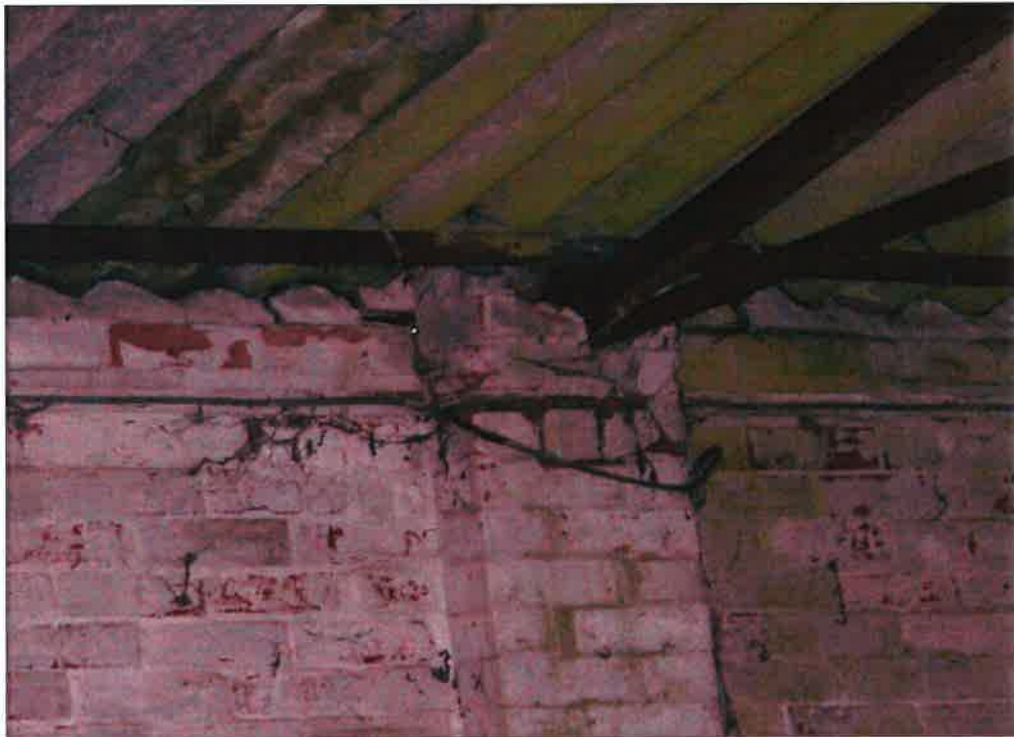
- 3.8 Internally the steel roof trusses, whilst suffering from surface rust, are not in a bad condition but some of the base plates within the brickwork are rusting lifting the brickwork above (Photograph No's. 5 and 6).

- 5.2 The roof covering and gutters should be stripped, the metal trusses including the base plates should be de-rusted and treated, and then the roof-covering reinstated along with new gutters and fallpipes.

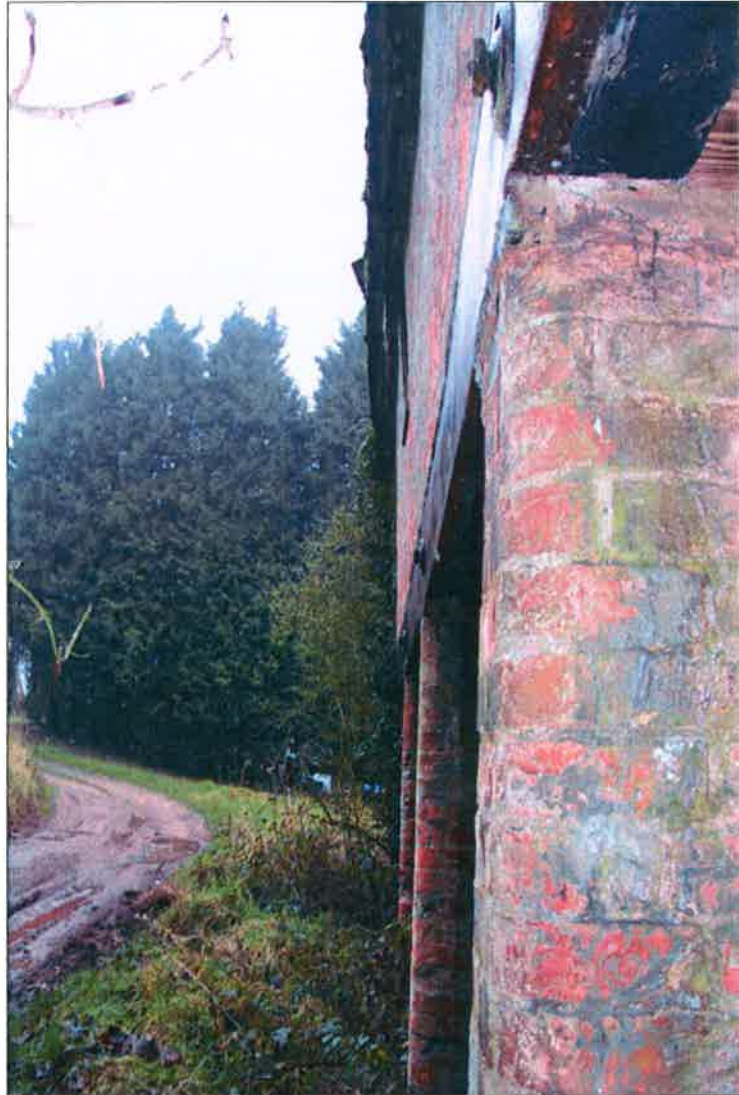
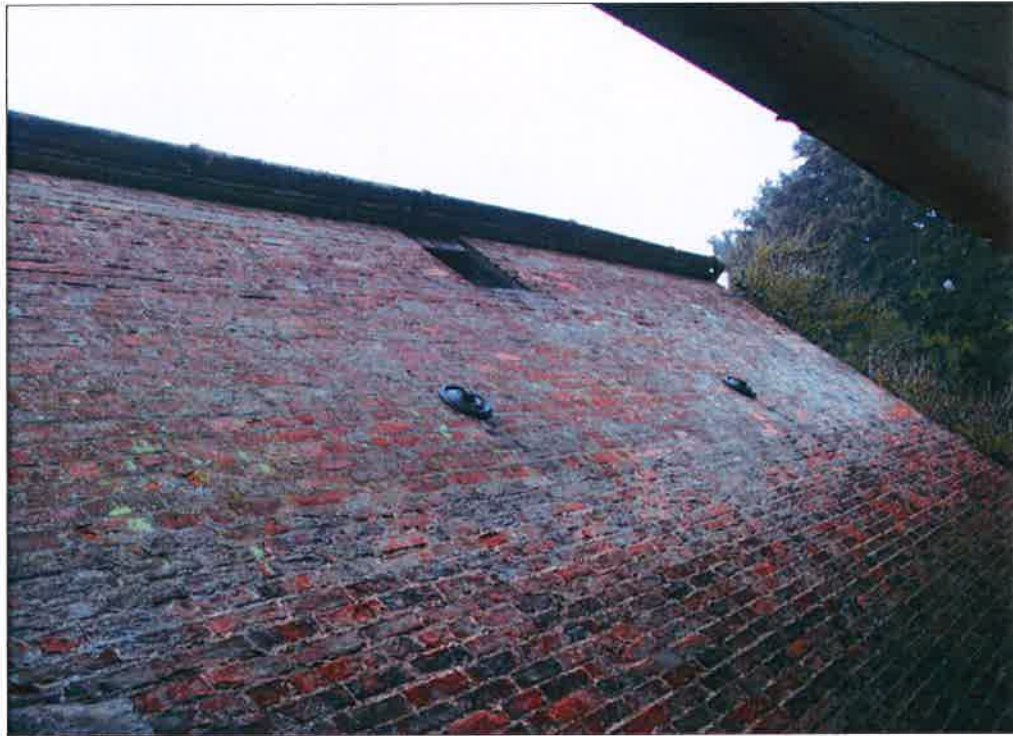
- 3.9 Externally the brickwork walls and brick columns are reasonably plumb at ground floor level, but to the first floor at the south end of the building, the walls lean out to both east and west elevations (Photograph No's. 7 and 8).

- 4.3 The distortion to the walls at high level is a result of water entering the building, softening the timbers and provoking the outbreak of dry and wet rot.

- 5.10 The brickwork to the east elevation where the principal truss has collapsed will have to be taken down and rebuilt.
- 5.11 Our inspection and report are concerned with the structural aspects of the building, such as foundations, walls, floors and roof but we have not concerned ourselves with details of other elements such as doors, windows and other fittings. Similarly we have not commented on dampness or timber infestation or services such as electricity, plumbing, heating or drainage.

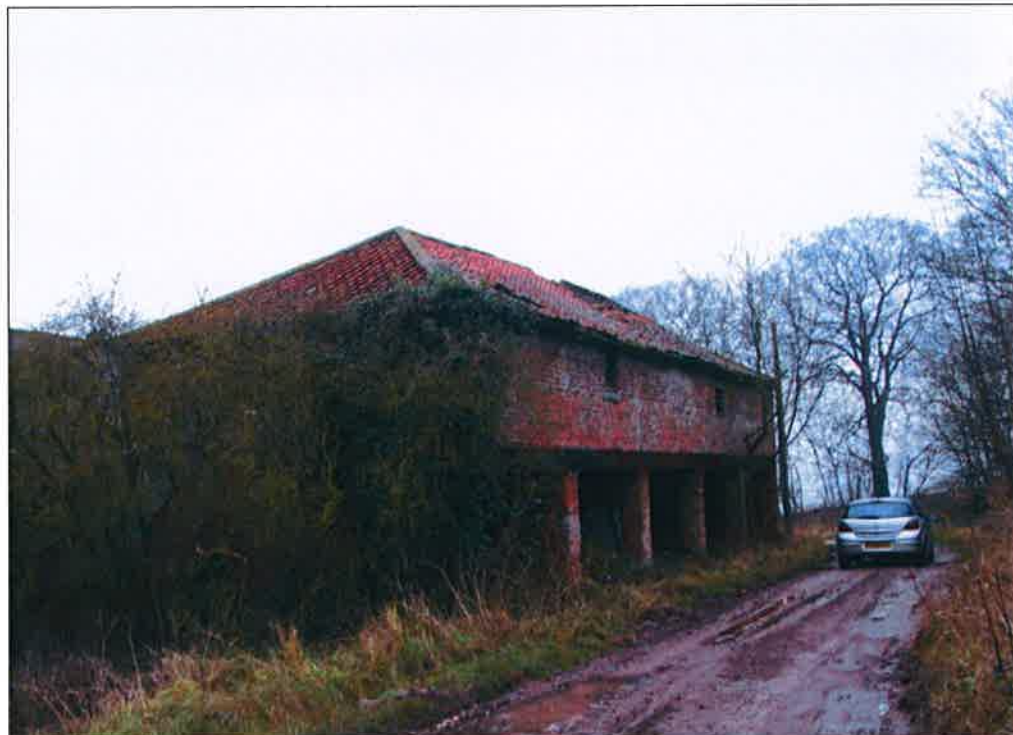
Photograph No. 9

- 3.10 A considerable area of the central roof covering is missing along with some to the south east corner (Photograph No. 9).
- 3.11 Internally the first floor is supported by large timber beams extending across the building in an east west direction. The beam closest to the south end of the building is suffering from rot and the floor to the south of it is collapsing (Photograph No. 10).

- 5.6 The roof should be stripped with the tiles and ridges saved for reuse. All roof timbers should be thoroughly examined as to their condition and treated by a timber specialist for rot. Any defective timber should be renewed.
- 5.7 The roof principal truss bearing should be examined and it may be that steel shoes will have to be fabricated if the rot has spread too far in the timber.
- 5.8 Once the timberwork has been repaired, the roof can be recovered along with new gutters and fallpipes.

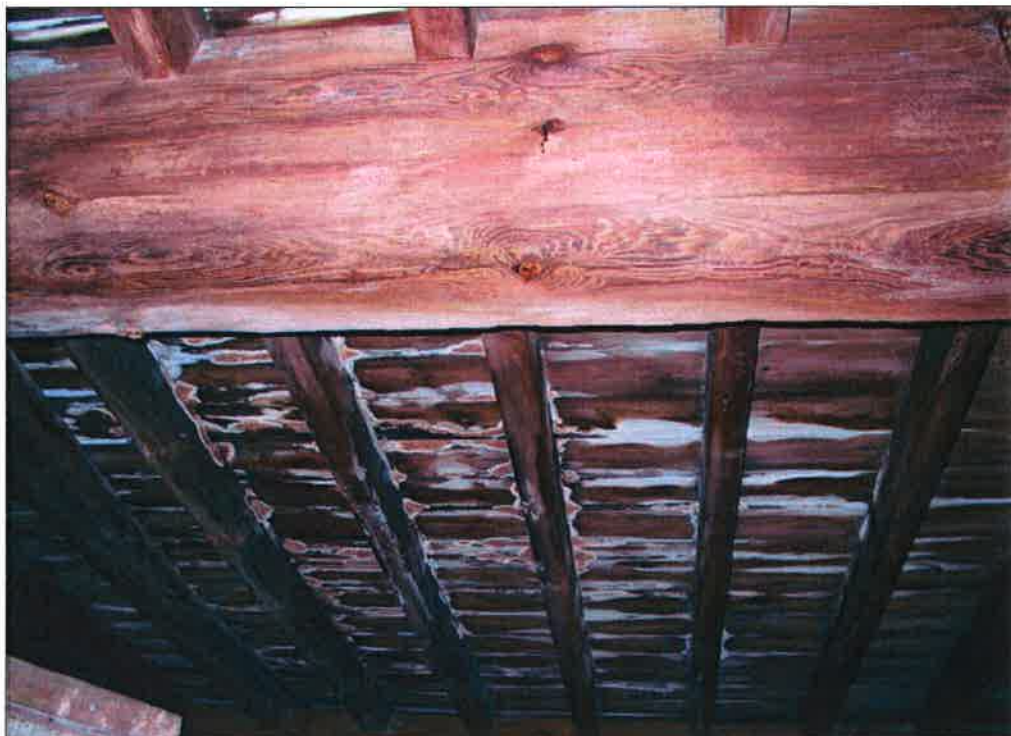
Photograph No. 11

- 3.12 There is an outbreak of dry rot to the first floor timbers beneath the central part of the roof which has the tiles missing. (Photograph No. 11).

- 5.9 The timberwork to the first floor requires similar treatment to that of the roof with any defective elements renewed and all areas treated for rot.

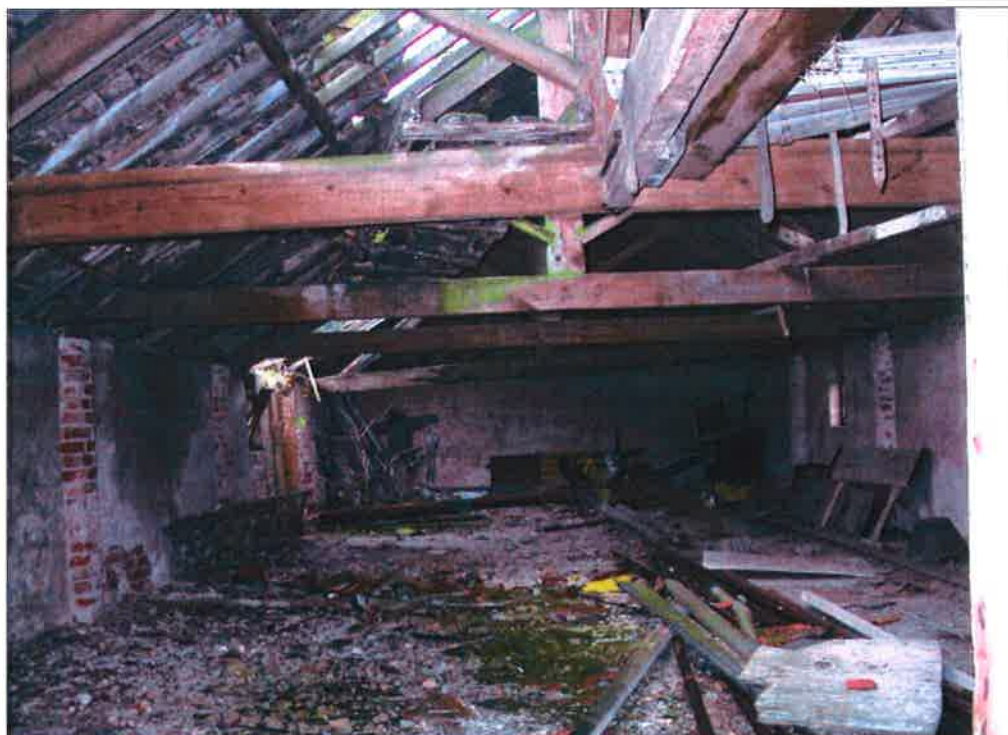
Photograph No. 12

- 3.13 At first floor level the most southerly principal truss has suffered from rot at its bearing to the east wall. The truss has moved down, the movement being resisted by the remaining roof timbers (Photograph No. 12).
