25 August 2010

Structural and Condition Report

The Parochial Church Hall, Church Street, Crowle, Scunthorpe, DN17 4LE.

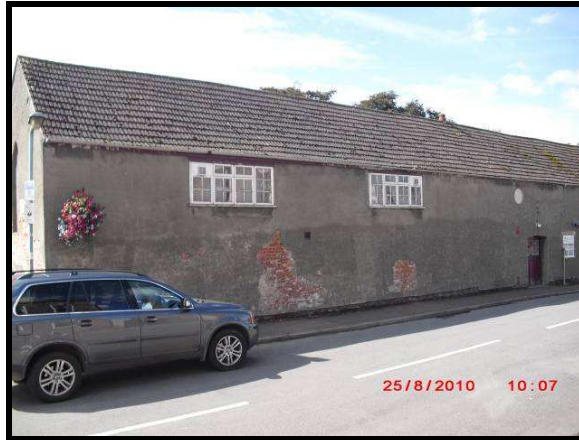
1. North Elevation

The cement rendering is in poor condition with much of it having lost it's key and fallen off or become detached from the brickwork beneath, hacking off all the external render and it's renewal is required therefore.

Finally the top 4 or 5 courses of bricks to the north and south elevations will need to be relayed to be able to provide a suitable base for a wall plate.

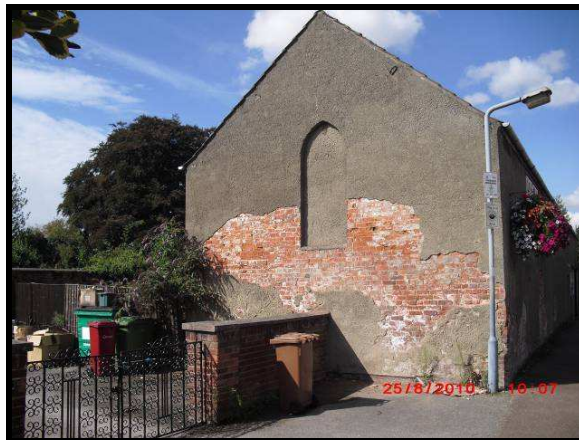
2. East Elevation

walls to lean outwards by as much as 20mm over 1200mm with the east gable wall leaning outwards by 40mm over 1200mm.

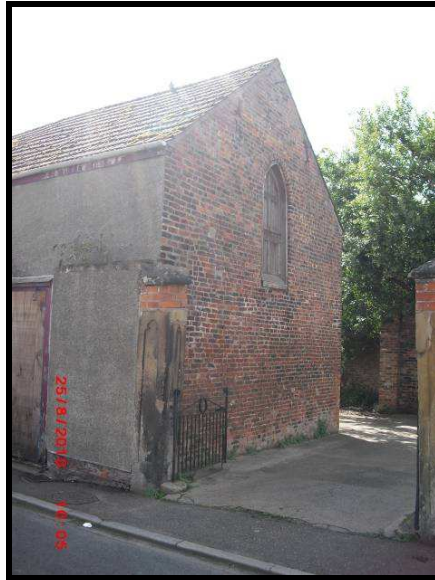
3. West Elevation

The external walls are constructed of 330mm solid brickwork which have been cement rendered to the north and east elevations. There are several infill panels of brickwork which are of 225mm solid construction. Areas of poor patch pointing have been carried to the south and west elevations giving an unsightly appearance.

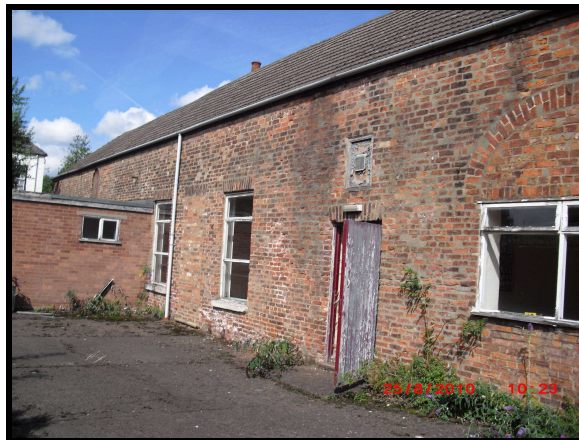
4. South Elevation

The infill panelling has been poorly keyed into the original brickwork providing poor structural continuity to the brickwork panel and thus reducing the overall stability of that section of wall most particularly to the south elevation. Rebuilding and properly tying in of these sections on infill panels is necessary.

The brickwork is showing signs of deterioration caused by weathering and water ingress particularly to the south elevation, (it is likely the north and east elevation have been rendered to cover over more severe weathering). Areas of the worst affected brickwork do need to be cut out and replaced, this will however give a patchwork quilt appearance to the e elevations.
