TECHNICAL REPORT ON A SUBSIDENCE CLAIM

Crawford Reference: SU1105866

**Mrs Sutton
West End Farm, Hew Lane
Winteringham
Scunthorpe
South Humberside
DN15 9NR**

SUBSIDENCE CLAIM

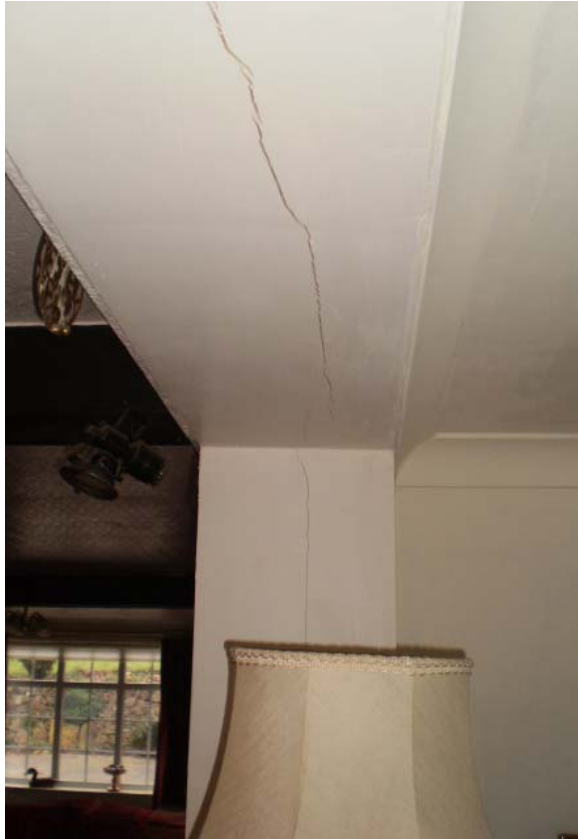
First floor rear bedroom

- 2.5mm vertical crack noted below window to right-hand flank
- 2mm vertical staggered crack was observed bottom left of rear window
- Rucking observed to paper along junction of wall and ceiling

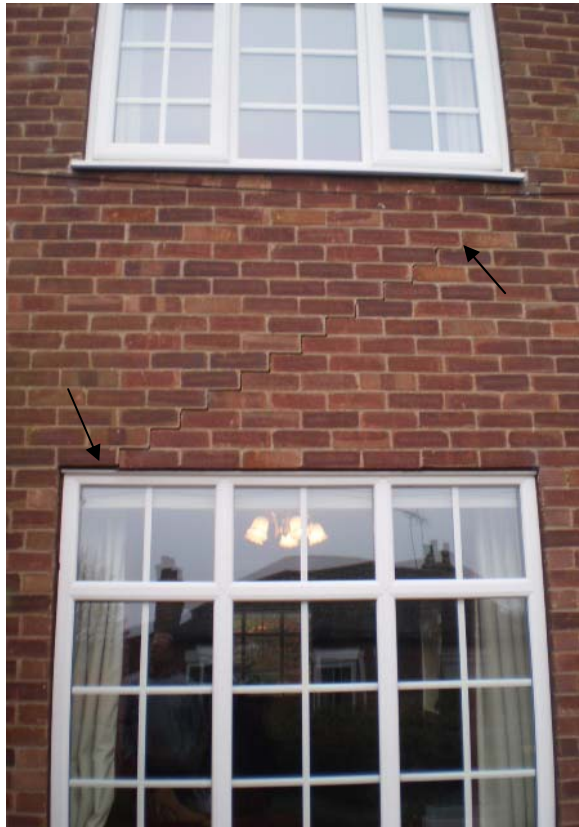
Extension right flank above ground floor window

- 8mm diagonal step crack observed to be extending bottom ground floor window
- 8mm diagonal step crack noted above ground floor window. Crack extends up towards bottom right of first floor window into a 1.5mm cracking. The brick lintel above the ground floor window has dropped by 12mm
- 11mm step crack noted top left of first floor bathroom window
- 1.5mm horizontal crack noted to be extending from ground floor window cill toward rear right corner of extension. Crack continues around onto right flank of single storey projection

The cause of movement (in this case, water escaping into the ground from leaking drains) needs to be addressed.

Once drainage repairs have been completed, due consideration may be given to superstructure repairs. A schedule of remedial works will be obtained and works may commence once the scope has been approved.

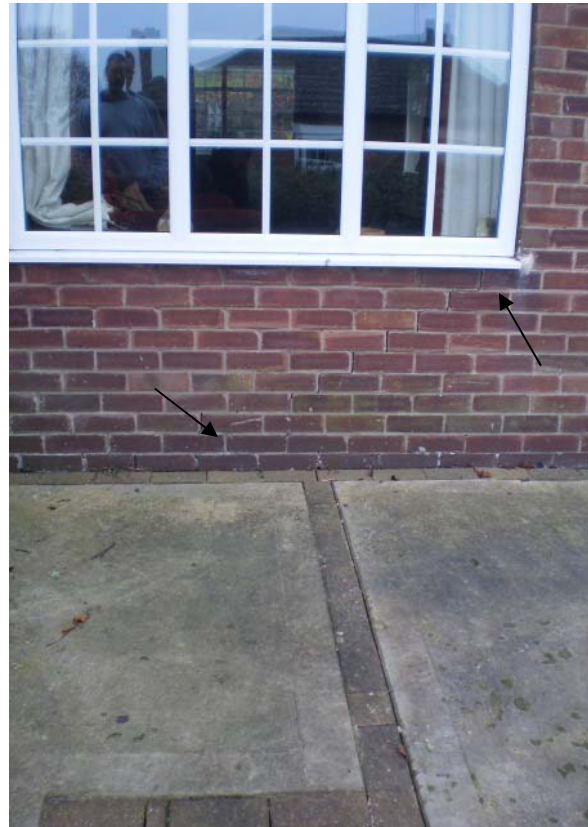
Extension right flank below ground floor window

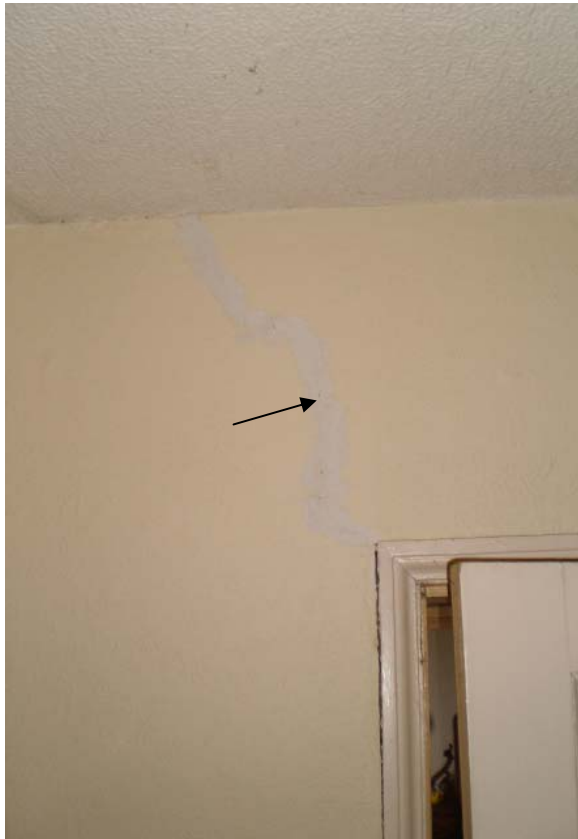
Damage noted within the first floor front right hand bedroom is not considered to be linked to the recent events. Historic distortion was noted to the floor and the damage to the dividing wall is long-standing in appearance.

Historic damage to first floor front right hand bedroom

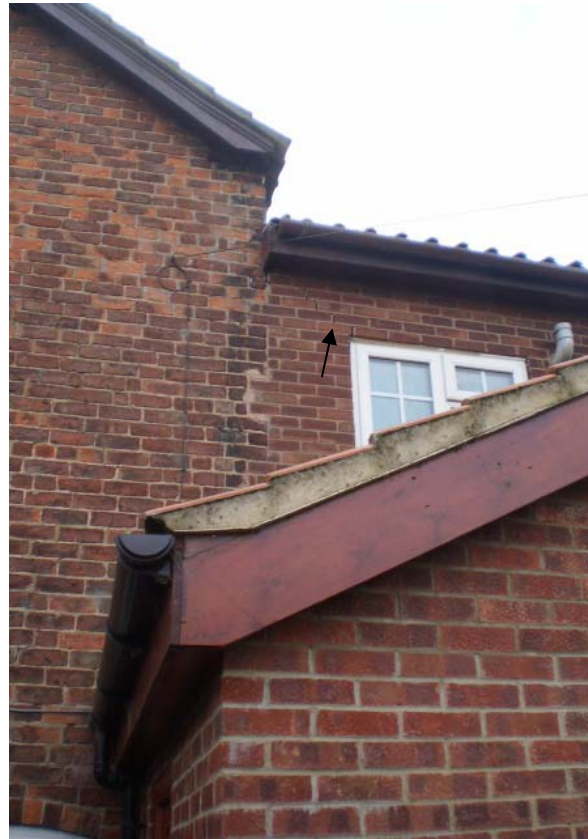
Right hand flank – damage top left of bathroom window

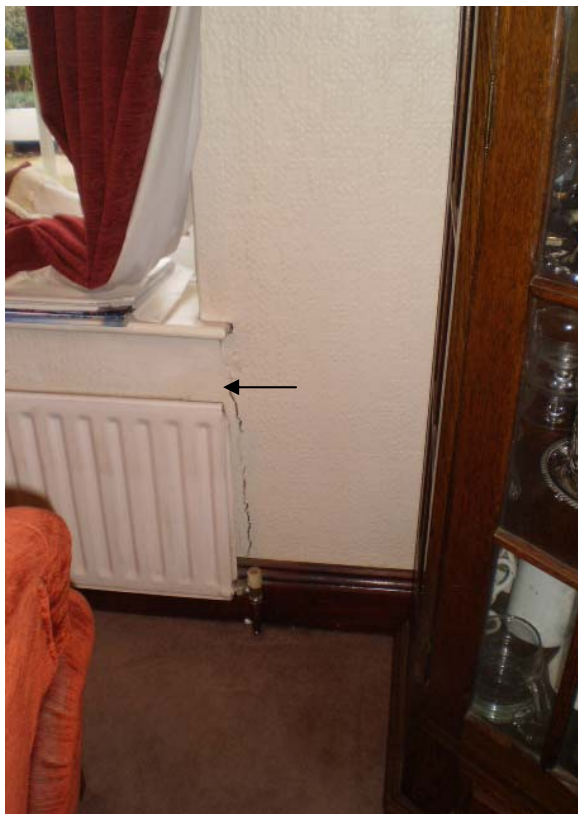
- 2.5mm cracking noted to beam above opening to rear extension. Crack span from left to right
- 3mm vertical crack noted bottom right of window cill to right hand flank. Crack extends down to skirting board level
- 1.5mm crack noted below rear window cill

Rear ground floor sitting room – right flank

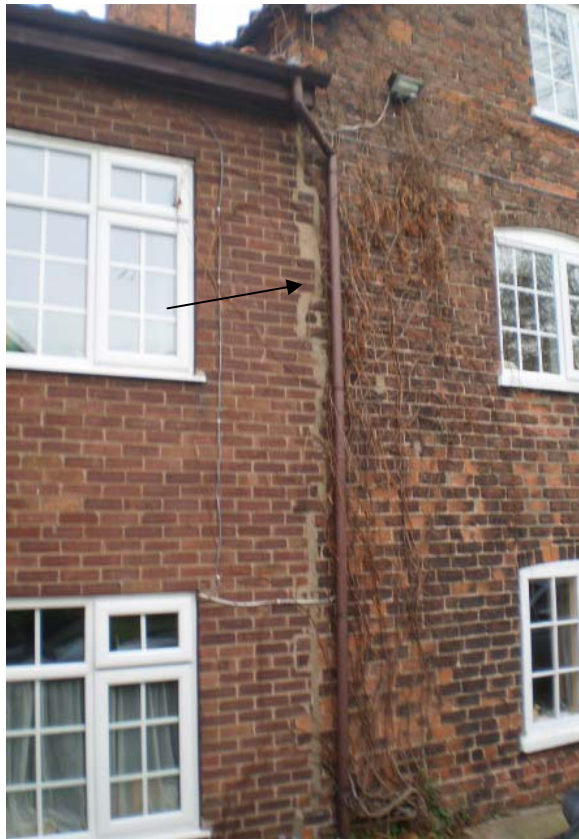
Historic damage noted to left hand flank
junction of extension and main house
