## **PRE-DEVELOPMENT ARBORICULTURAL IMPACT APPRAISAL AND REPORT**

**BARTON SCHOOL  
BARROW ROAD  
BARTON upon HUMBER  
NORTH LINCOLNSHIRE  
DN18 6DA**

**NEW OPTIONS LTD**

Ref: LTS/13023/New Options Ltd

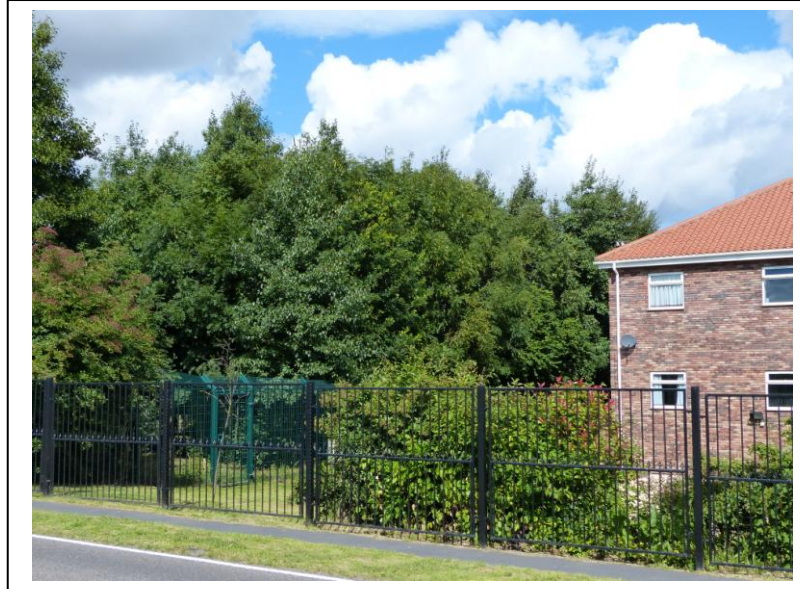
**Picture 1**

The position of the proposed access is located through the railings to the left of the picture. The Italian alder on the extreme left-hand side stands in the roadside belt being retained.

The roots of the closest tree at the eastern end of the belt may need to be physically protected where the temporary route passes it. This is likely to take the form of a raised, “no-dig” type of construction for the track, as well as a protective barrier fence for the trunk lining its southern margin. Since the exact location of the route margin is not known at this time, this information will require more detail under reserved matters.

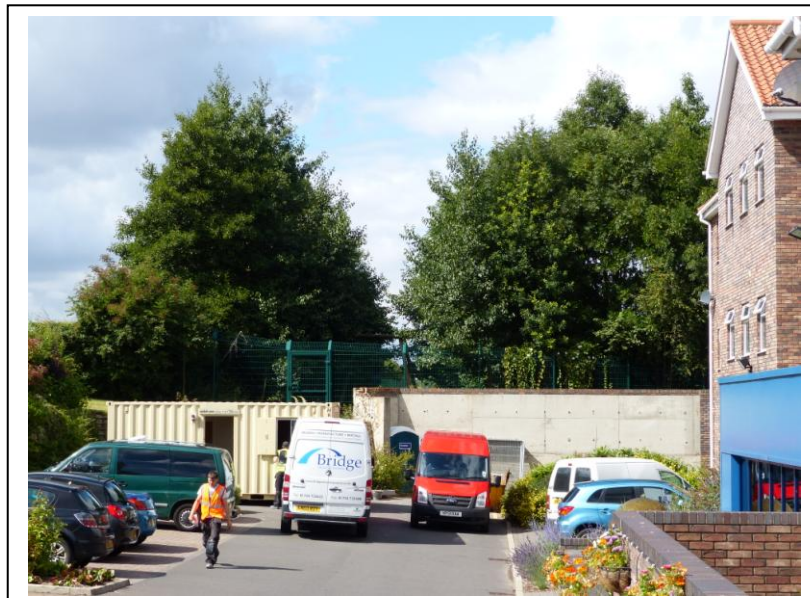
**Picture 2**

A general view of the site from the east. The retained roadside tree screen stands to the left. The trees in the main copse which are to be removed are growing to the right of the gap created to accommodate the zip-wire apparatus.

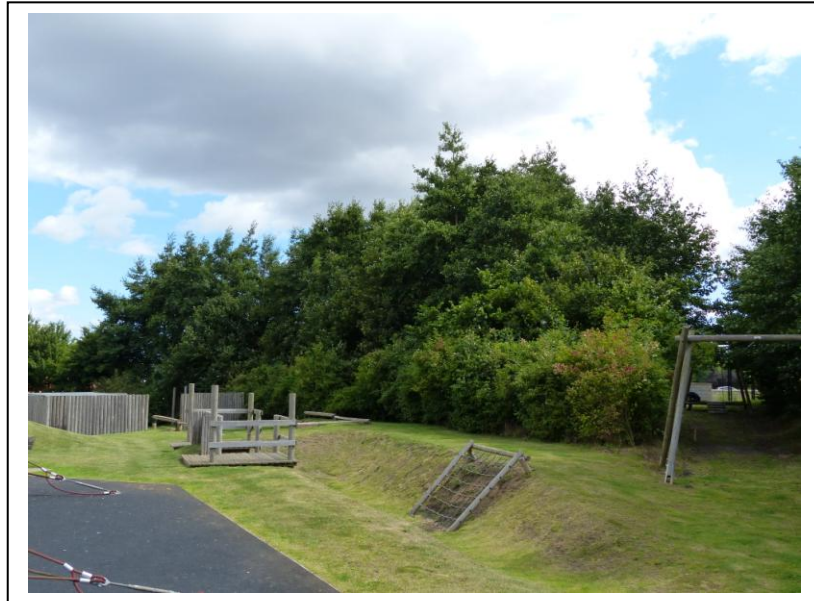
**Picture 3**

View from the west showing the main group of trees to be removed. Those to the far left of the group will be retained, as will the group of shrubs in the foreground immediately to the left of the zip-wire frame.

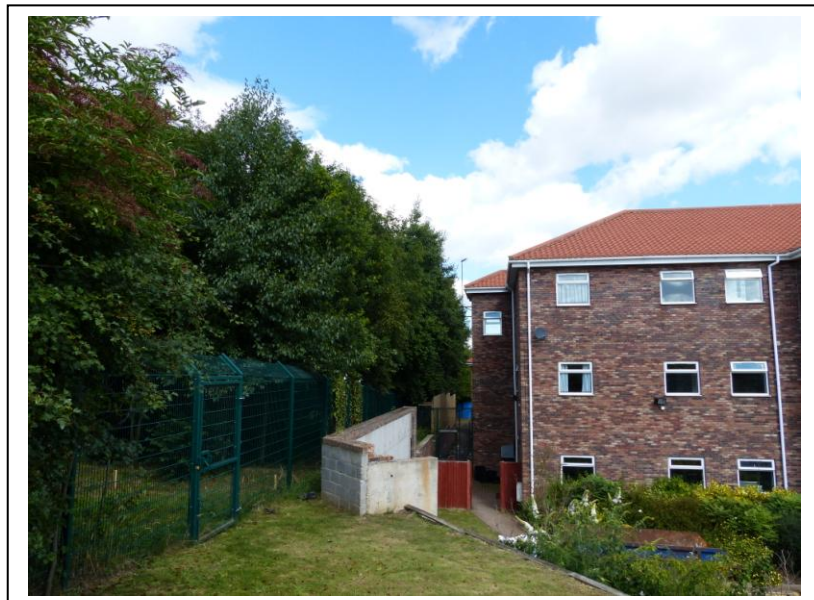
**Picture 4**

The site viewed from the south showing the proximity of trees to the building. The trees beyond the green fence are those to be removed, whilst the gate indicates the approximate location of the temporary access.

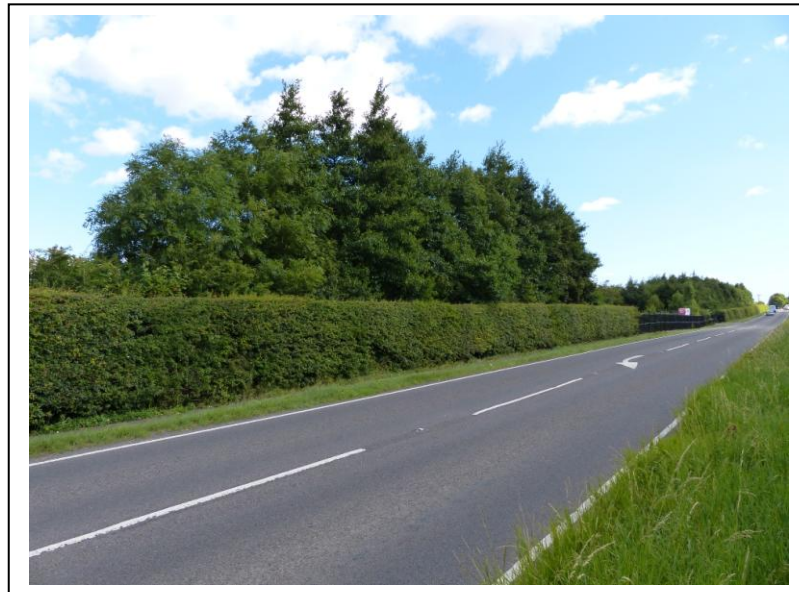
**Picture 5**

The copse viewed from the south-west. All the trees shown comprise the roadside belt which will remain intact.

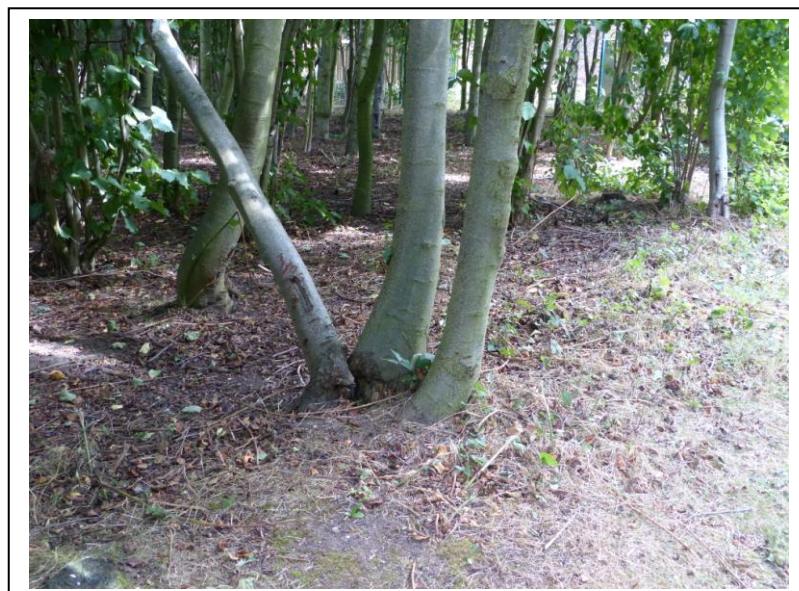
**Picture 6**

The copse margin beside the zip-wire showing the failure of a coppiced alder stem and the open aspect of the woodland floor with its absence of ground flora.
