**PRE-DEVELOPMENT ARBORICULTURAL  
IMPACT APPRAISAL AND REPORT**

**PLOT B  
CHRISTINE CLOSE  
YADDLETHORPE  
SCUNTHORPE  
NORTH LINCOLNSHIRE  
DN17 2AT**

**MR D & MRS J STURMAN**

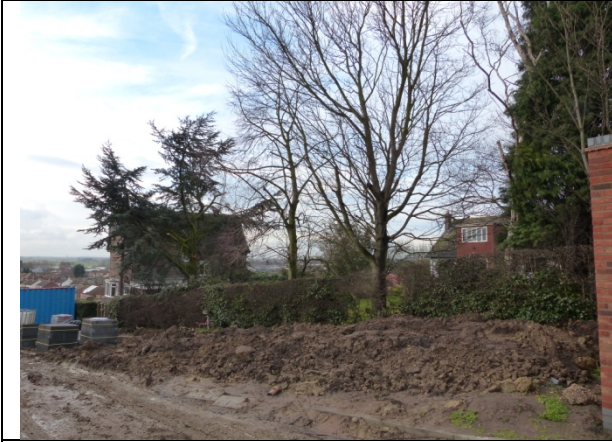
**Picture 1** – showing cedar T1, lime T2 and Norway maple T3 to rear of boundary hedge H1.

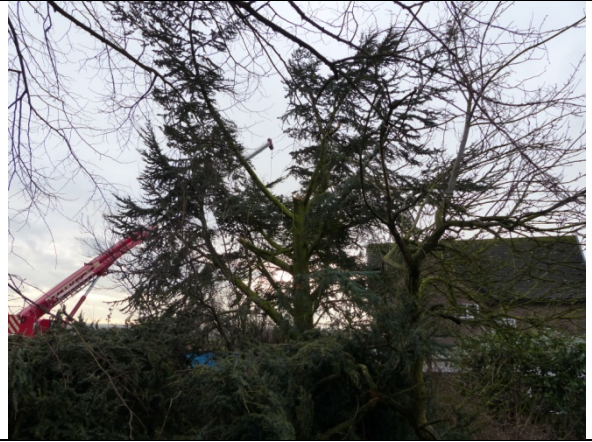
The trees and boundary hedge to the rear of 49a Moorwell Road present as an attractive screen and form a useful shelterbelt to the property which stands in an elevated location on top of The Cliff. The recent storms of November 2013 have inflicted significant damage to the blue Atlas cedar T1. The entire upper crown and several main branches have been broken out, equating to an estimated 25% of the canopy. Although the remaining growth is healthy and likely to survive, I am compelled to rate this tree as "Unclassified" under British Standard 5837:2012. The common lime T2 and the Norway maple T3 are in good physiological condition and are structurally sound. Various branches have been badly pruned back from the south side of both trees by a previous owner of the neighbouring land. They are located closest to the development on Plot B in Christine Close and both are worthy of retention. The boundary hedge, which comprises hawthorn, holly and ivy, has been well-maintained by annual clipping and forms a useful visual screen affording some security to the rear garden. It continues to provide additional functions as a windbreak and as shelter for wildlife.

Tree No	Species	Age Class	Condition	Height (m)	Crown Spread (m)	DBH (mm)	Root Protect Radius (m)	Remarks / Recommendations	Retn Code
T1	Blue Atlas cedar <i>Cedrus atlantica</i> 'Glauca'	EM	Phys Good  Struct Poor	13	N - 4 S - 6 E - 5 W - 5	552	N/A	3 <sup>rd</sup> party tree growing in rear garden of 49a Moorwell Road. Sound root collar and graft union. Sound, erect trunk to first major lateral limb at 2.5m to S. Lower crown above radiates evenly in all quarters. Upper crown devastated by recent storms, having its entire central trunk blown out at 6.5m. Falling top remains on ground with diameter of approx. 300mm where fractured. Several substantial secondary branches shattered or completely torn out by falling section during same event. Owners have expressed a wish to retain the tree to keep the screening it affords intact. <b>Owners to retain tree and reduce/ reshape crown to disguise defects. Note – this tree will require regular re-inspection and reduction on a 3 - 5 year basis depending on rate of regeneration. This work must be completed to ensure the tree's hazard rating remains acceptably low.</b>	U

**Picture 2** – Cedar T1.

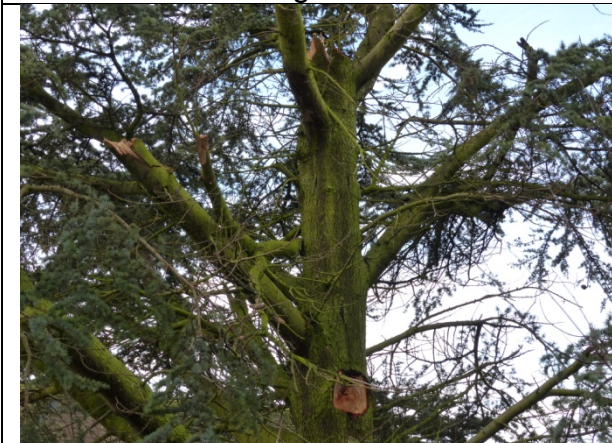
**Picture 3** – close-up detail of damaged cedar.

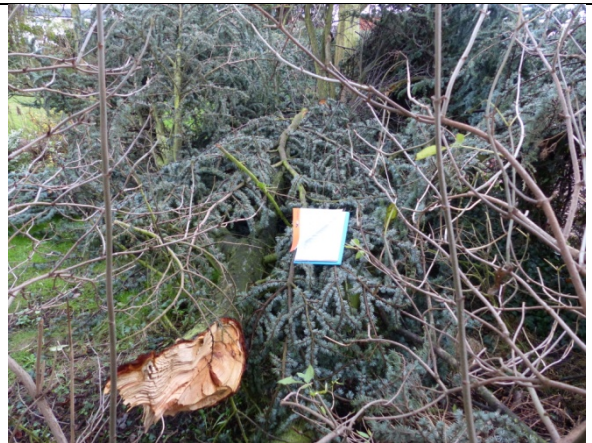
**Picture 4** – close-up of fallen cedar top with clip-board for scale.

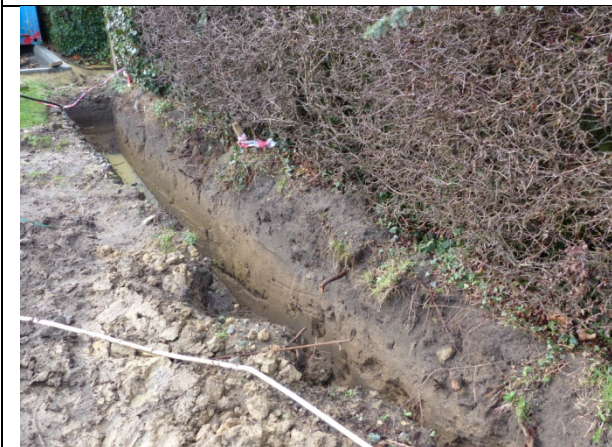
The trench has been mechanically dug immediately alongside the boundary hedge and has severed roots in the process. The majority of the exposed root material measures less than 15mm in diameter. A single cedar root has been exposed and severed at 20mm in diameter, with the remaining material being hawthorn roots from the hedge. The presence of rooting material is to be expected at this proximity. However, the impact of the damage on the hedge will be negligible because it is tightly clipped and does not carry a great quantity of foliage as a result of its maintenance. The vigour of this summer's growth may be slightly impaired but the affected plants are unlikely to die.

**Picture 5** – showing trench beside hedge H1. Note absence of major roots.
