Saxby Hall, Saxby All Saints

TREE SURVEY REPORT

25th July 2016.

Prepared by: David Brown BSC (HONS), MICFor

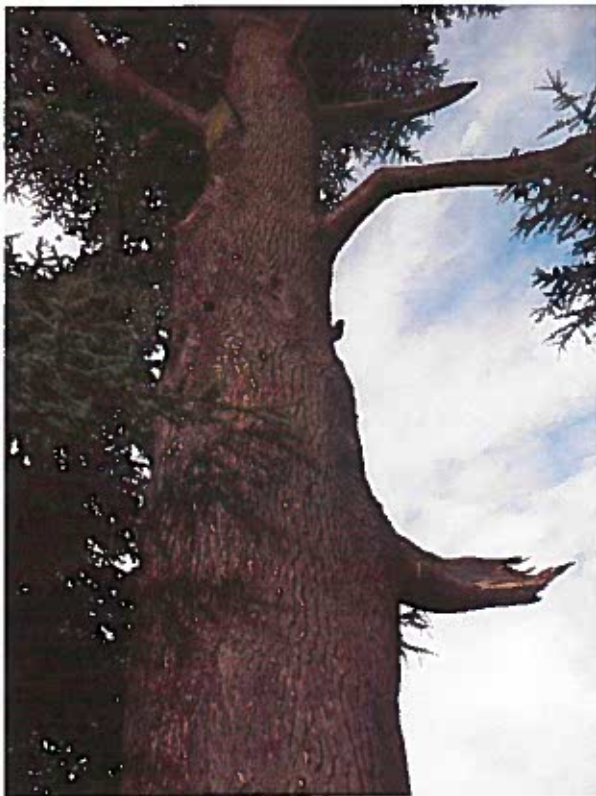
1st and 2nd stubs

First limb stub at 320° should be cut back to the main stem collar, slightly to the west of this is a previously severed limb, which is showing signs of occluding albeit very slowly.

Second limb stub again is to be cut back to main stem collar above, this to reduce deadwood. The two stubs (fractured limbs) should be pruned back to correct branch collar target points e.g. back to the main stem – this to avoid any potential for further decay.

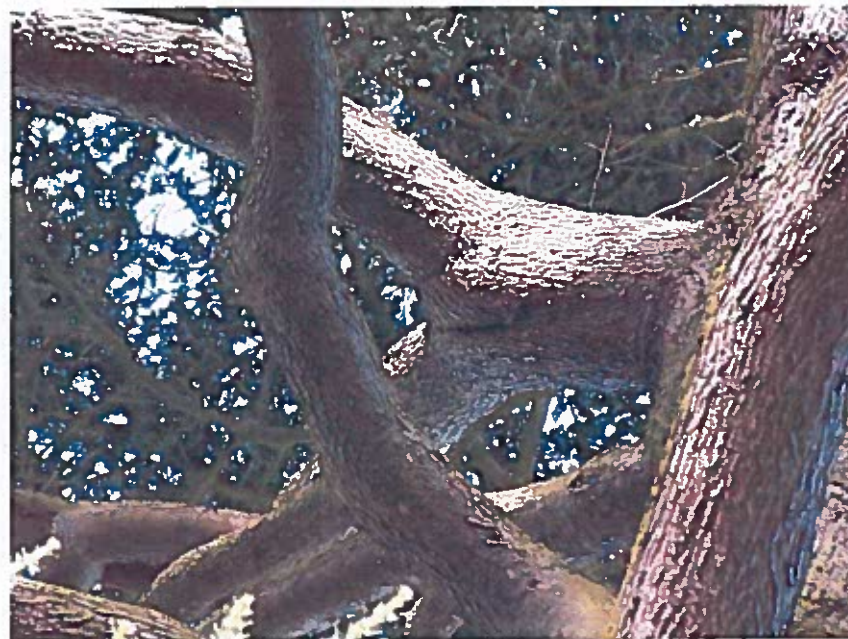
Third (at 230°) southern limb from ground level - reduce by 20% then rebalance and reshape. Seventh scaffold limb (at 200°) of 45cm diameter (est.) extends from the main stem by 90 centimetres then divides into two main laterals, at this point the union is weak and shows signs of dividing, in order to allivate pressure at this point the laterals should be end weight reduced by 20%.

Seventh scaffold limb showing weak union.

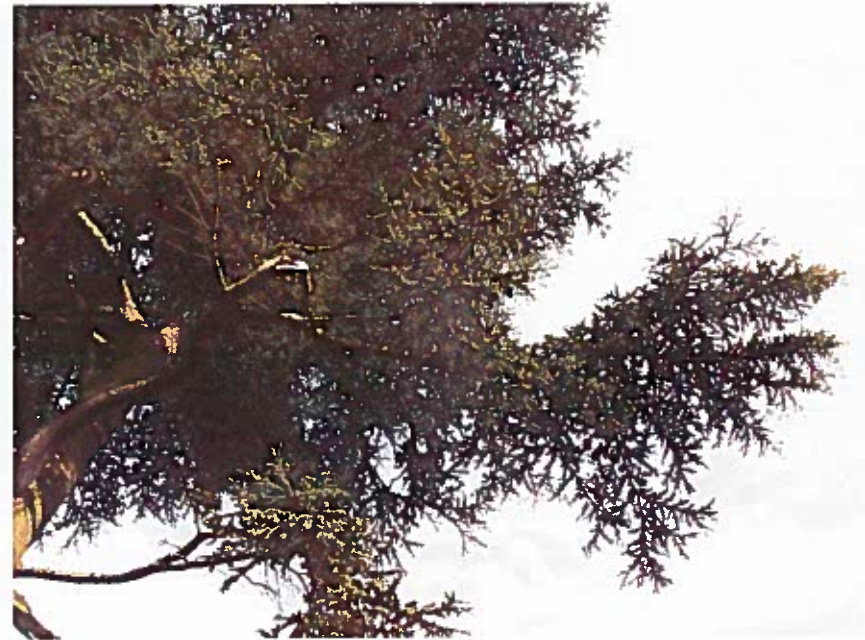
Severed eastern Limb

Eastern limb (Photo shows severed branch) should be reduced back to main scaffold limb with end weight reduction to the remainder.

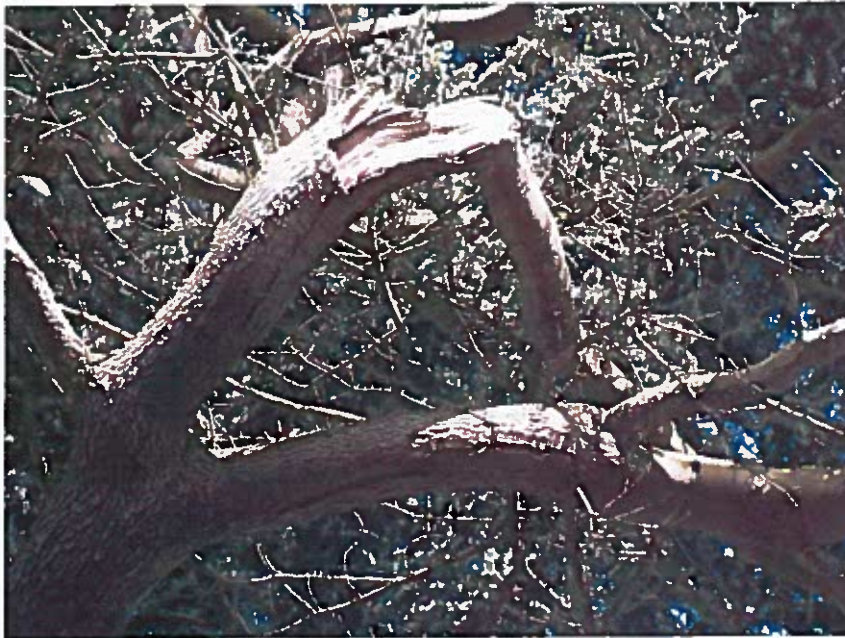
Severed Eastern Limb
