**Arboricultural Report and Tree Condition Survey  
For Proposed Residential Development at  
Land to the Rear of  
41 High Street,  
Burton upon Stather,  
Scunthorpe,  
DN15 9DG**

**Prepared  
for  
Mr and Mrs Clark**

Prepared by  
John Graham PhD BSc ND (Arb)  
JFG Consultancy

Our Ref D/01/25/05/16/JG  
May 2016

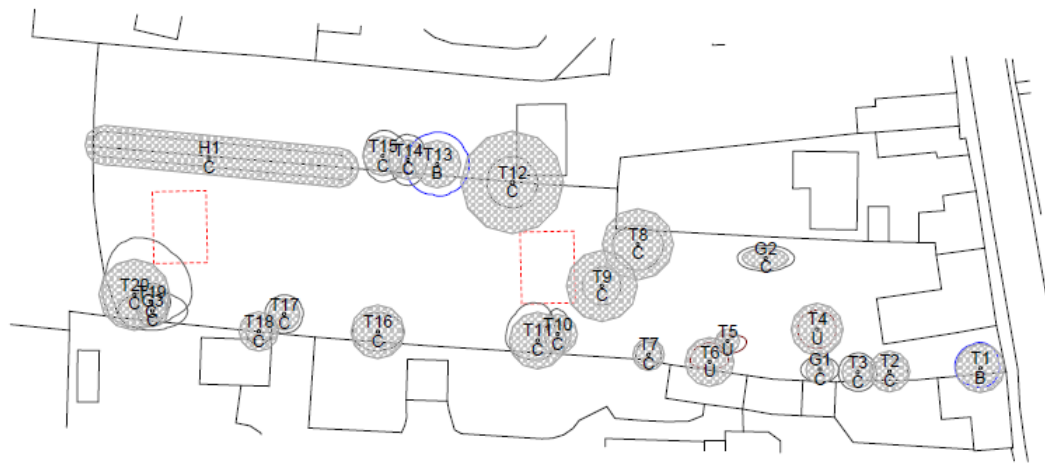
Tree Constraints Plan 01. 05/05/2016  
Scale 1:500 @A3  
41 High Street, Burton upon Stather,  
Scunthorpe, North Lincolnshire, DN15 9DG

Tree No.	Species	Hgt (m)	Dia. @ 1.5m (mm)	No of stems	CS N (m)	CS E (m)	CS S (m)	CS W (m)	ER CY	Vig.	Form	Age Class	Description	Works	BS Cat
T1	Crab Apple	5	310	1	4	3	3	4	20+	A	A	M	An ornamental tree in reasonable condition planted in shrub bed to south of the site.	No Works	B1
T2	Crab Apple	7	260	1	2	3	2	3	20+	A	A	M	As per T1.	No Works	C1
T3	Crab Apple	6	200	2	3	3	3	3	20+	A	A	M	As per T1.	No Works	C1
T4	Domestic Apple	5	330	1	3	3	3	3	<10	P	A	OM	An old fruit tree with signs of die back loss of vigour and some cavities.	Fell as in decline	U
T5	Domestic Apple	4	180	2	1	2	2	2	<10	A	A	OM	As per T4.	Fell as in decline	U
T6	Cedar	7	310	1	3	3	1	3	10	A	P	SM	An ornamental tree planted close to a third party building. This tree will need to be removed in order to avoid damaging the building.	Fell as too close to third party building	U
T7	Juniper	4	200	1	2	2	2	2	10	A	P	SM	As per T6	Fell as too close to third party building	C1

T8	Pear	6	450	1	3	4	4	4	10	P	A	OM	An over mature fruit tree with a large cavity in its main stem, signs of die back and loss of vigour	No Works	C1
T9	Maple	6	450	1	3	3	3	3	20+	A	P	SM	An ornamental tree located in the centre of the rear garden. This tree has been heavily crown reduced and is of low amenity value.	Fell for proposed development	C1
T10	Birch	14	260	1	4	2	3	2	10	A	A	SM	This tree appears to have been topped at about 4m in height. A new leader has grown from the site of the wound and is a possible hazard.	Fell for proposed development	C1

Tree No.	Species	Hgt (m)	Dia. @ 1.5m (m)	No of stems	CS N (m)	CS E (m)	CS S (m)	CS W (m)	ER CY	Vig.	Form	Age Class	Description	Works	BS Cat
T11	Birch	13	360	1	6	3	3	5	10	A	A	SM	As per T10	Fell for proposed development.	C1
T12	Leyland Cypress	14	650	2	4	4	4	4	20+	A	P	EM	a third party tree growing very close to their property.	To be felled by third party	C1
T13	Ash	15	300	1	5	5	5	5	20+	A	A	SM	A large spreading tree that dominates this part of the rear gardens. The tree has reasonable form and appears to be in reasonable condition.	No Works	B1
T14	Willow	11	200	1	3	3	3	3	20+	P	P	SM	This third party tree is planted close to the north boundary. The tree is suppressed and has poor form.	No Works	C1
T15	Walnut	11	250	1	3	3	3	3	20+	A	P	SM	As per T14.	No Works	C1
T16	Cherry	6	340	1	3	4	3	4	20+	A	A	SM	An ornamental tree planted in a shrub bed to the west of the side. The trees in this area form a dense planting. The trees are individually of limited landscape value.	No Works	C1

T17	Rowan	7	200	1	3	3	3	3	20+	A	A	SM	As per T16.	No Works	C1
T18	Lawson Cypress	8	220	2	2	2	2	2	20+	A	A	SM	As per T16.	No Works	C1
T19	Birch	18	220	1	3	3	3	1	20+	A	A	SM	A tree that forms part of a small planting to the south-west corner of the rear garden. The tree has a phototropic habit.	No Works	C1
T20	Weeping Willow	18	450	1	7	7	7	7	10+	P	P	M	This ornamental tree is the largest tree on site. Its landscape impact is limited by its location and the presence of adjacent trees. There is dieback/anthracnose throughout the crown and the tree has a pronounced lean.	Fell for proposed development.	C1

Tree No.	Species	Hgt (m)	Dia. @ 1.5m (m)	No of stems	CS N (m)	CS E (m)	CS S (m)	CS W (m)	ER CY	Vig.	Form	Age Class	Description	Works	BS Cat
TG1	Cypress & Yew	6	180	1	2	2	2	2	10+	A	A	SM	A small dense group of ornamental conifers of low landscape impact.	No Works	C2
TG2	Cypress Hawthorn Hazel and Yew	4	150	1	2	2	2	2	20+	A	A	SM	A dense planting within an ornamental bed.	No Works	C2
TG3	Cypress Birch and Poplar	15	200	1	3	3	3	3	10+	A	A	SM	A small dense planting to south- west corner of garden. The group is of low landscape impact due to location.	No Works	C2
H1	Leyland Hedge	12	300	1	3	3	3	3	20+	A	A	EM	A third party hedge that is maintained on subject site side to 3m in height.	No Works	C2

- 4.2 The vegetation to be removed to allow for the proposed development is the over-mature Apples T4 and T5, the Cedar T6 and Juniper T7, which are very close to third party building, a previously topped Maple T9, the two Birch trees T10 and T11 (topped in past) and T20 a Weeping Willow with anthracnose and associated dieback. With regard to the size and location of the trees to be removed it is felt that the removal of this vegetation will not impact on the wider area. In addition these removals can be mitigated by new planting within the garden of both the existing and proposed properties.
