ARBORICULTURAL SURVEY

***Midby Park,
High Street,
Barrow Upon Humber,
DN19 7AA***

Barrow upon Humber Parish Council

Ref: AWA1765

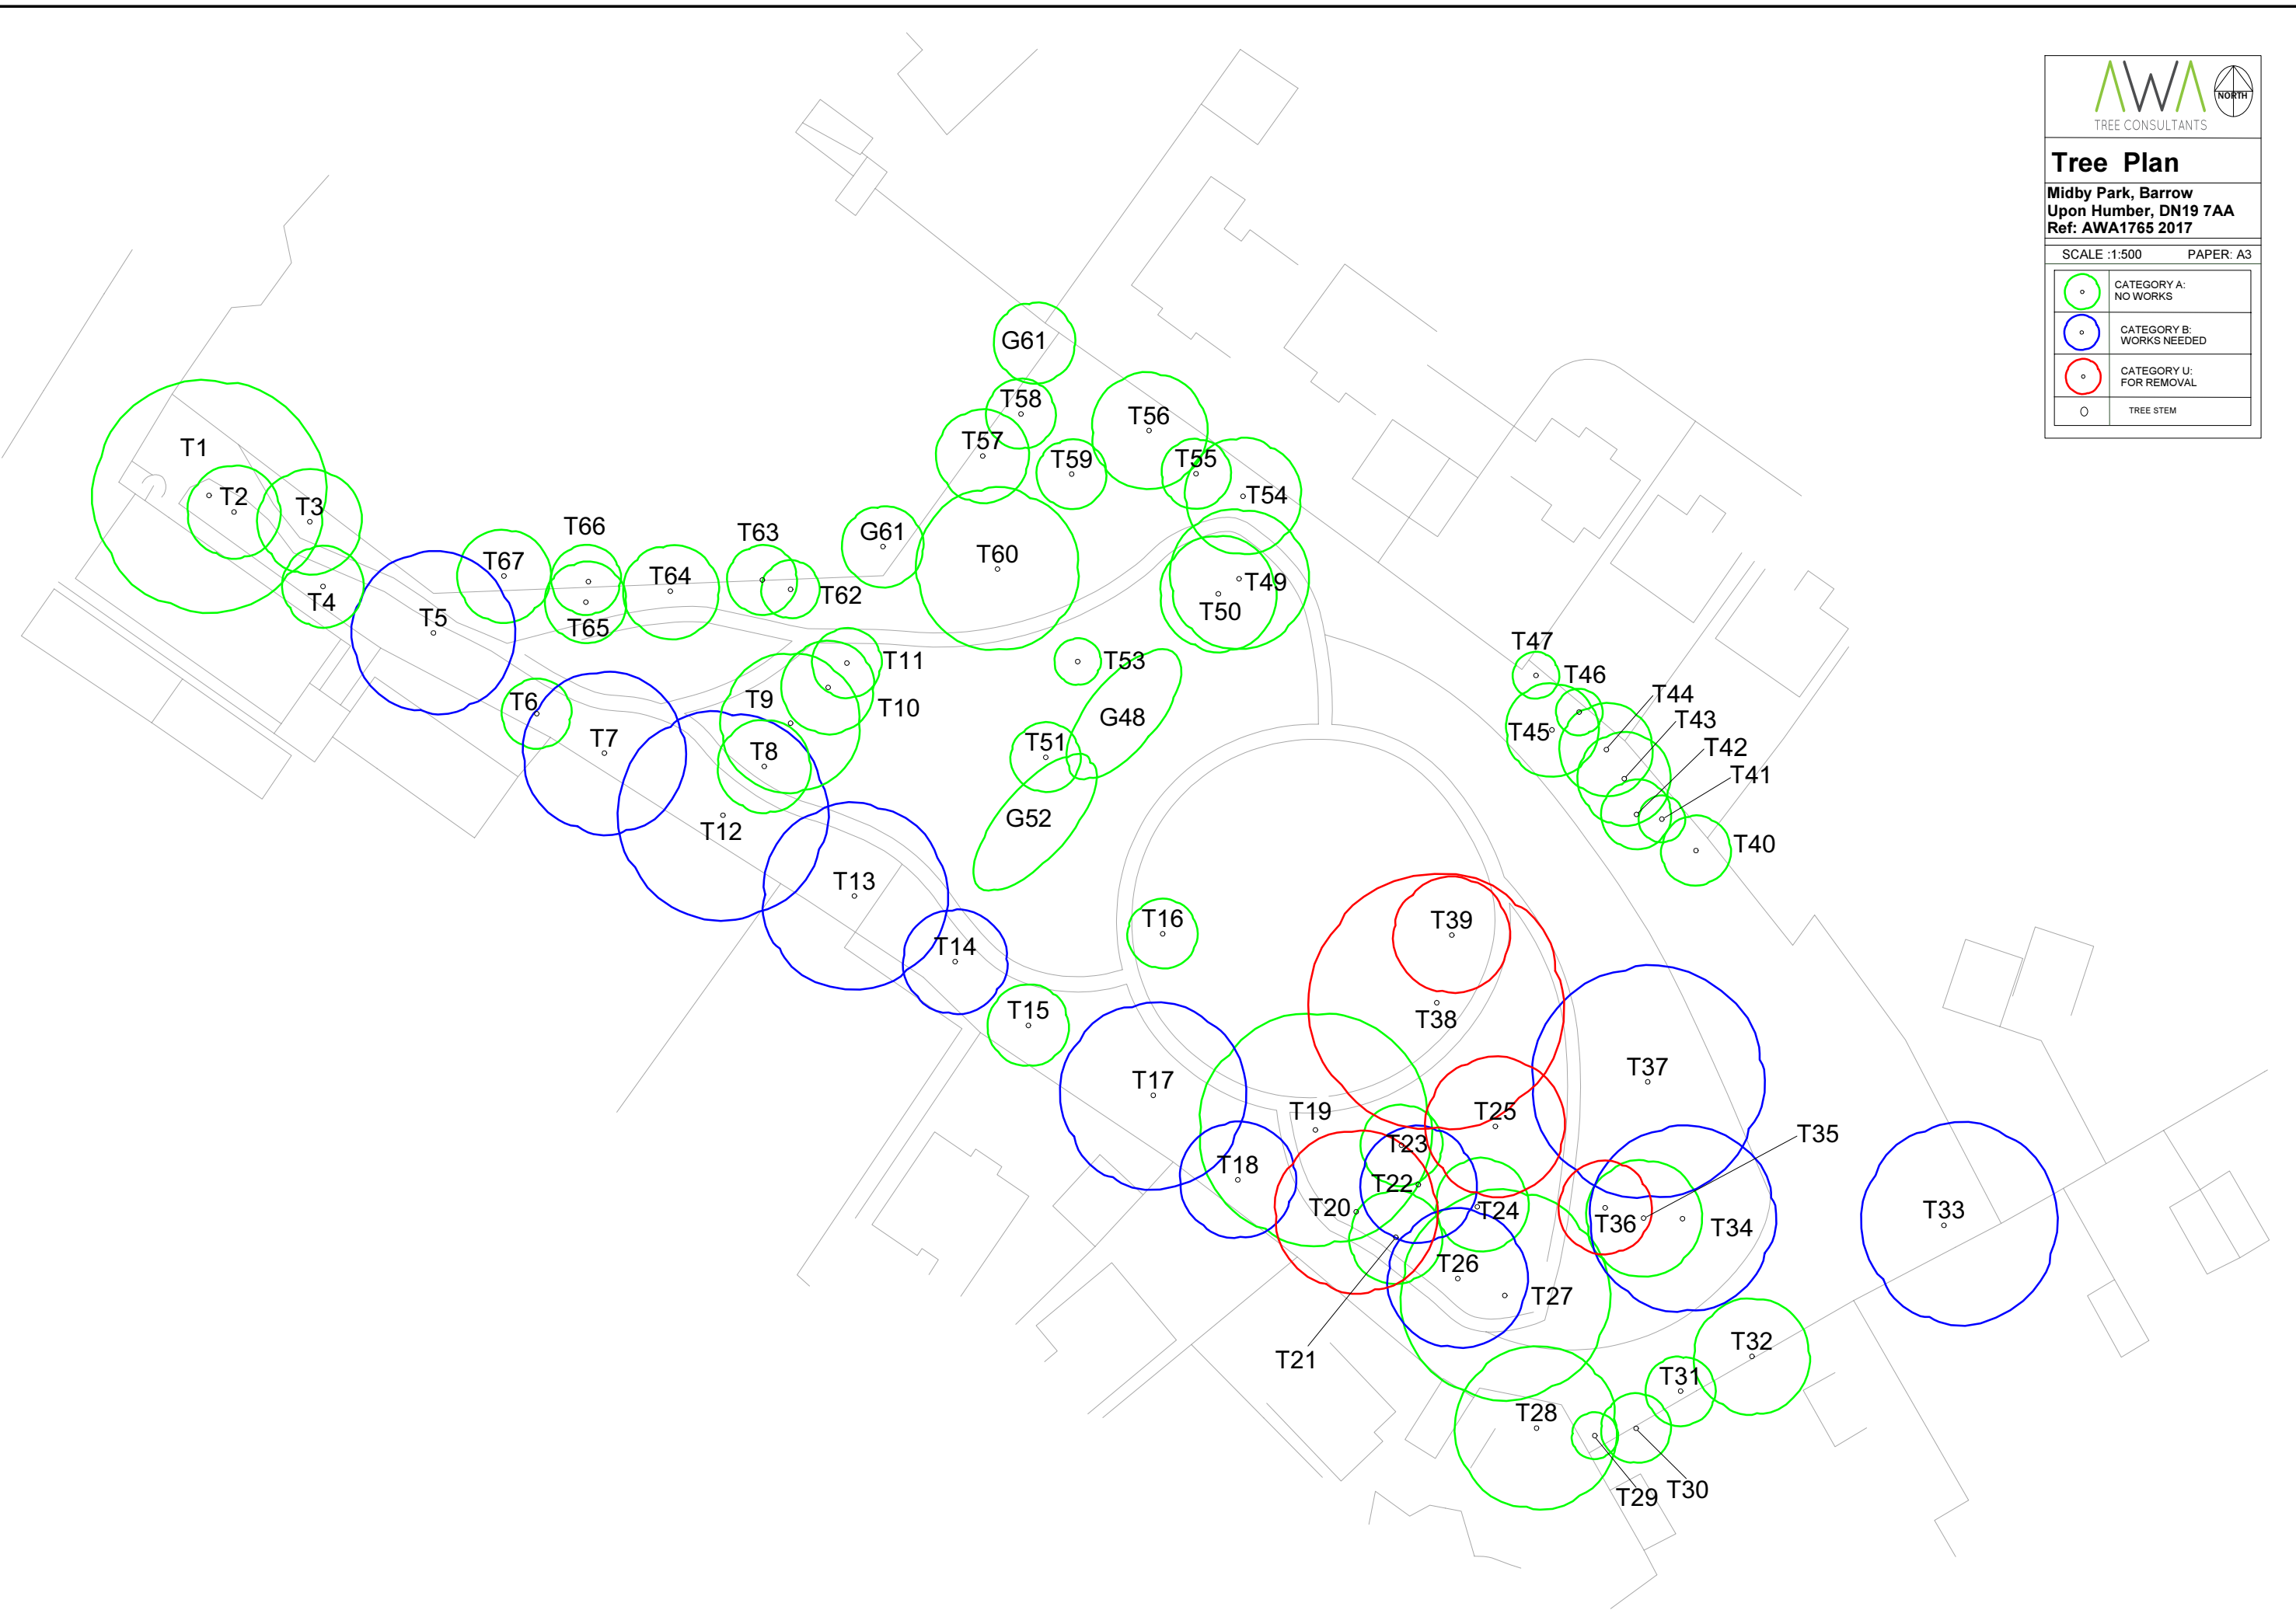
Tree Plan

- 3.2.3 **Tree Removals:** 6 trees were assessed as posing an unacceptable risk to people or property. The trees are highlighted in red on the attached tree plan at Appendix 5 and the work is detailed in Appendix 4. Trees T20, T25, T36, T38, T39, T68 were recommended to be removed. Removal work of moderate or high urgency is required for T20 Ash and T38 Ash. The other recommended removals are of a lower urgency.
