ARBORICULTURAL REPORT

to **BS5837:2012** at:

***Park Lea,
Barton Road,
Wrawby,
Brigg,
Lincolnshire
DN20 8SH***

Reference: *AWA1970*

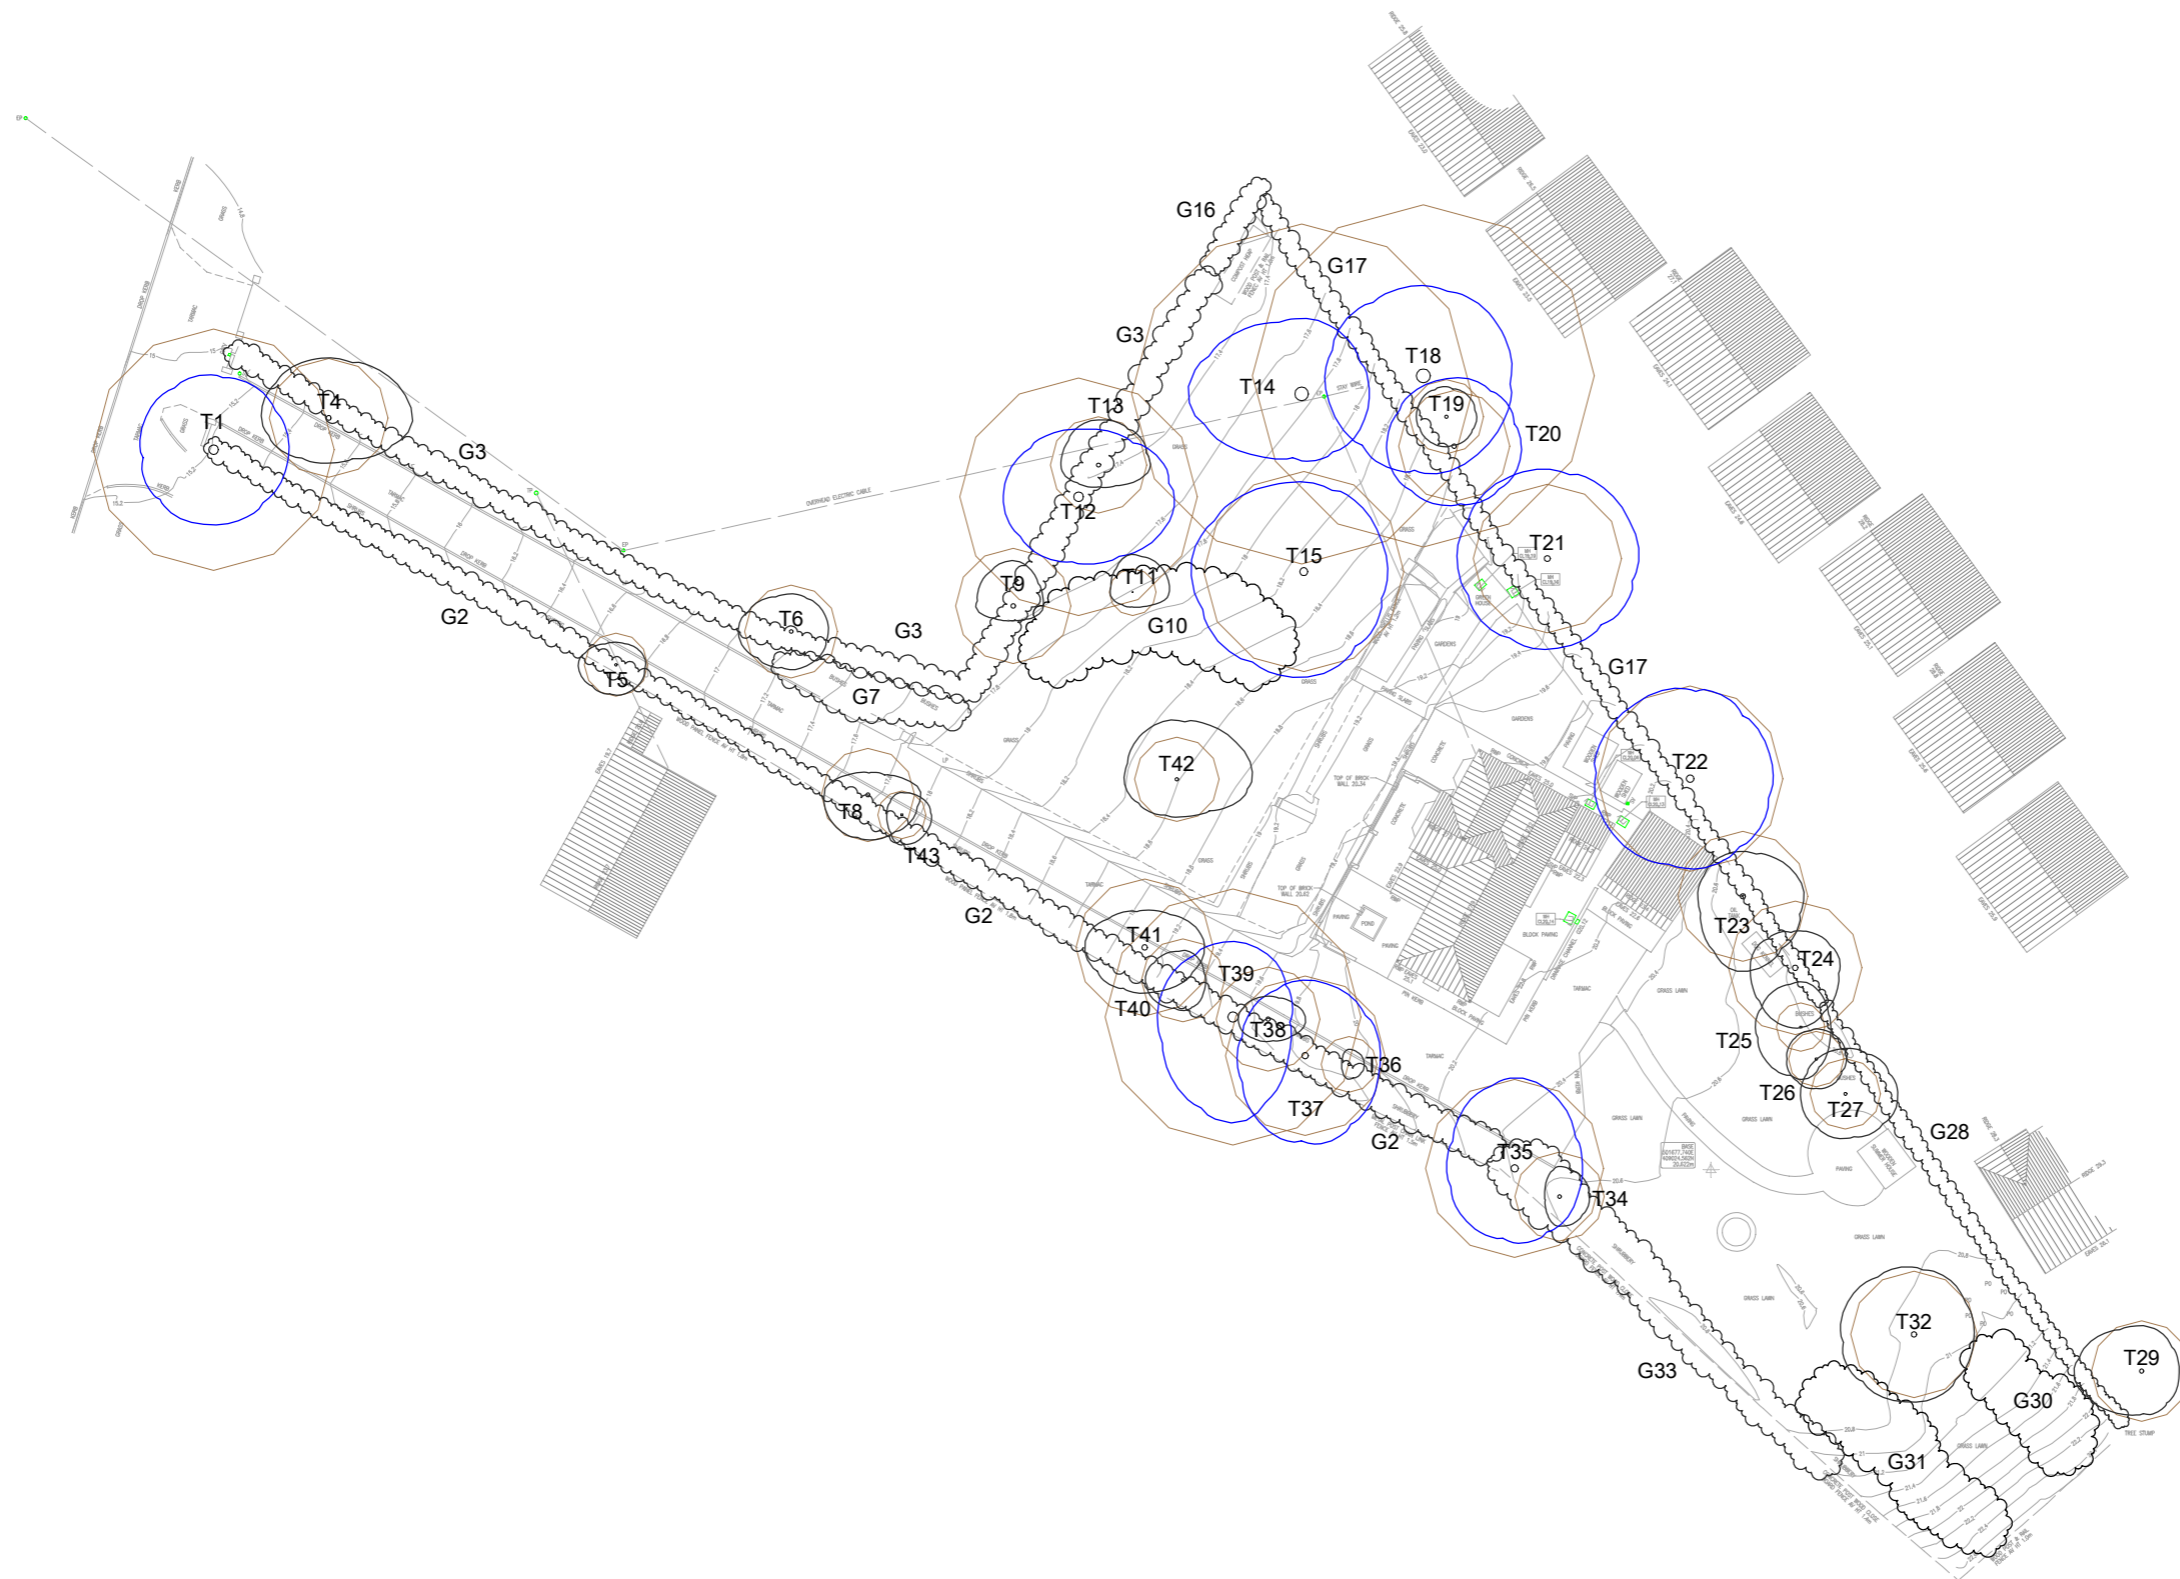
Appendix 5:
Tree Constraints Plan
 Park Lea, Barton Road, Wrawby, Brigg
 Ref: AWA1970

4.3.1 The tree Root Protection Area (RPA) detailed on the Tree Constraints Plan at Appendix 5, has been used as a layout design tool, to inform on the area around a tree where the protection of the roots and soil structure is treated as a priority.

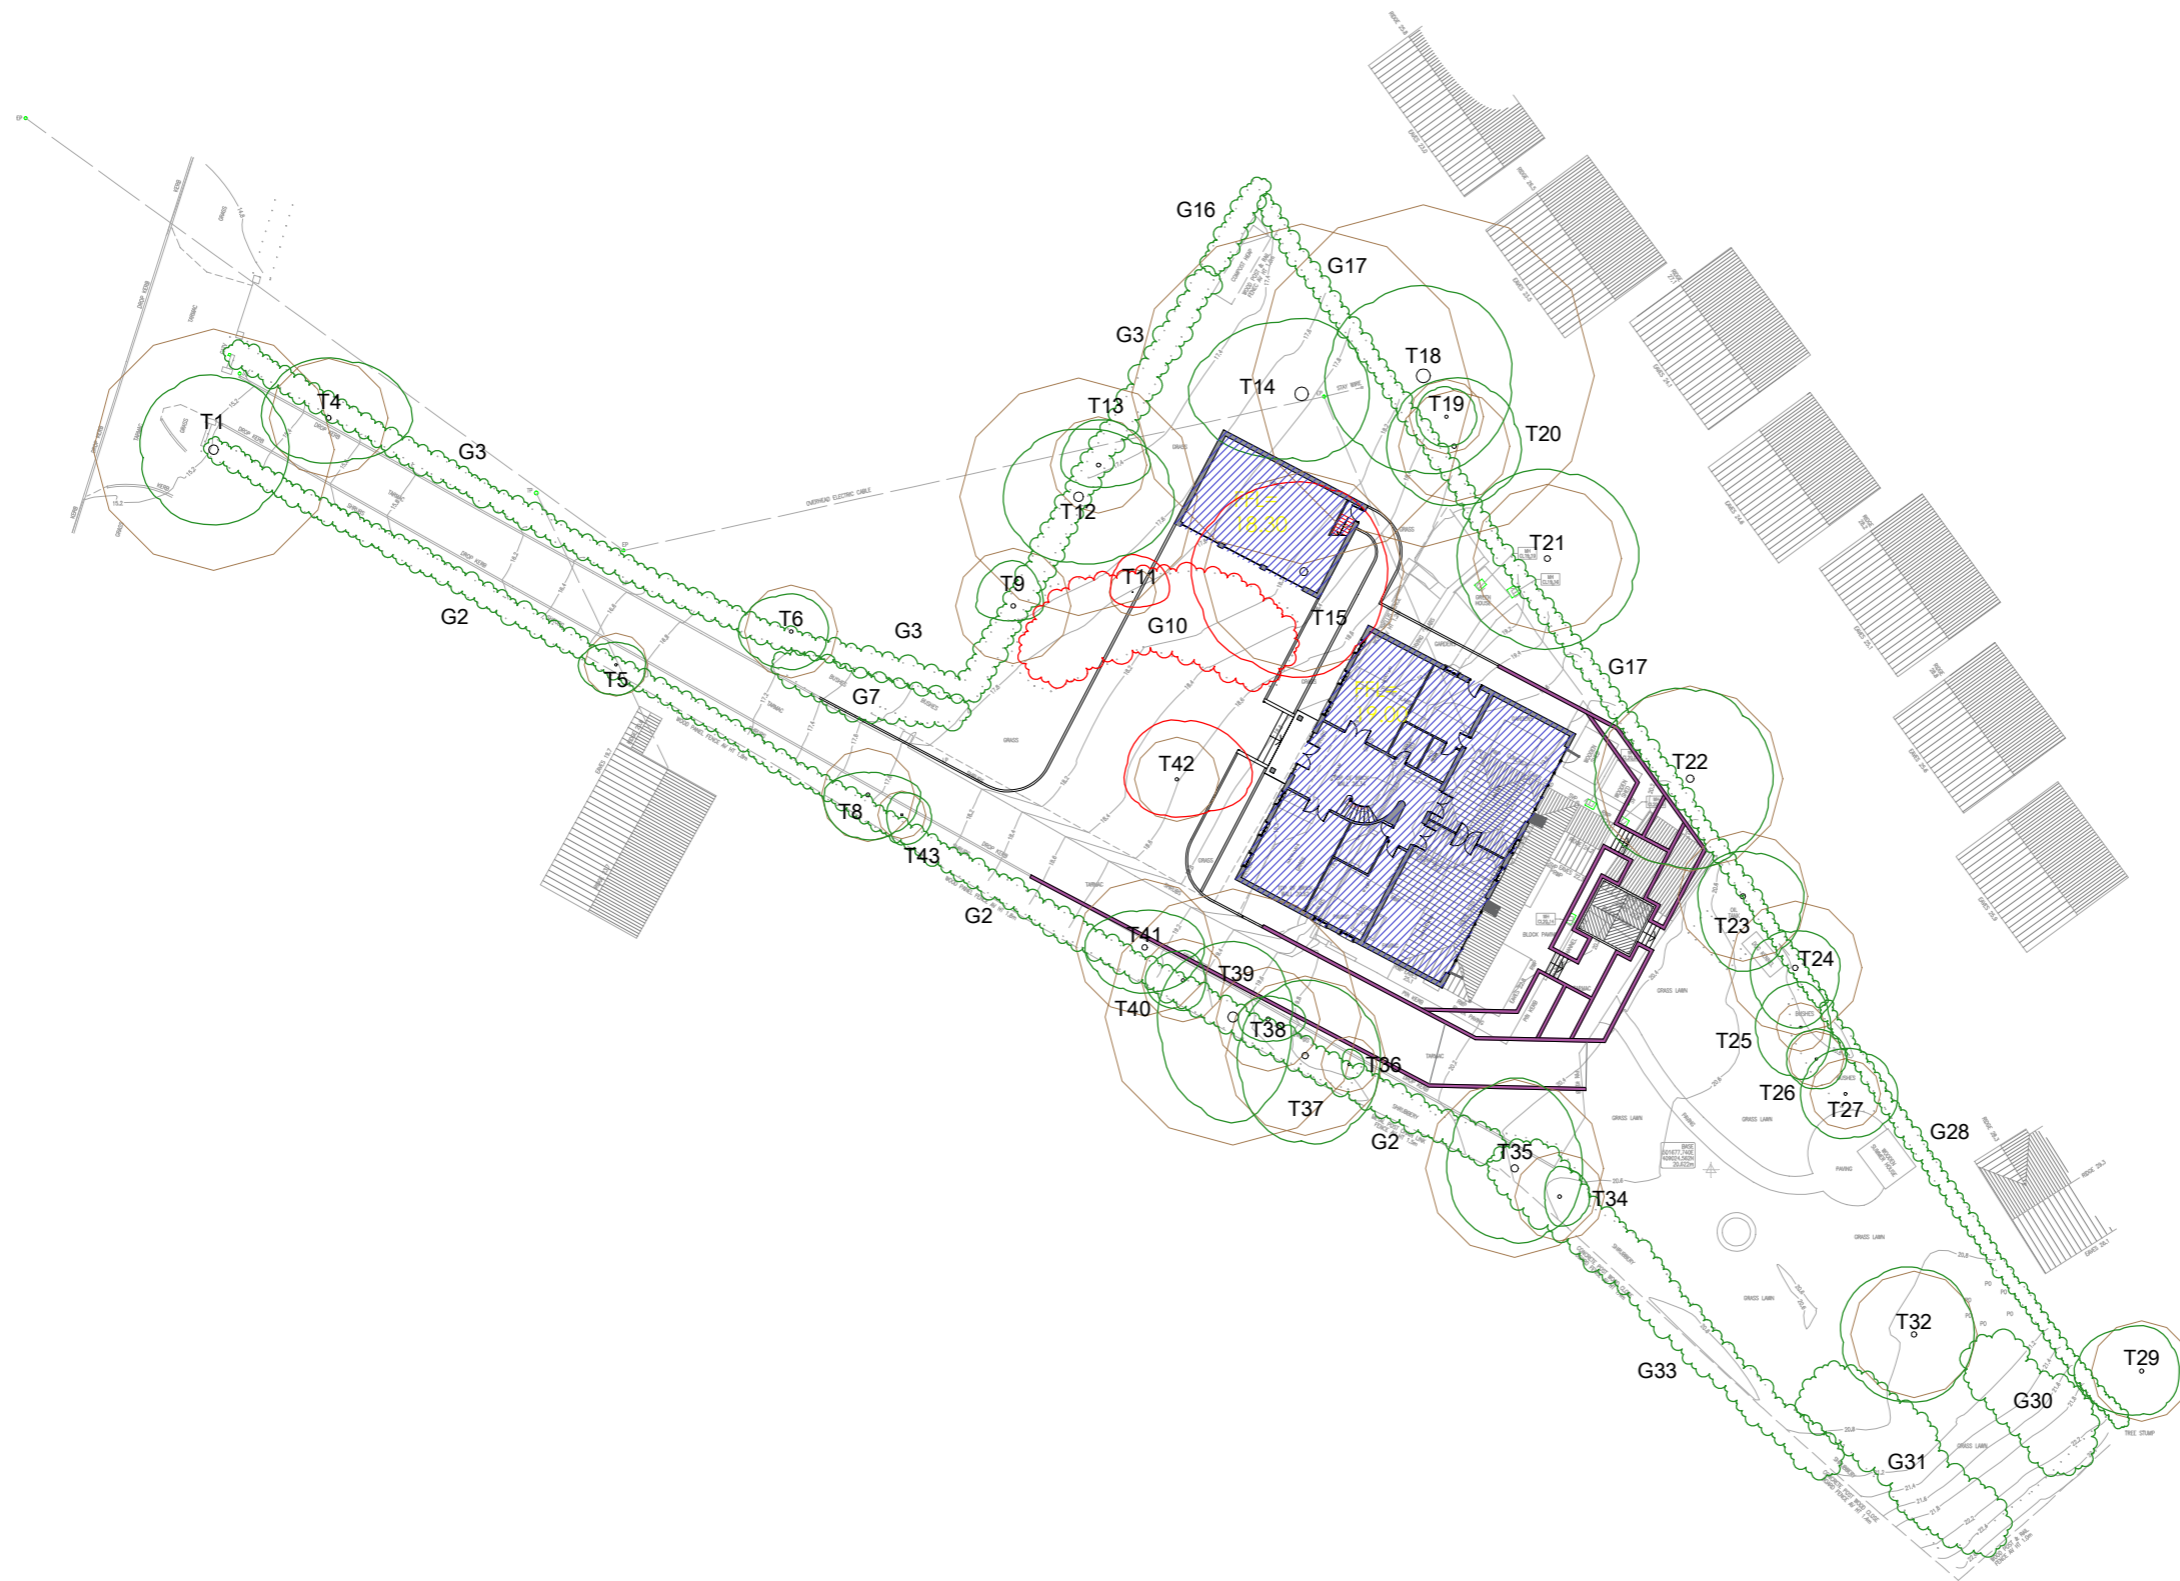
**Appendix 6:
Tree Impacts Plan**

4.2.1 From assessing the new development proposals, 3 trees and 1 tree group will require removal as they are situated in the footprint of the structure or their retention and protection throughout the development is not suitable.

4.2.2 The trees that require removal are G10, T11, T15 and T42.

4.3.2 Potentially damaging activities are proposed in the vicinity of retained trees. The proposed new house encroaches into the RPA of G17, T22 and T23, and the proposed new garage encroaches into the RPA of T12, T14 and T18.

- 4.3.3 New access drives are proposed that encroach into the RPA of G7, T8, T35, T36, T37, T38, T39, T40, T41 and T43. The construction of hard surfaces within the RPA can have negative impacts on tree roots. However, the potential negative impacts can often be overcome or minimised by employing a 'no-dig' type construction methods with a porous final surface.

4.2.4 In addition to the tree removals, a retained tree will require pruning works to facilitate the proposed new development. T14 will require its western crown reducing by around 3m and its southern crown reducing by around 1m to facilitate the proposed new garage. It is likely the tree will readily tolerate this pruning work and the amenity value it provides will not be significantly affected. The pruning works to T14 should be undertaken between April and July.

Construction within the RPA, can have negative impacts on tree roots. However, if required, the potential negative impacts can be overcome in this instance using special foundation design, such as mini/micro pile and suspended beam, or cantilevered foundations.
