Phase 2 (site investigation) report

9a Darwin Street, Kirton in Lindsey

Produced for C & K Builders

Title:	Phase 2 (site investigation) report 9a Darwin Street, Kirton in Lindsey
Client:	C & K Builders
Report number:	1166/4758/P/P2

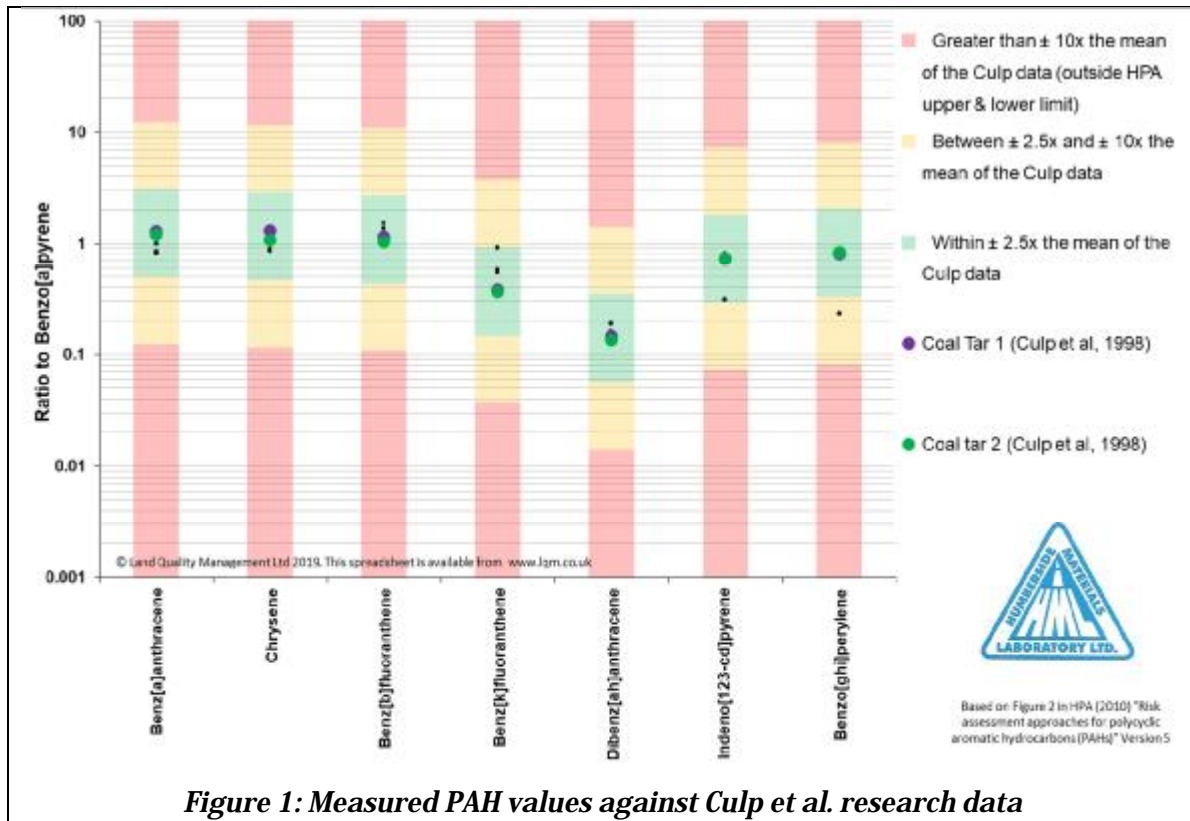
Figure 1: Measured PAH values against Culp et al. research data

Figure 1 shows the measured PAH data for all three samples lies reasonably close (within 2.5 times the mean) to the Culp et al. (1998) data. The only slight outliers are from the BH4 sample data some values of which were substituted with the limit of detection. Overall, PAH double ratio profiling should be applicable to the data.

Therefore, the source of the PAH contamination in the made ground could be either (A) ash or clinker from burnt wood or coal or (B) coal tar. Given the site history, either source is feasible.

It is noted that the detected PAHs are not of a petroleum signature. Therefore, the results are not a potential indicator of petroleum hydrocarbon contamination.

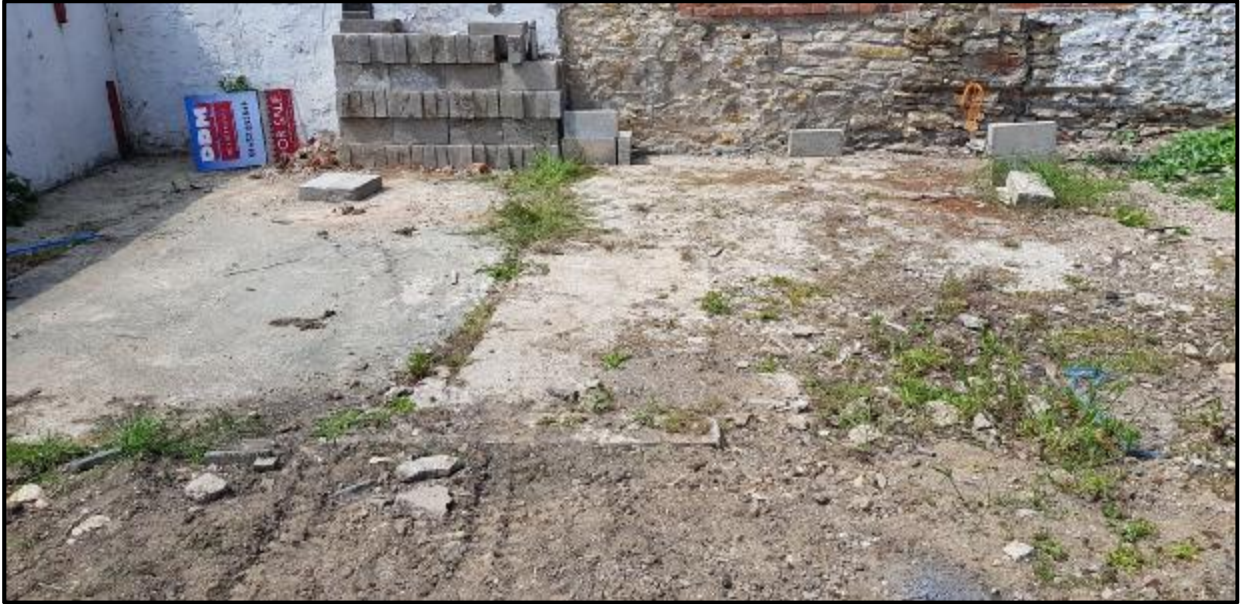
The 2009 Google Streetview also appears to show a steel bowser or tank to the rear of the older building. This could have been used to store and transport water or some other fluid, possibly fuel.

Southwest site corner and possible former bowser / tank storage area (view to west)

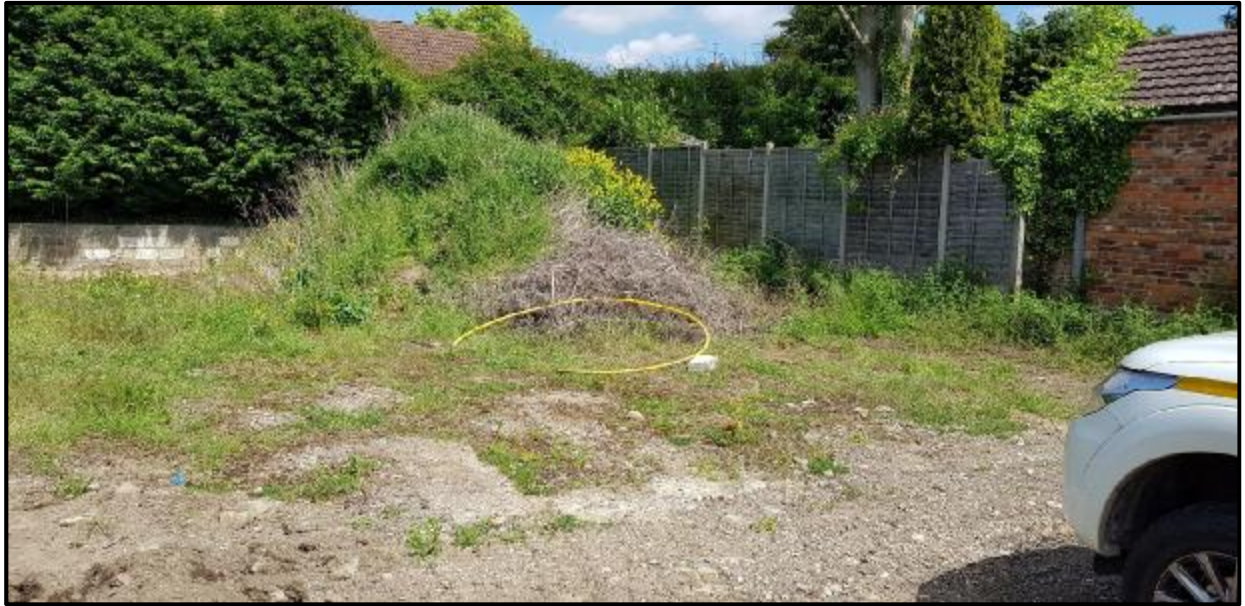
Unless further testing can prove otherwise, the mound material is not suitable for re-use in garden areas. The soil mound has been found to contain potentially elevated levels of dibenzo(ah)anthracene PAH. Further PAH and SOM testing (as a minimum) with favourable results would be needed before the mound material could be considered safe for re-use.

Northeast corner of site and stockpile (view to northeast)

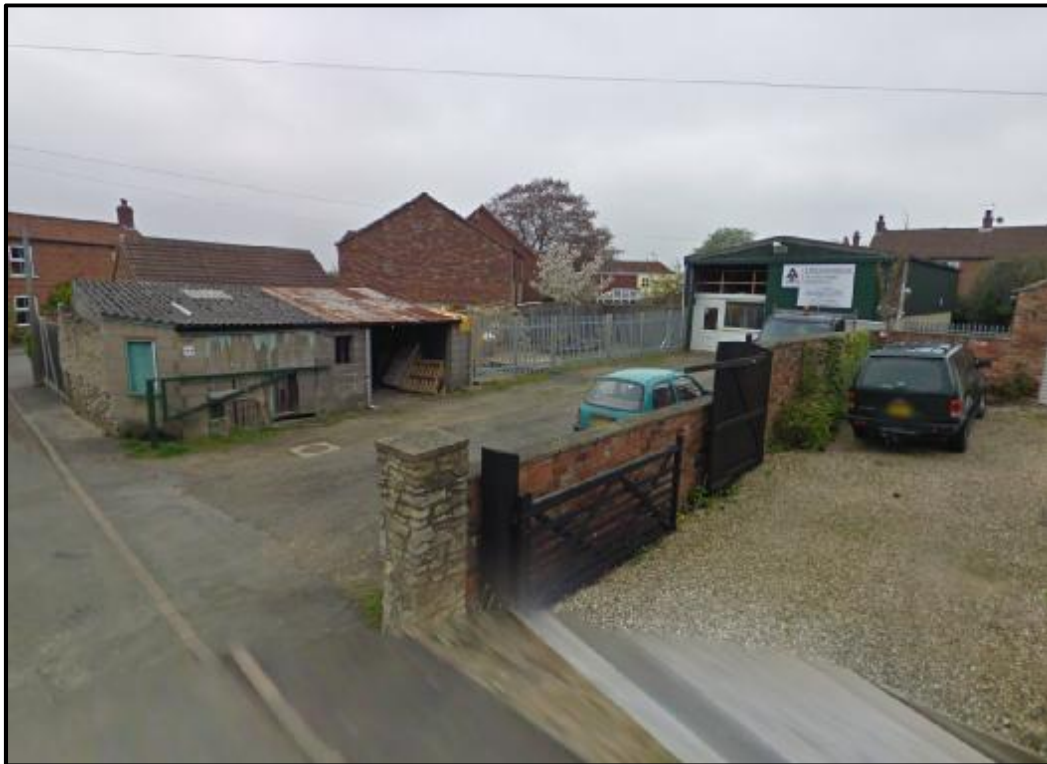
The 2009 Google Streetview shows the older building in the front left corner of the site has likely been largely demolished and rebuilt during its long history. The walls were mainly of modern masonry and the roofing was a combination of cement and steel corrugated sheets (possibly asbestos-containing).

The 2009 Google Streetview shows the front right side (i.e. southeast part) of the site was used for vehicle access and parking. Other parts of the site could have been used for the storage of construction materials.

Historical Google Streetview of the site from Apr 2009 (view to northwest)
