# Arboricultural Appraisal Report

## Subsidence Damage Investigation at:

10 March Street  
 Kirton Lindsey  
 Gainsborough  
 DN21 4PH

CLIENT:	Davies Group Ltd
CLIENT REF:	71815688
MWA REF:	SUB190501-4363
MWA CONSULTANT:	Mark Johnson (FdSc;M.ArborA)
REPORT DATE:	22/05/2019

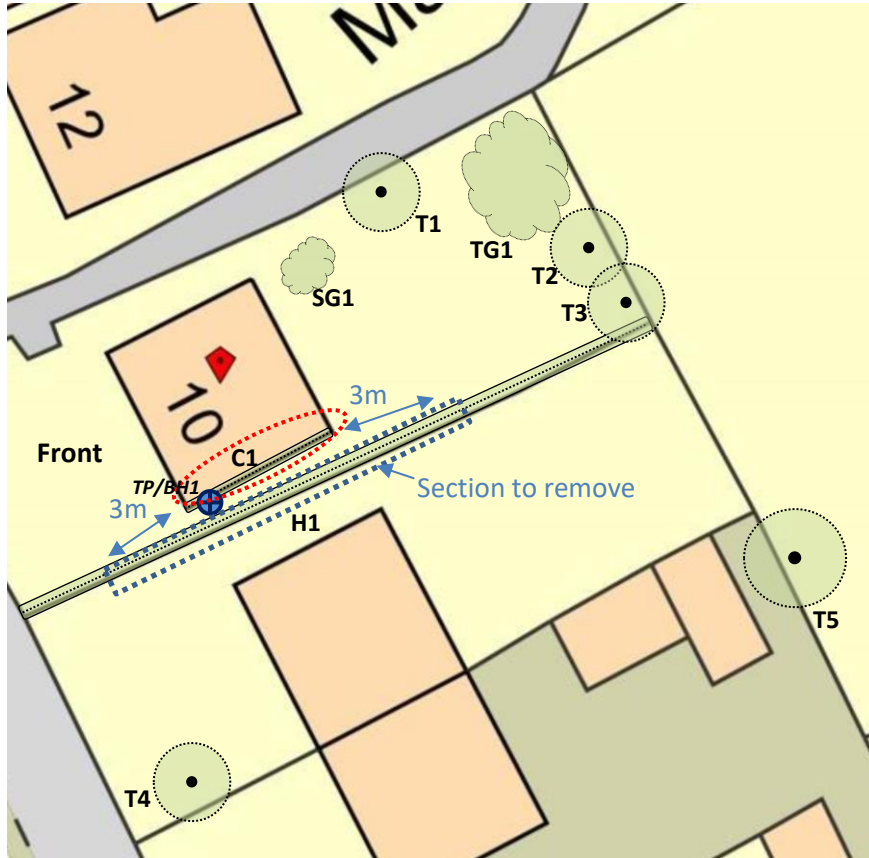
Site Plan

Approximate areas of damage

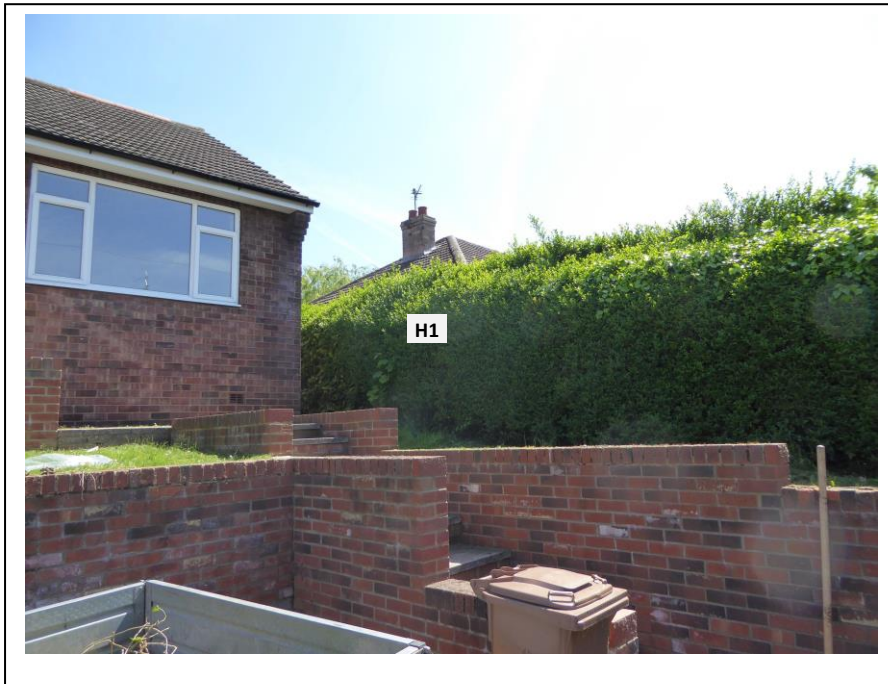
View of H1

Roots were observed to a depth of 1200mm bgl in TP/BH1 and recovered samples have been positively identified (using anatomical analysis) as Ivy, the origin of which will be H1 and C1 confirming their influence on the soils below the foundations.

Based on the technical reports currently available, engineering opinion and our own site assessment we conclude the damage is consistent with shrinkage of the clay subsoil related to moisture abstraction by vegetation. Having considered the information currently available, it is our opinion that H1, TG1 and C1 are materially contributing to the current subsidence damage.

If an arboricultural solution is to be implemented to mitigate the influence of the implicated trees/vegetation we recommend that C1, TG1 and a section of H1 are removed.

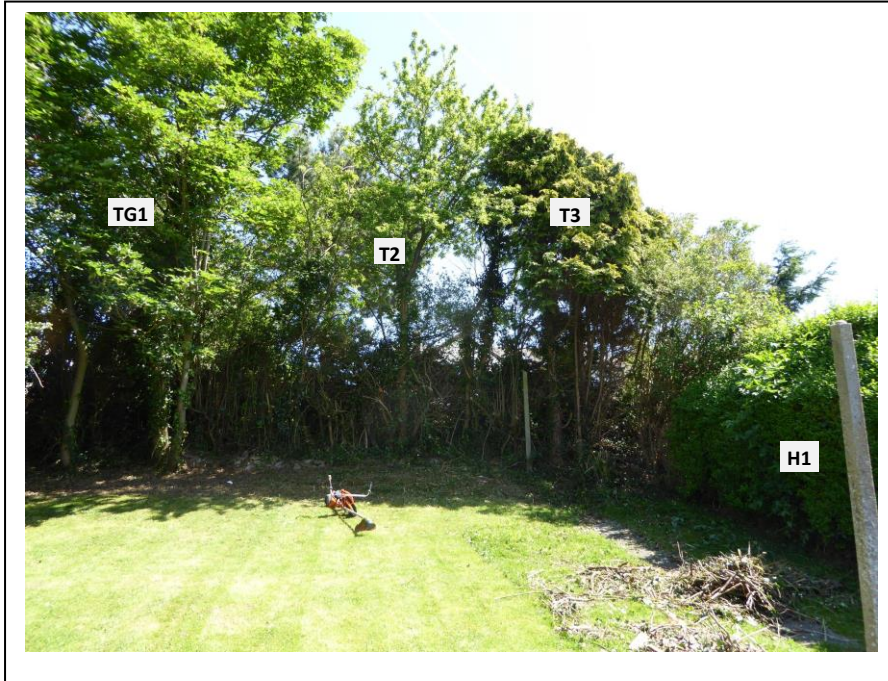
View of TG1, T2, T3 and H1

Irrespective of the identification of recovered root samples, the roots of TG1 (Norway maple group) are also likely to be present below foundation level in proximity to the area of movement/damage and influencing soil moisture and volumes.

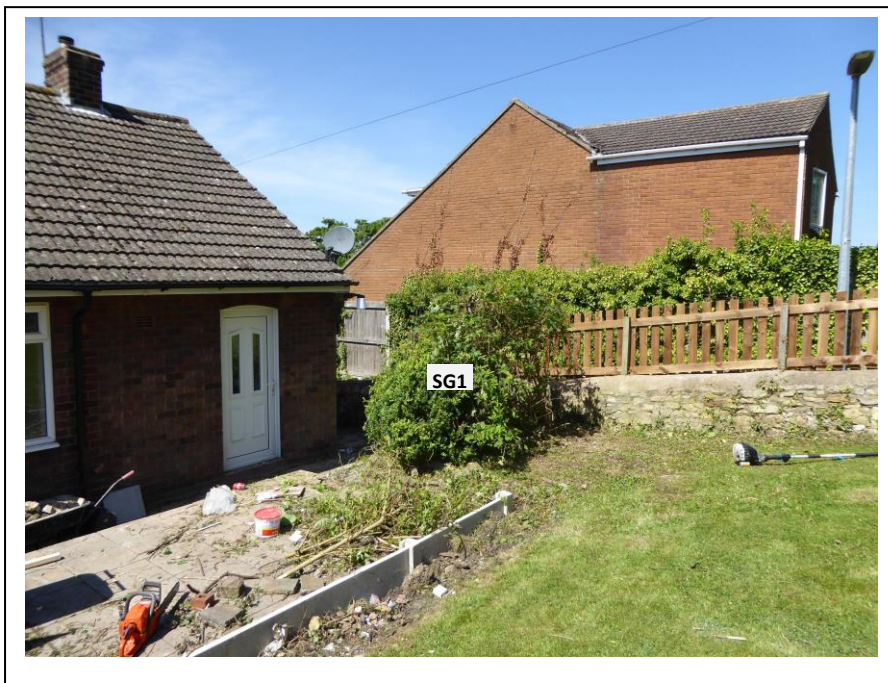
View of SG1

Other vegetation recorded presents a potential future risk to building stability.
