**PRE-DEVELOPMENT IMPACT
ASSESSMENT AND REPORT ON TREES**

**BROOK HOUSE FARM
CHURCH STREET
HIBALDSTOW
BRIGG
NORTH LINCS
DN20 9RA**

CLIENT - JAMES CAVILL PROPERTIES LTD

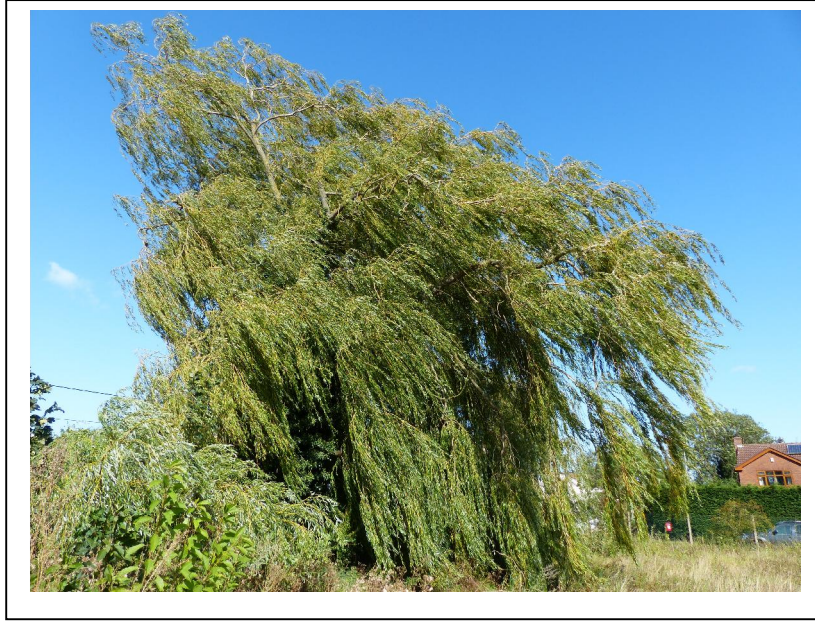
The tree is the westernmost of the pair and stands further into the site from Becksides. The root collar, trunk and major limbs are all densely colonised by ivy preventing clear visual assessment of its structural integrity and any major defects. The crown is heavily biased to the south due to the former presence of T5 (felled some years ago) and from persistent pruning to clear the roadside. Defective branches are visible in the canopy where decay has formed due to the occurrence of pruning and failure, eg at 7m in the southern quarter. Dead wood to 100mm in diameter exists in the central crown. The outer canopy continues to function and exhibits normal growth rates. However, its density is thinner than would normally be expected for the species in good physiological condition..

Photograph 1 - showing the asymmetric crown habit of T6 looking north-east from within the site.

Clean out the ivy and review the tree's structural condition. If it is deemed structurally sound, clean out the dead wood and broken branch stubs. Reduce and re-shape the southern quarter of the crown by approximately 3m to balance the crown spread with the remaining quarters. Finish the pruning cuts to suitable secondary growths. Also ensure any stray branch tips encroaching on Becks side are pruned back to within the site boundary.

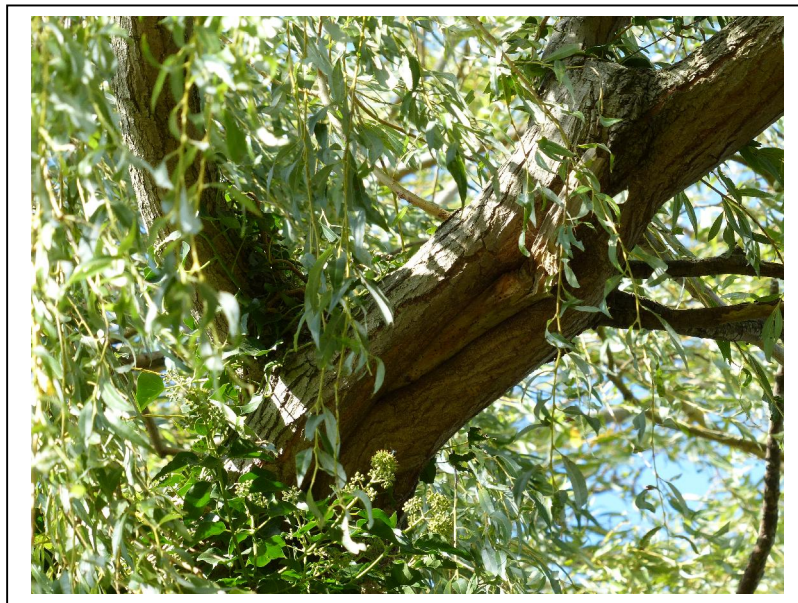
Photograph 2 - showing the decay following an old branch failure wound at 7m on the south side of the crown.

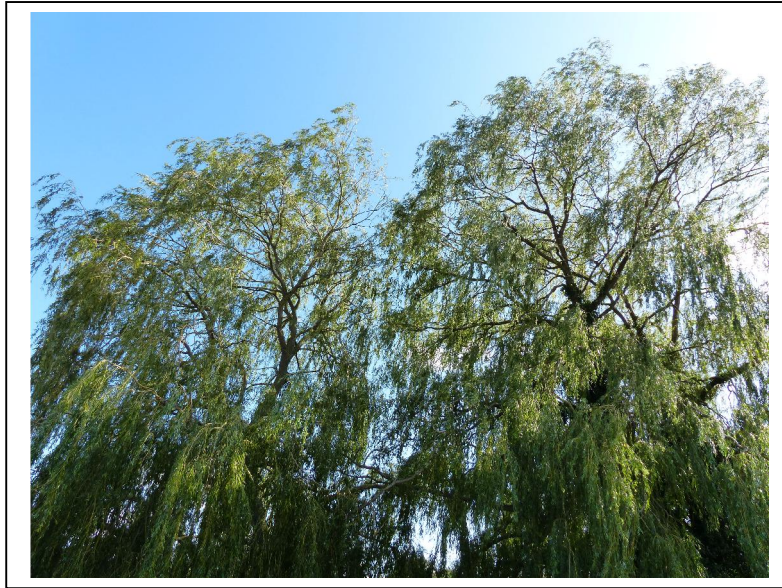
Both willows are approaching the later stages of their safe useful life expectancy and stand within falling distance of the cottages on the northern margin of Beckside. Both trees are currently making healthy growth but their crown densities are thinner than should be expected in this species growing with normal health and vigour. There is evidence of minor branch failure around both crowns and the incidence of dead wood is greater than usual. I cannot comment on the integrity of T6 due to the density of the ivy which obscures all the main structural parts.

Photograph 3 - showing the abnormally thin crowns of both trees (T7 to the left and T6 to the right).

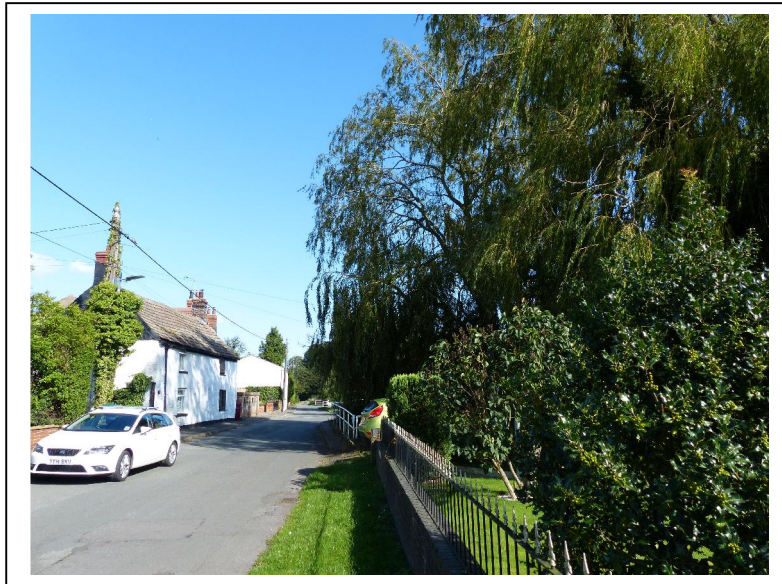
The root collar, trunk and major limbs remain sound. Parts of the upper crown are dying back in places, notably in the western quarter. The upper canopy is generally thinner than would normally be expected for the species and contains dead wood to 50mm throughout. The crown has had to be persistently reduced to the north in order to clear the road.

Photograph 4 - showing the proximity of the crown of T7 beginning to overhang the street on Beckside. Also note the lack of crown density of the tree.

Clean out the dead wood and broken branch stubs. Also ensure any stray branch tips encroaching on Becks side are pruned back to within the site boundary.
