ARBORICULTURAL REPORT

to BS 5837:2012 at:

Land at:
**King Edward Street,
Belton,
North Lincolnshire
DN9 1QN**

Reference: AWA3768

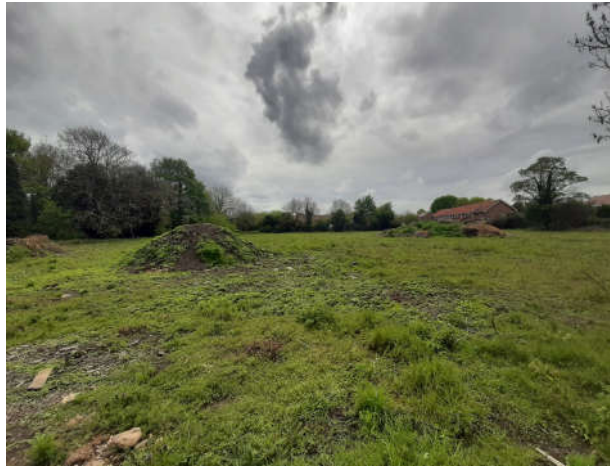
Photo 1: The site, as viewed from the north

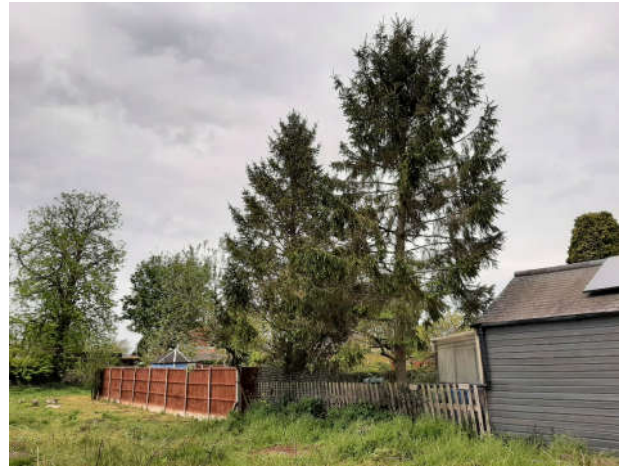
- 3.2.4 At the north-east boundary of the surveyed area are T1 to T4. T1 and T2 are small Plum trees, situated within the boundary, with limited value due to being obscured by adjacent structures and vegetation. Additionally, T2 has a significant lean, due to being suppressed by adjacent trees. T3 and T4 are Spruce trees situated in the neighbouring garden, which provide screening value at the boundary.

Photo 2: T1 to T4, at the northern boundary, with T3 and T4 providing screening

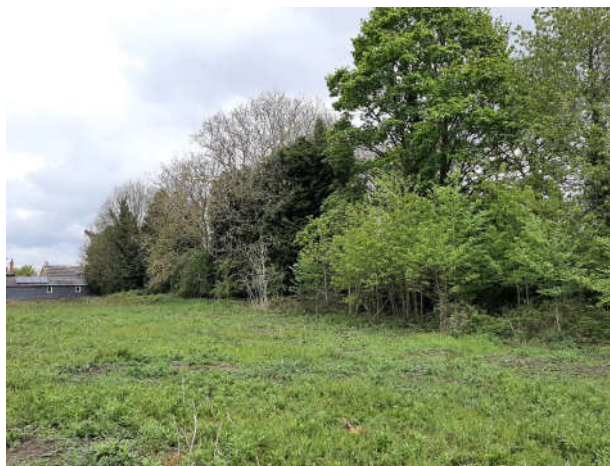
- 3.2.5 At the eastern boundary there are a number of trees that extend along the fence line of the neighbouring garden. These include G5, and T6, T7 and T9 to T11. Of the individual trees, T6, T7, T9 and T10 are of more moderate amenity value, and have reasonable long-term prospects. G5 is a little-managed, predominantly Cypress hedge group that provides good boundary screening. T11 is a large, mature Ash tree with occasional indicators of Ash dieback in the lower crown and was particularly late to flush compared to other surveyed Ash trees, and so may have more limited long-term prospects.

Photo 3: Trees at the eastern boundary, including G5, T6, T7 and T9

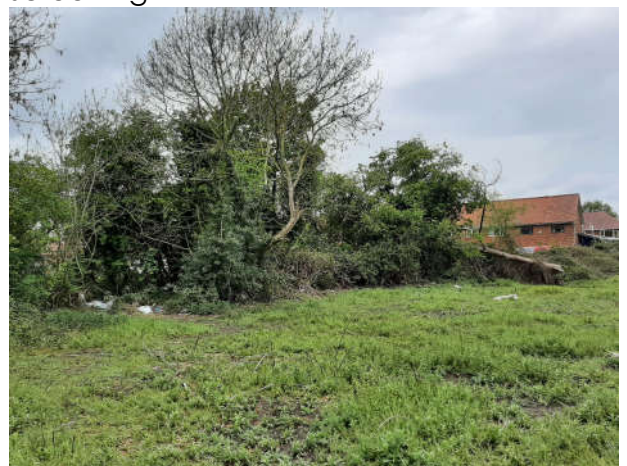
- 3.2.6 At the southern boundary is large screening group G12, with individual trees T13 to T15, and T29, situated throughout. G12 has a number of failed stems at the western aspect, as well as occasional gaps which have been used for fly-tipping. The trees at the southern boundary have limited individual value but do collectively provide reasonable screening.

Photo 4: Trees at the southern boundary, including G12 and T15

- 3.4.3 If required by the development proposals, occasional lower value, retention category 'C' trees at the southern boundary could be removed, and replacement planting would largely mitigate their losses.

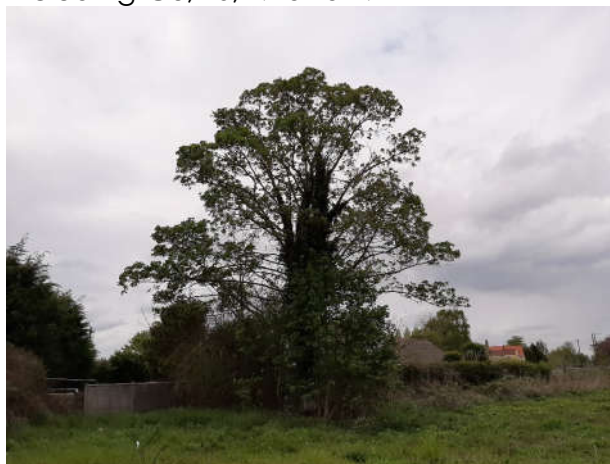
- 3.2.7 At the western boundary is T16, a large mature Sycamore. The tree is prominent within the surveyed area, and will likely be prominent from neighbouring properties, and so has moderate amenity value.

Photo 5: T16, at the western boundary, with understory group G17

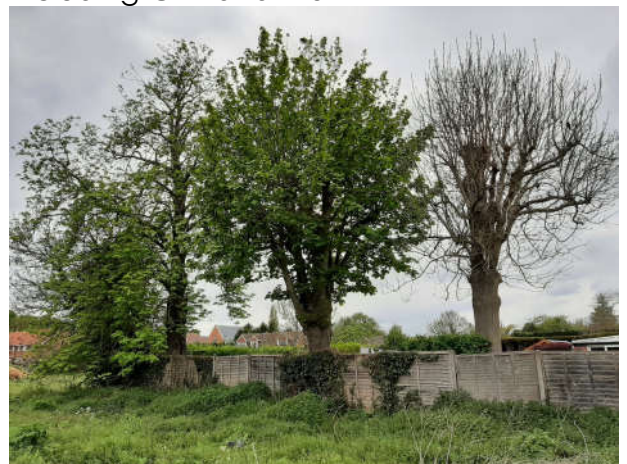
- 3.2.9 At the site access, linking the open space to the highway to the north, are trees T24 to T26. T24 is a mature Horse Chestnut, in good condition and with moderate amenity value. T25 and T26 are previously been pollarded at approximately 9m, although do not seem to have been managed in a number of years and so have reasonably large regenerative growth from pollard points. This can result in weaker attachments, and so reduces the long-term prospects of these trees. While the prospects of T25 may be increased with similar future management, T26 is an Ash tree and may be more susceptible to damage from Ash dieback if re-pollarded.

Photo 6: T24 to T26, in the adjacent garden, close to the site access
