**Proposed Coffee Drive-Thru Development,
Mannaberg Way, Scunthorpe**

Stage 1/2 Road Safety Audit

November 2020

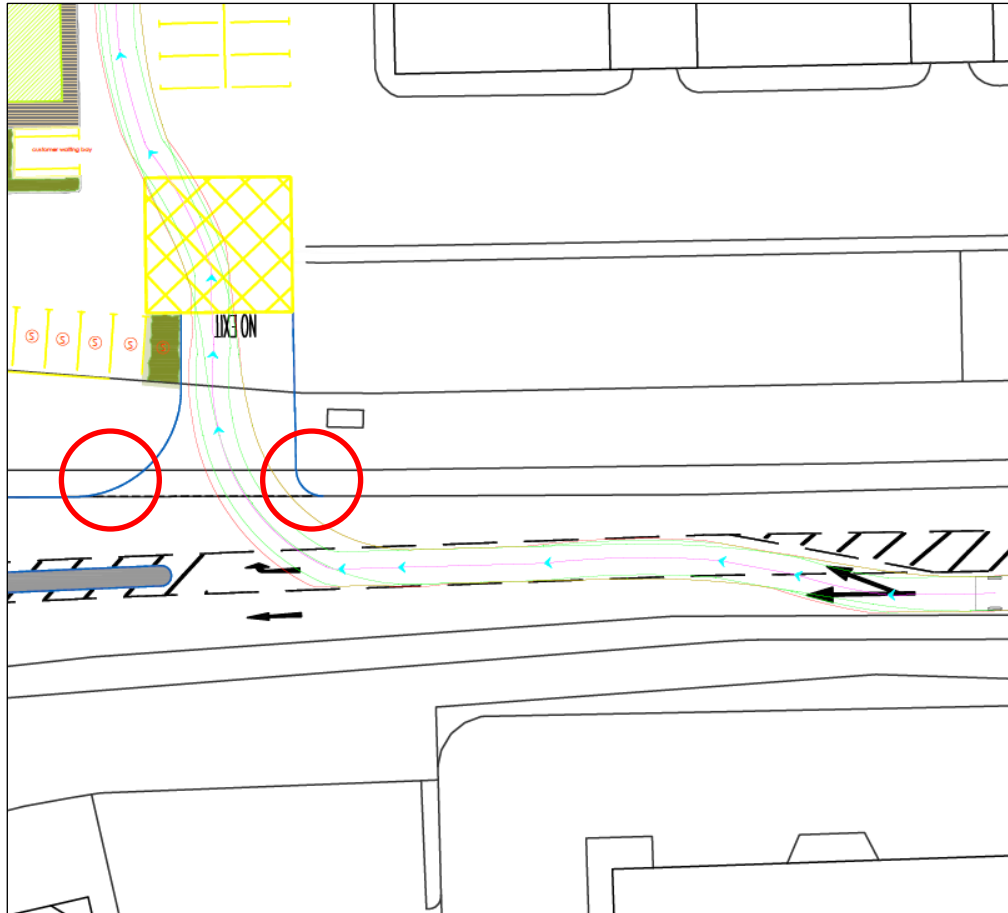
Location: Site entrance on Mannaberg Way

Summary: Lack of dropped kerbs and tactile paving

There are no dropped kerbs or tactile paving shown across the site entrance, which crosses a footway. Visually impaired pedestrians could trip and injure themselves over full kerbs when attempting to cross the entrance to the site without any dropped kerbs or tactile paving in place.

It is recommended that suitable dropped kerbs and tactile paving across the site entrance are provided.
