Arboricultural Report

Principle Formal Arboricultural Report/Survey

Location: land off Main St, Scawby, Nr Brigg, Lincs

Date: 22nd July 2021

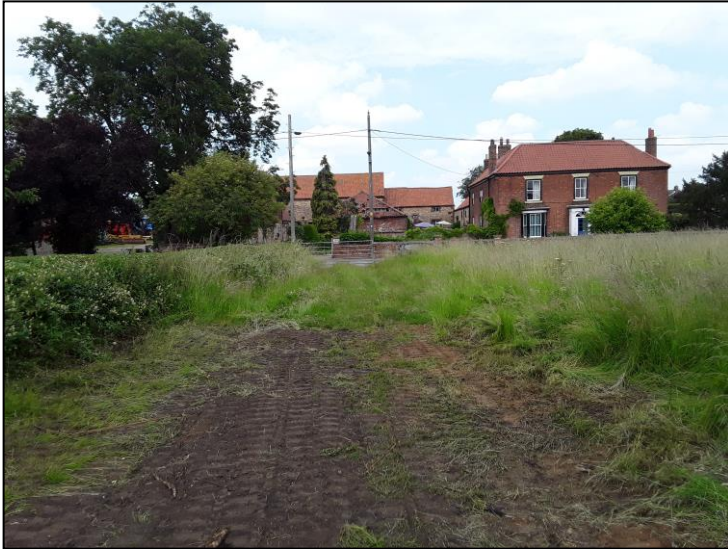
The existing access has no formal type of construction. From the gateway off Main Street the site is accessed via a rough grass track

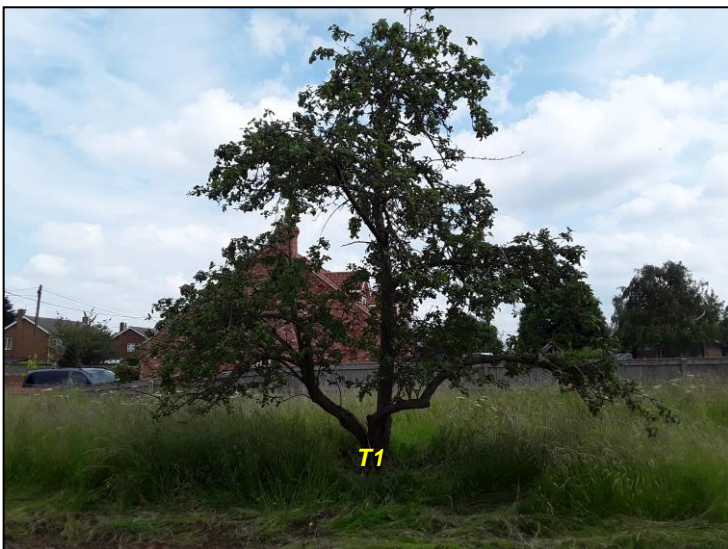
6.3 Five individual trees, T1, T4, T6, T9 & T10 have been categorised as "U". These trees have a serious, irremediable, structural defect, such that early loss or part failure is expected. Short- or long-term retention is not considered a viable option.

T1 is structurally compromised. Failure or part failure is expected

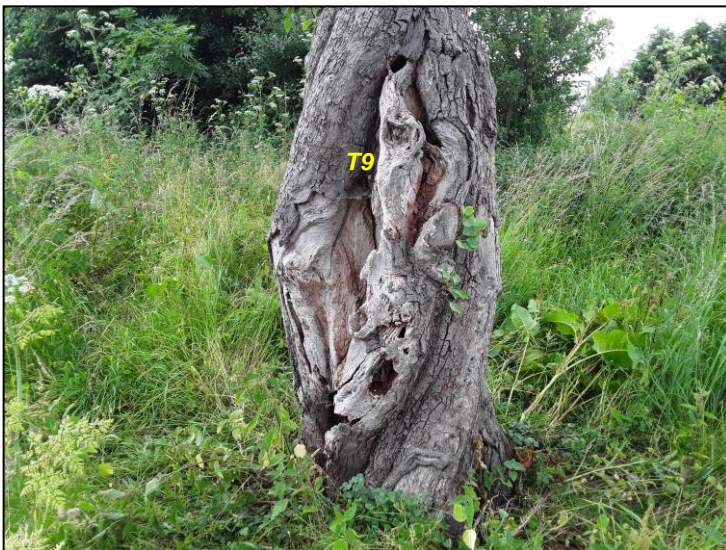
Cavities, disease, and structural defects are commonly associated with many of the trees within the site, whereby retention is not a viable option

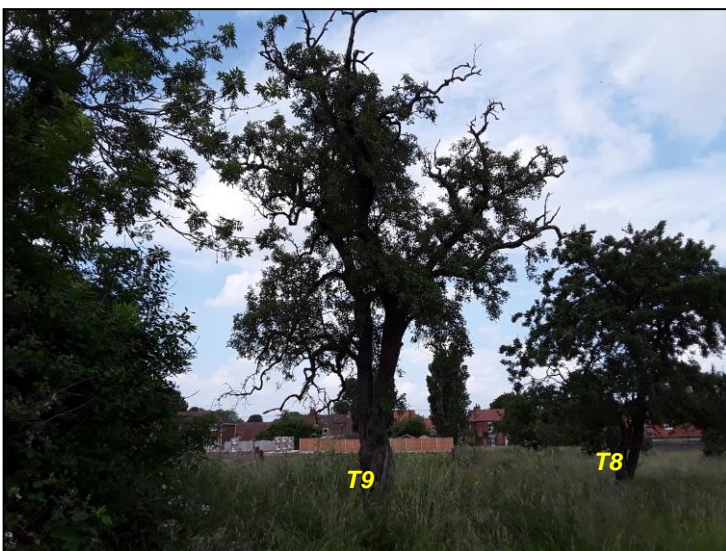
Trees T9 and T8 are low quality, low value trees considered to have very limited merit

T9	Pear	Over Mature	70	8.4	221.7	1	10	N5, E3, S4, W4	Poor	Poor	Single stem up to approx 2m, from here the tree develops two co-dominant stems. Elephant ear on east side union. Extensive decay and cavities on the lower to mid main stem. Thor hammer test reveals hollowness around main stem. Probe investigation reveals extensive cavities. Canopy die back with stag headed dead wood. Major/minor dead wood present.	Fell	<5	U

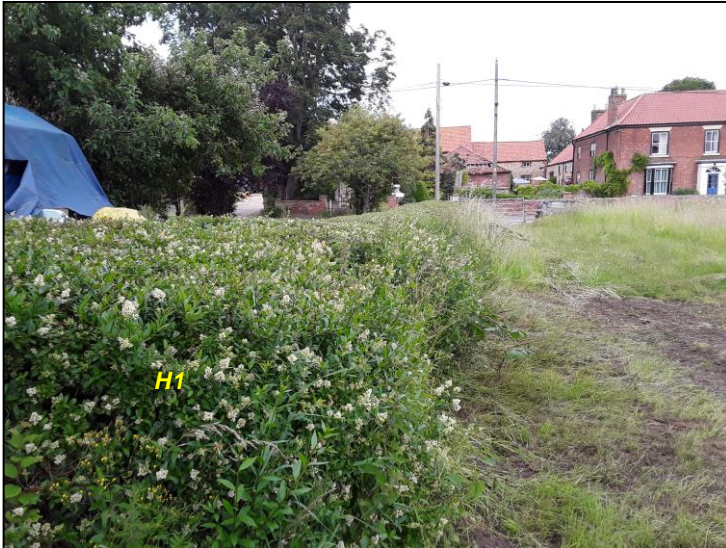
H1 is a single species privet hedgerow, marking the boundary between the site and an adjacent residential property. This hedge is regularly managed to a height of around 1m

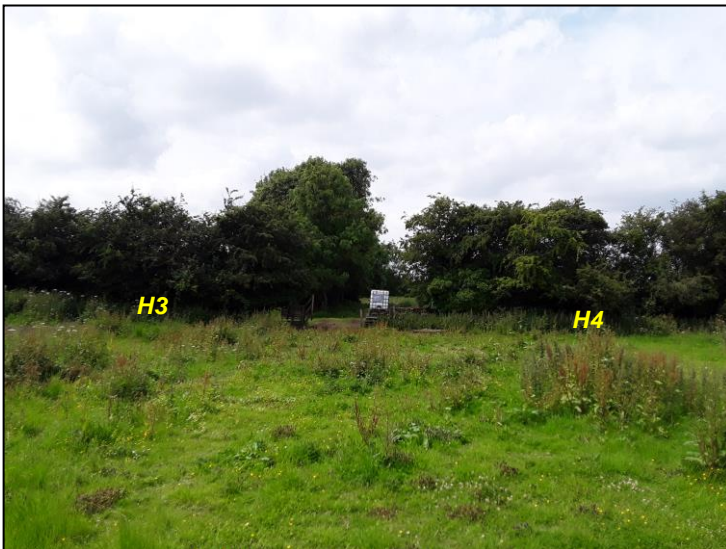
H3 & H4 are located within the site, a field boundary dividing two field compartments. Neglect of management is now seeing hedge plants beginning to develop as individual trees

H3	Hawthorn	7m	Good	Good	Single species hedgerow, with good form and good vigour. Management neglect is resulting in hedge plants beginning to establish as individual trees. Minor dead wood present, crossing and duplicating branches.	In context with the current land use hedgerow should be brought back into formal management. Should development occur management should be reconsidered in context with the proposed land use	20+	B2
H4	Hawthorn	7m	Good	Good	Single species hedgerow, with good form and good vigour. Management neglect is resulting in hedge plants beginning to establish as individual trees. Minor dead wood present, crossing and duplicating branches.	In context with the current land use hedgerow should be brought back into formal management. Should development occur management should be reconsidered in context with the proposed land use	20+	B2
H5 (off site)	Hawthorn	7m	Good	Good	Hedgerow off site. Single species hedgerow, with good form and good vigour. Management neglect is resulting in hedge plants beginning to establish as individual trees. Minor dead wood present, crossing and duplicating branches.	In context with the current land use hedgerow should be brought back into formal management. Should development occur management should be reconsidered in context with the proposed land use	20+	B2

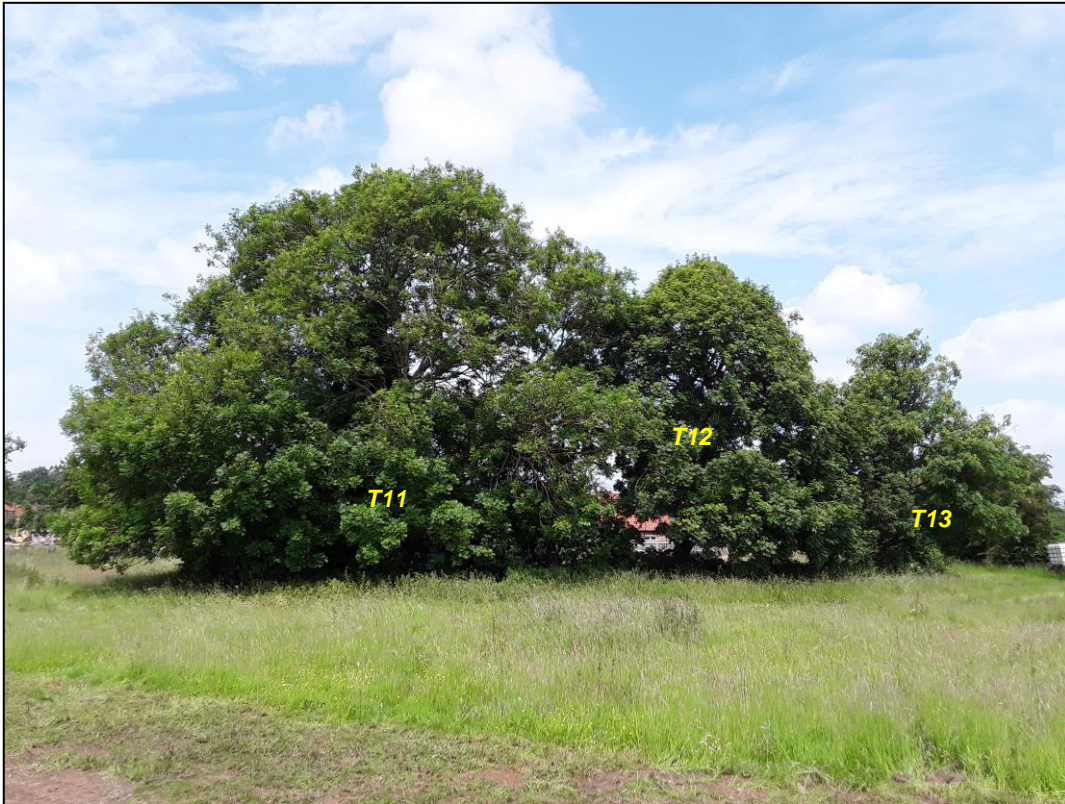
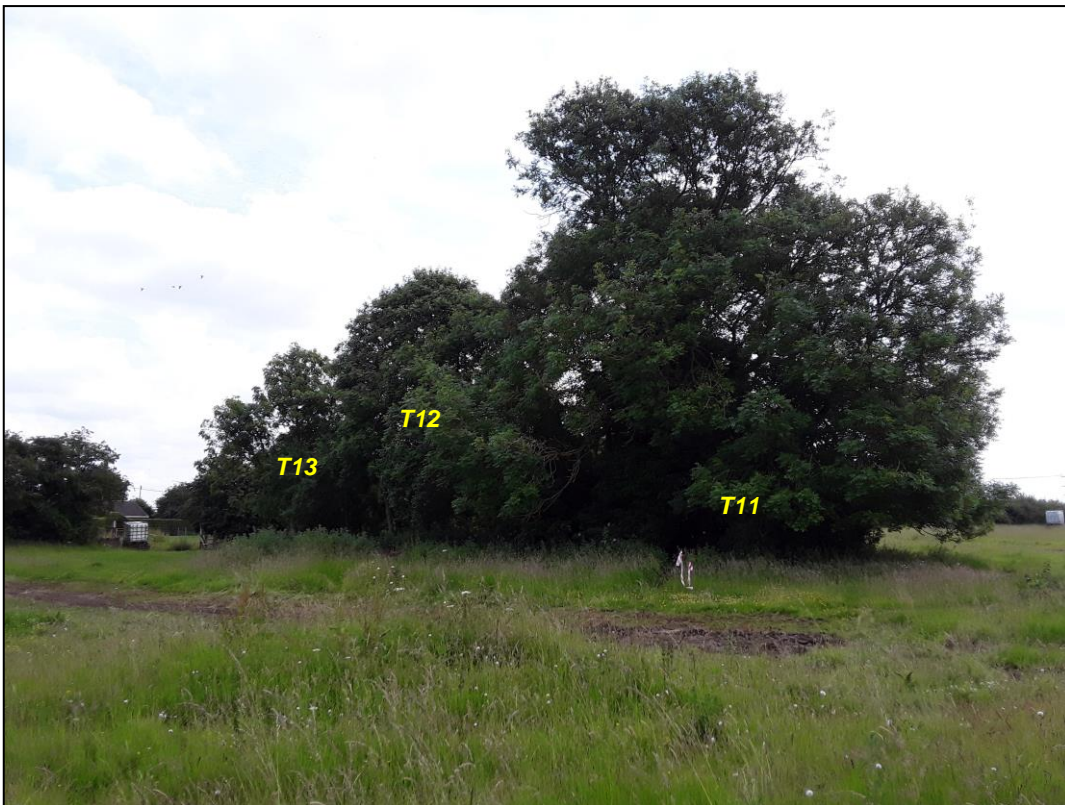
Trees T11, T12 & T13 are located towards the rear of the site. T11 is a particularly large dominating tree

Only 2 trees, T11 & T12 are considered to have some merit for retention
