**Proposed Coffee Drive-Thru Development,
Mannaberg Way, Scunthorpe**

Stage 1/2 Road Safety Audit

November 2020

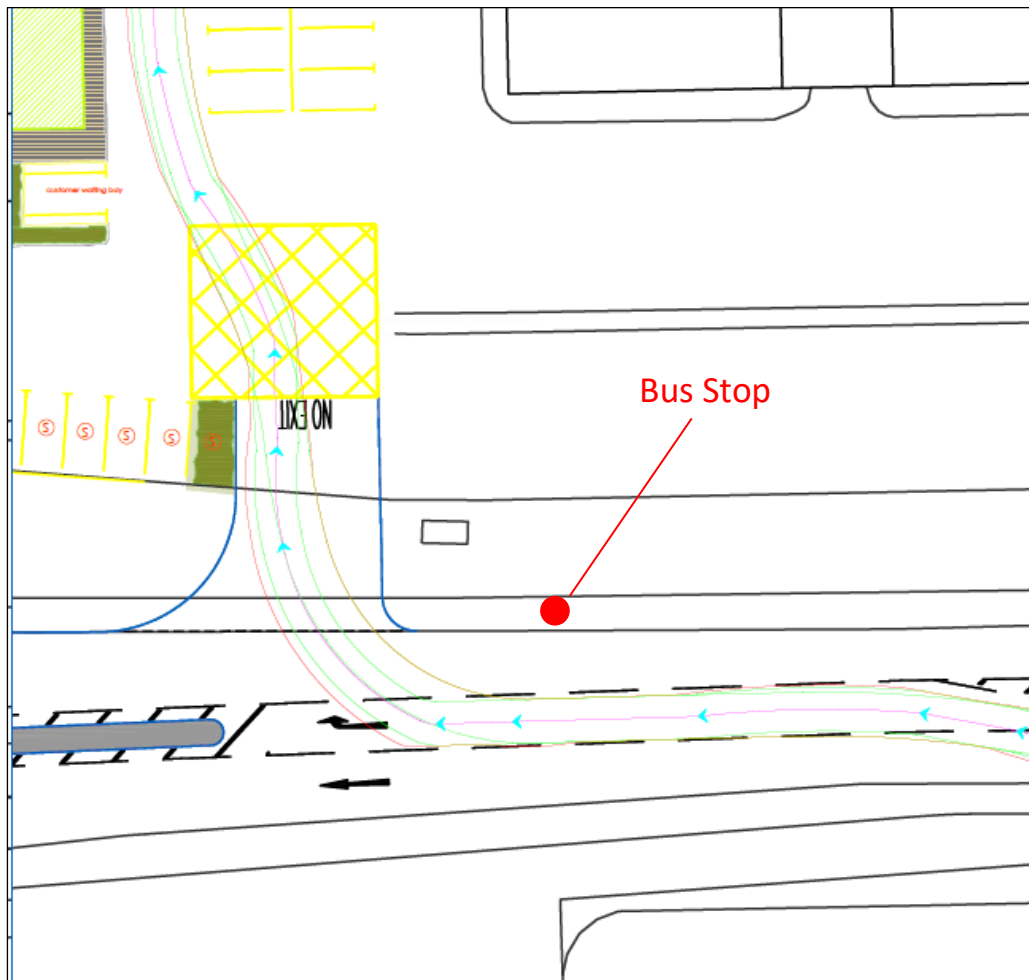
Location: Mannaberg Way

Summary: Bus stops on Mannaberg Way too close to site entrance and proposed central island

On Mannaberg Way there is an eastbound bus stop which will be very close to the proposed site entrance. There is a possibility that a stationary bus could overhang the site entrance and any vehicles turning into the site, particularly right turners, could come into contact with the bus, risking injury to vehicle occupants. The westbound stop on the southern side is also close to the proposed splitter island, and any overtaking vehicles could come into conflict with the island or be mistaken for a right turn movement into the access, increasing the potential for shunt type collisions.

It is recommended that the bus stops are moved further east from the entrance so that it is kept clear when a bus is stationary at the stop.

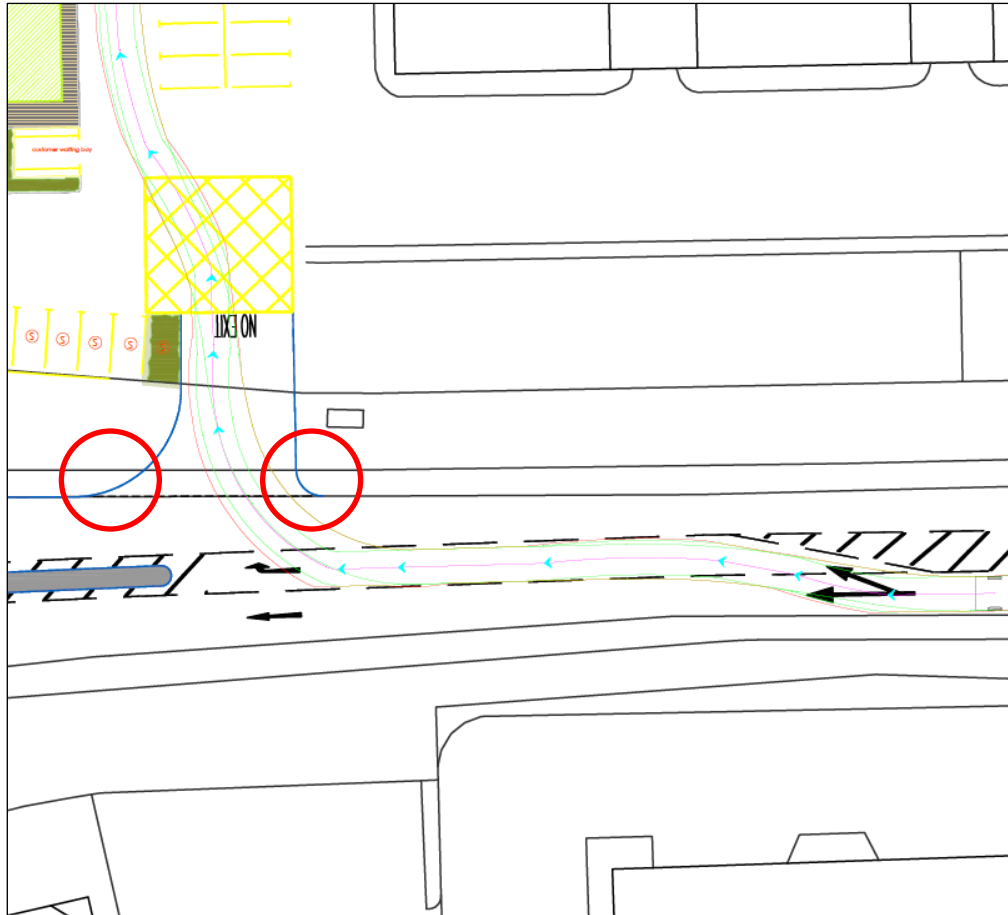
Location: Site entrance on Mannaberg Way

Summary: Lack of dropped kerbs and tactile paving

There are no dropped kerbs or tactile paving shown across the site entrance, which crosses a footway. Visually impaired pedestrians could trip and injure themselves over full kerbs when attempting to cross the entrance to the site without any dropped kerbs or tactile paving in place.

It is recommended that suitable dropped kerbs and tactile paving across the site entrance are provided.

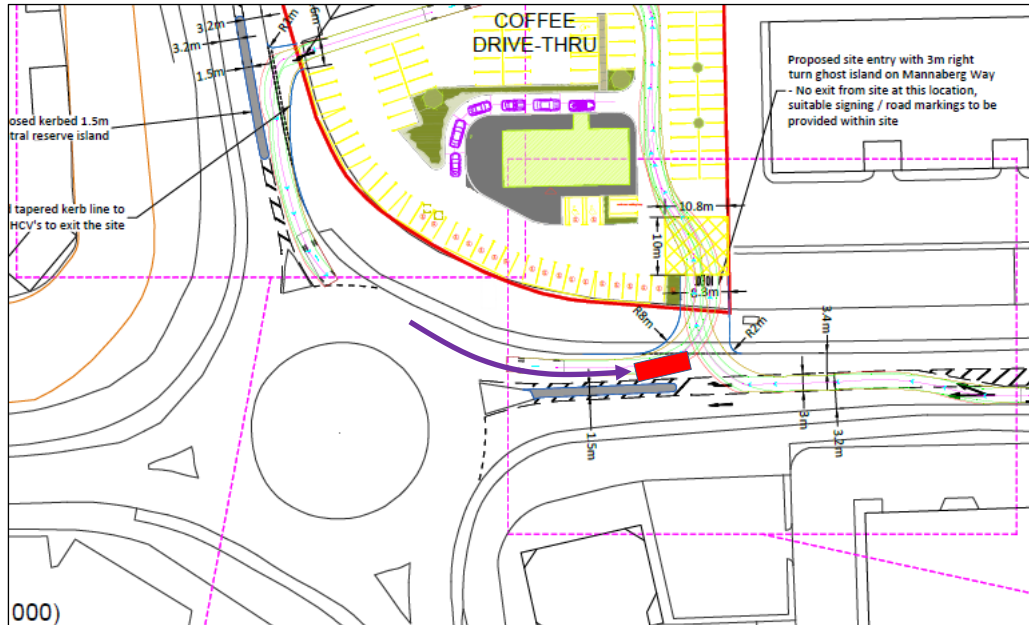
Location: Site entrance on Mannaberg Way

Summary: Conspicuity of proposed access

The proposed site entrance is located within an existing 40mph speed limit approx. 40m east of the Normanby Road roundabout. Any hesitancy or late braking amongst vehicles turning left into the proposed access could increase the risk of shunt type collisions as vehicles exit the roundabout.

It is recommended that the scheme designer assesses the conspicuity of the access for approaching drivers prior to any S278 application and, if deemed necessary, that further measures are implemented within the highway or within the site to, as far as practicable, reduce the risk of shunt type collisions. Examples of further measures could include warning signing, high performance surfacing, reduced speed limit, marker posts, or appropriate works/signing within the site boundary.

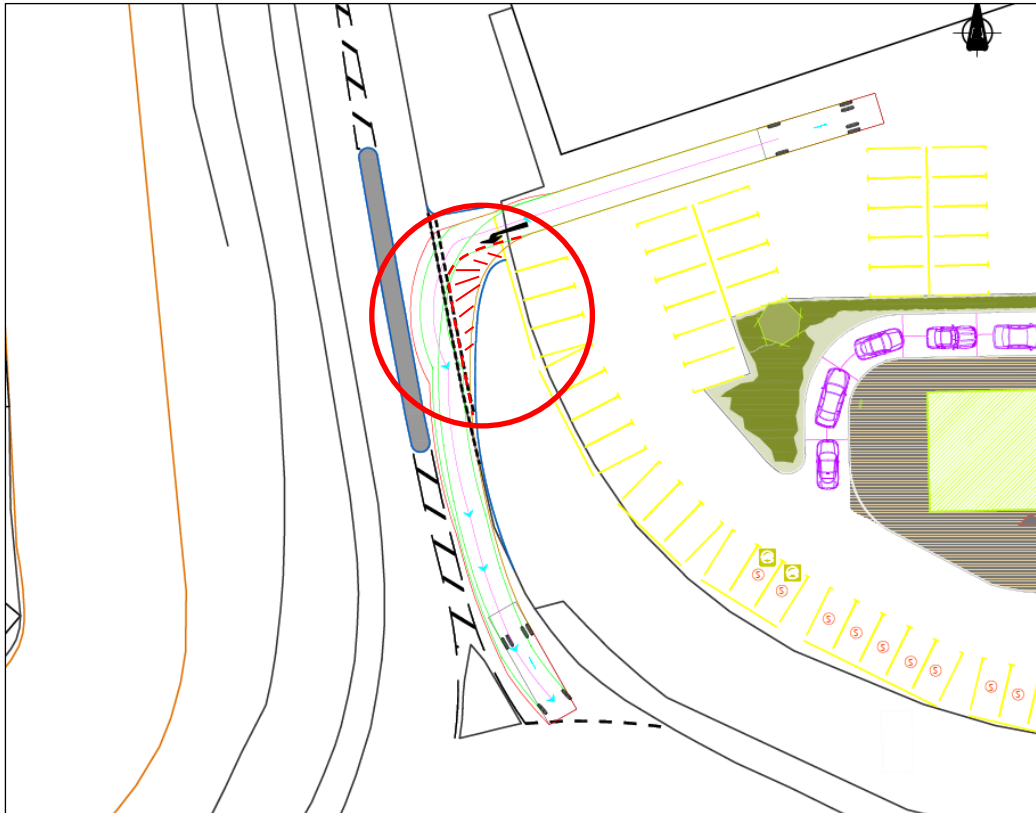
Location: Site exit on Normanby Road

Summary: Acute angled exit reducing drivers' visibility to the right

The exit from the site onto Normanby Road is indicated as left only and is intended to be enforced by an elongated island in Normanby Road which will prevent drivers turning right from the site. As a consequence the exit is shown with an acutely tapered kerb which will allow large vehicles to exit the site without striking the central island. However this may also encourage drivers of other vehicles to position themselves at an acute angle while waiting to enter Normanby Road; consequently their visibility to the right will be impaired as they will have to look over their shoulders, which may be difficult for some drivers. This could cause drivers to enter Normanby Road without seeing any vehicles approaching from their right, risking contact and possible injury to vehicle occupants.

It is recommended that an area of hatching and/or an overrun area are provided on the southern part of the exit so that drivers are encouraged to present their vehicles more squarely at the give way markings.

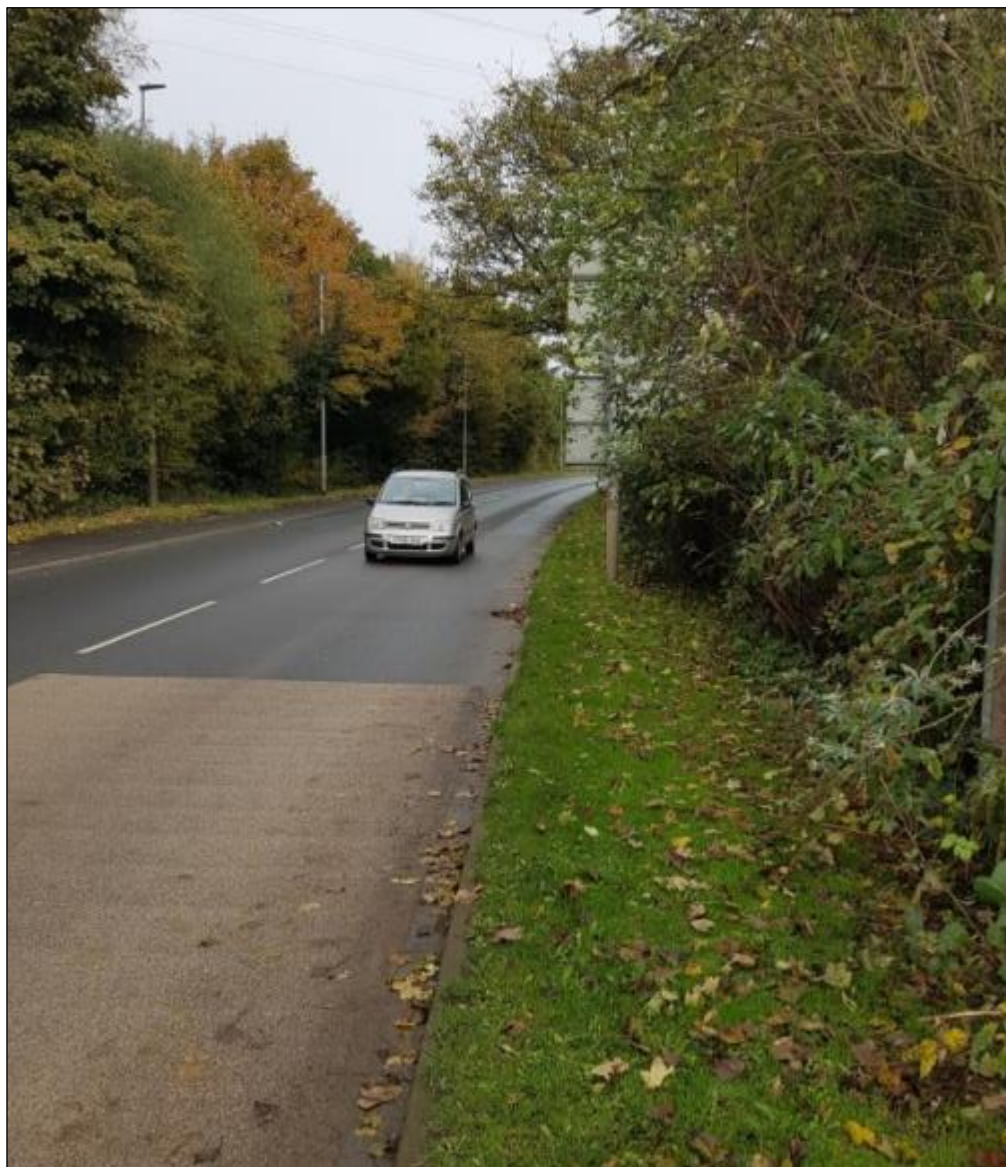
Location: Site exit on Normanby Road

Summary: Restricted visibility along Normanby Road from the site exit

The visibility to the right from the proposed site exit along Normanby Road is severely limited by the presence of overhanging foliage and a large ADS and is exacerbated by the slight bend in the road to the right. It is possible that exiting drivers may not be able to see approaching vehicles and, as Normanby Road has a 40 mph speed limit, vehicles could be passing the exit at the same time as exiting drivers resulting in possible contact and injury to vehicle occupants.

It is recommended that the foliage is cut back and the ADS is raised so as not to impede drivers' visibility to the right from the site exit.

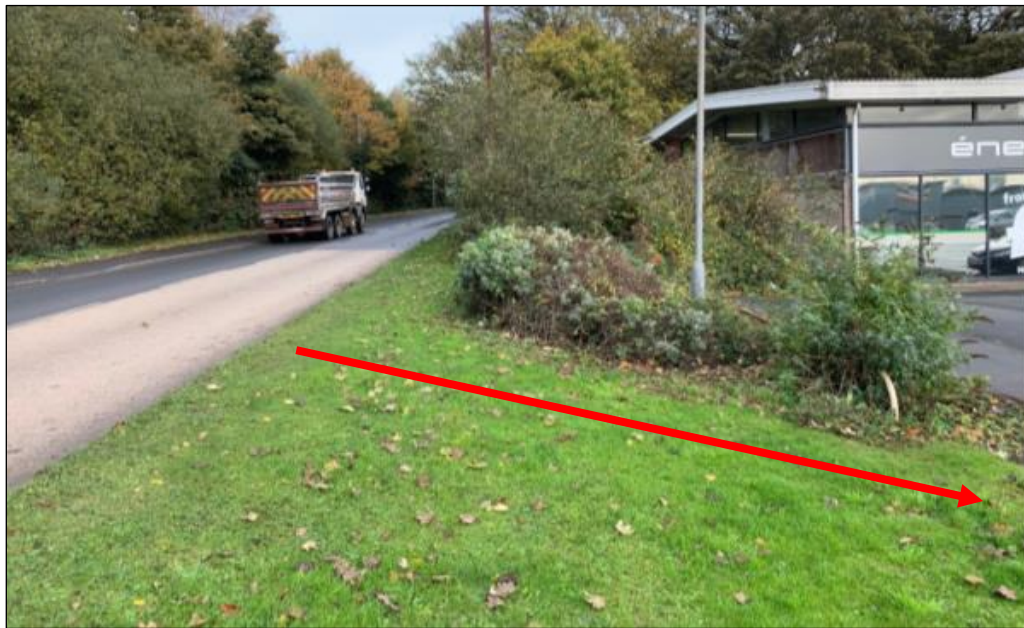
Location: Site exit on Normanby Road

Summary: Difference in level between the site and Normanby Road

At the location of the proposed exit from the site there is a pronounced difference in level with the site surface significantly lower than the surface of Normanby Road. The resulting gradient of the exit could cause a problem for exiting vehicles as, during wet or icy conditions, they could slide back into following vehicles risking injury to vehicle occupants.

It is recommended that the exit ramp gradient is no greater than 6% (CD 109 Highway Link Design Revision 1).
