BROWN BEAR TREE CARE

Visual Tree Assessment

48 Franklin Way, Barrow-upon-Humber, DN19 7BJ

VTA22-01

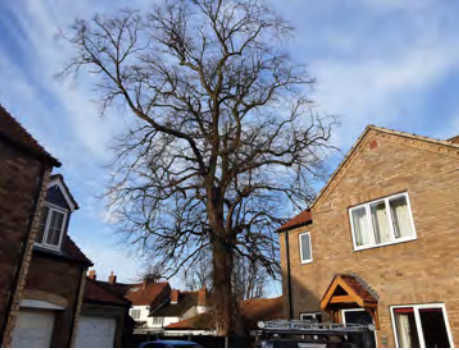
Location	Root Plate	Cavity South at 1.5m	Large wound and Ivy

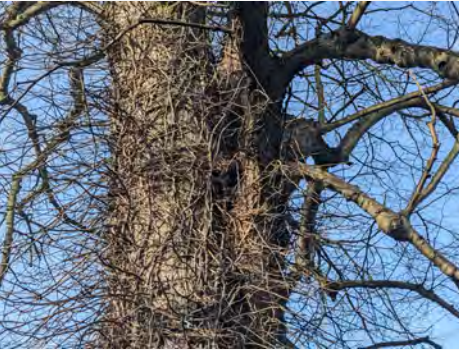
Compression union North at 5.5m	Possible compression union at 10m	Hanging deadwood South at 10m	Major deadwood West

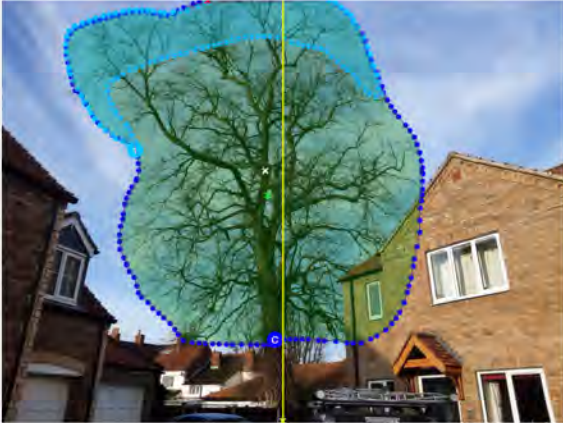
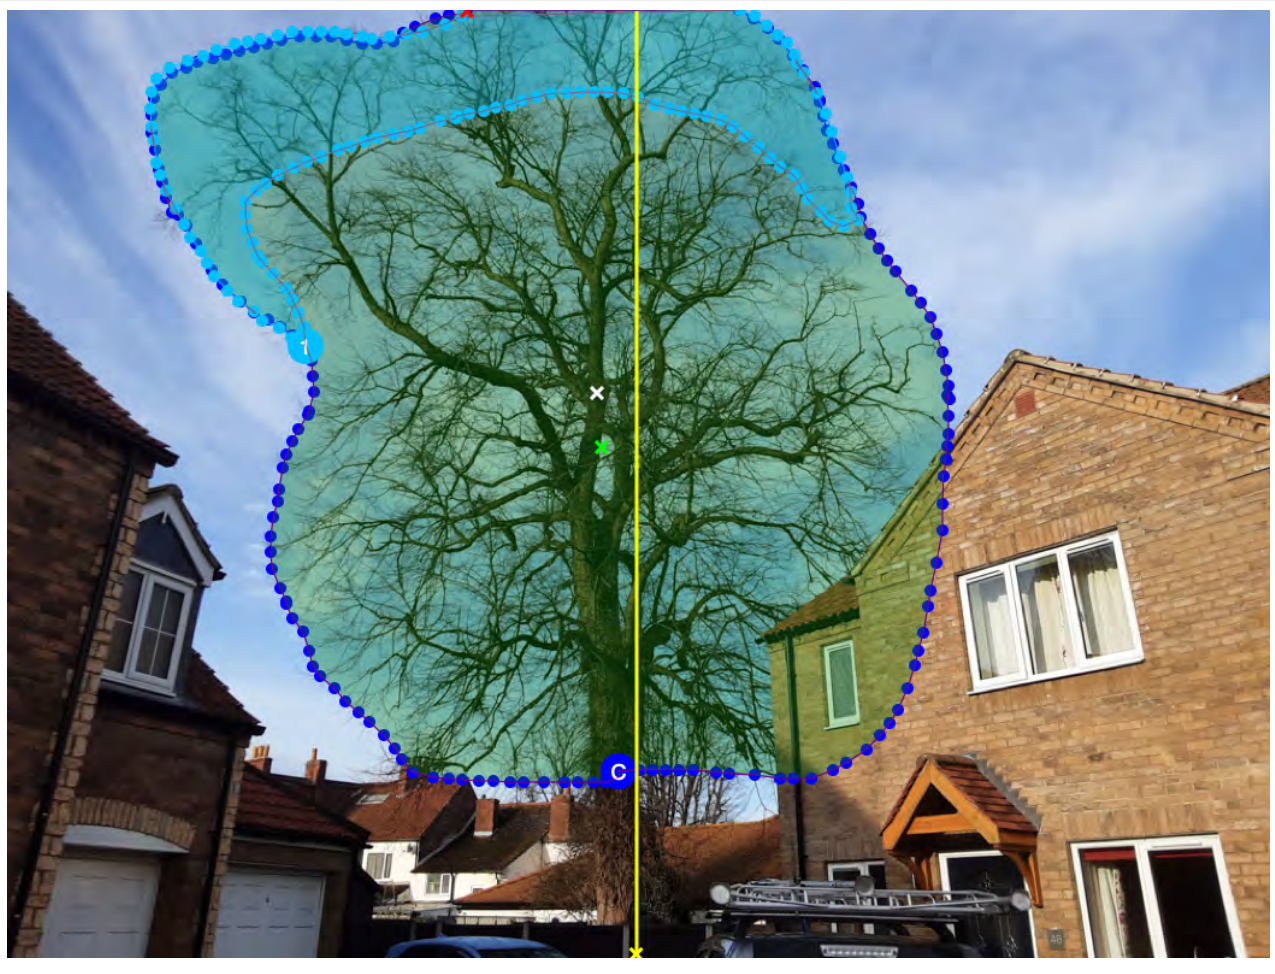
Reduction of 5 meters in height reduces wind load experienced at the white X by 54% for constant wind speed of 22m/s (50mph).
 The light blue area represents the material to be removed (better image below) by crown reduction.

Recommendations						Targets		Work priority
<p>It is my recommendation to reduce the trees crown in both height from 22.5m to 17.5m (5m reduction approx 22%) and spread of southern bough limb by 2 meters. This will reduce wind loading by 54% (see ArboStApp report below).</p> <p>Removal of all deadwood, prune clear of the property by 2 meters, remove stem epicormic growth and the remainder of the dead ivy.</p> <p>Reduce the end weight of the damaged limb West at approx 5.5 meters.</p>						Owners dwelling. Multiple neighbours dwellings and outbuildings.		Deadwood 1-2 months
Reinspect		18 Months
