STRUCTURAL APPRAISAL REPORT

GRANGE FARM

Report 20633-H-RP-001-R0

2 September 2022

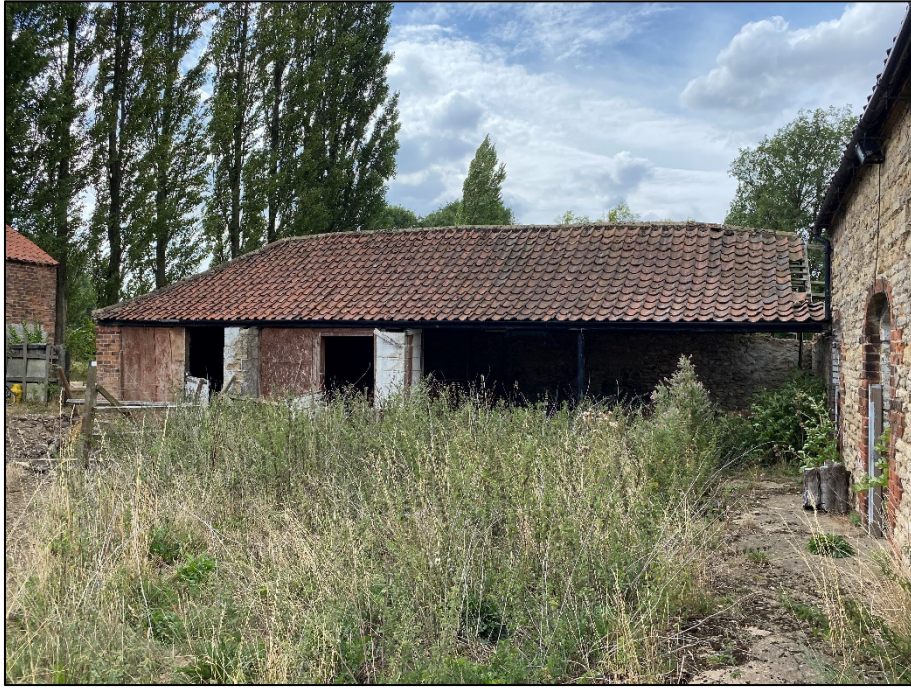
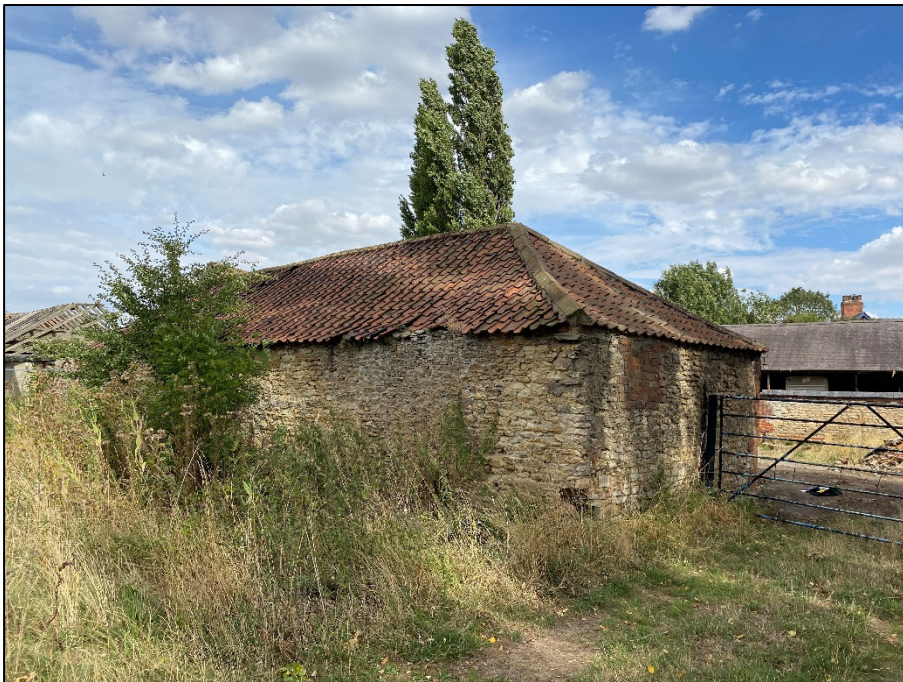
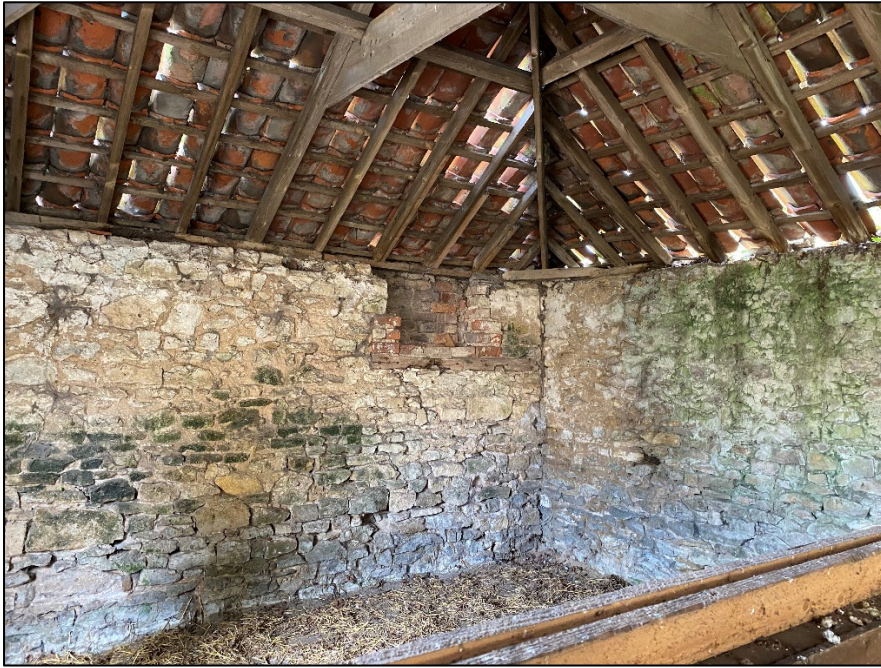
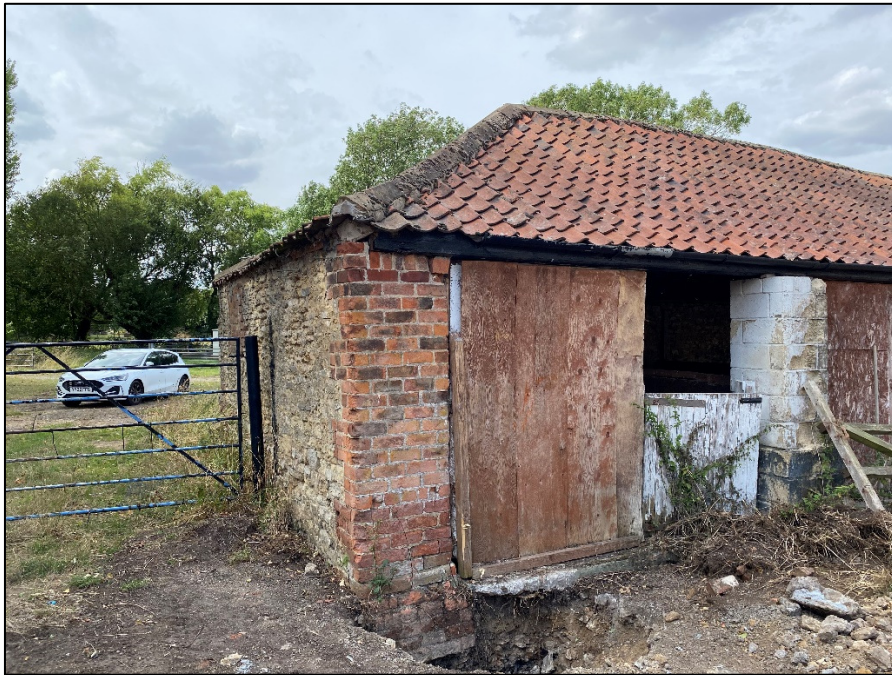
Plate 1 – Building 1

4.1.1 We noted a 20mm plus vertical crack in the northwest corner and a 5mm wide vertical crack in the north wall. The north wall leans in at a gradient of 25mm in 1 metre.

In the southwest corner, there is a 30mm + separation in the masonry. Loose stonework was visible in the base of the south wall which was measured at being 420mm thick. The walling adjacent to this was seen to be very loose.

We noted that the purlins are heavily bowed to the east pitch as are the common rafters.

5.2.3 However, the condition of buildings 1 and 2 and the external stairway to Building 8 are of concern, and we cannot guarantee the short-term stability of these buildings.

- 2.6.1 Carry out an asbestos survey and Damp/Decay survey of the buildings.
- 2.6.2 Carry out a CCTV survey on the drainage serving the farm complex.
- 2.6.3 Partially demolish Building 1 (rear section including deformed roof plate).

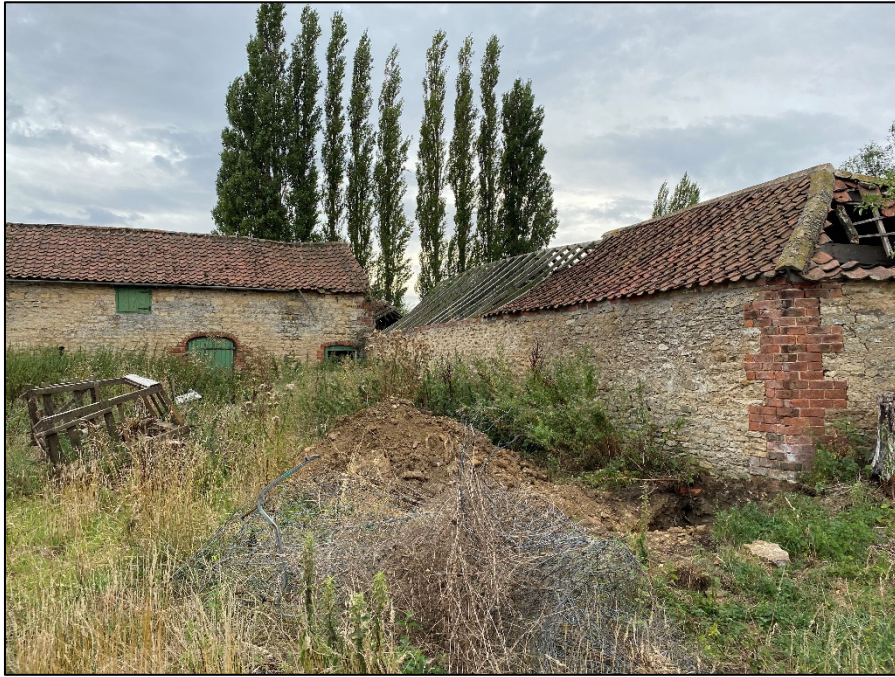
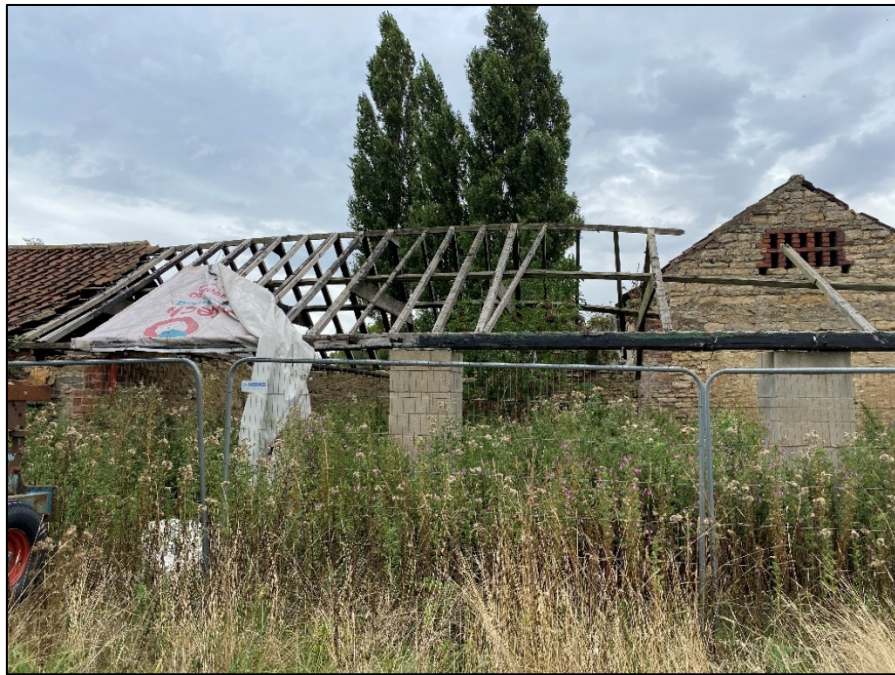
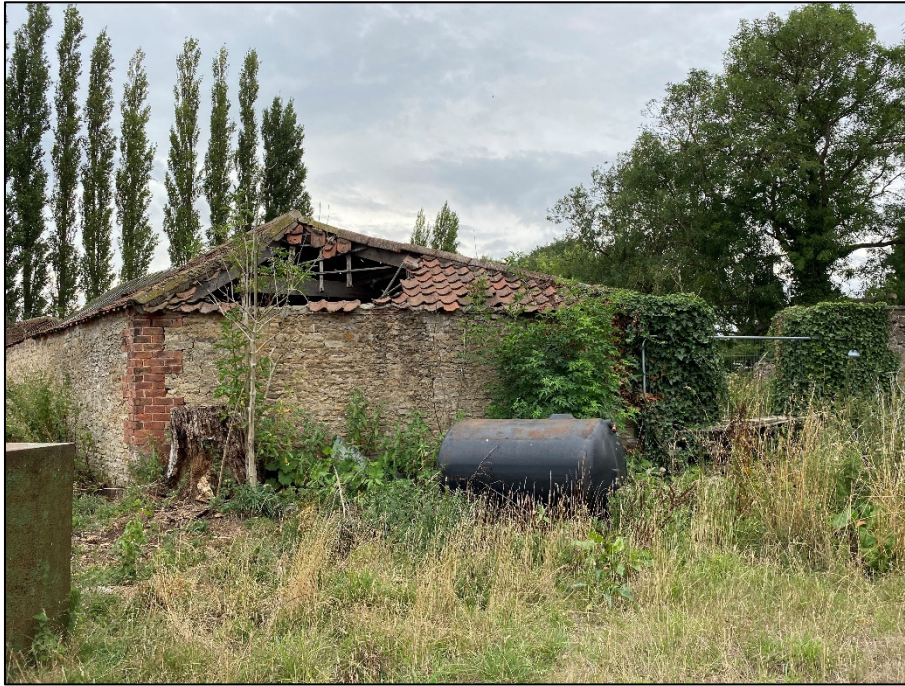
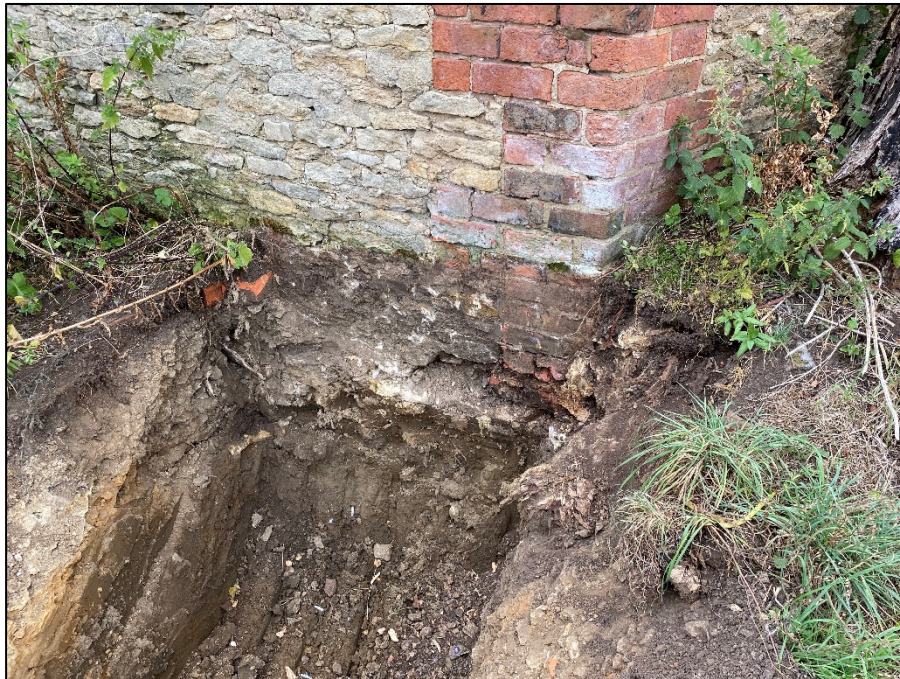
Plate 5 – Building 2

4.2.1 We noted the heavy outward lean on the southeast corner.

4.2.2 There are longstanding cracks to the stonework on the south and west elevations.

4.2.4 The existing foundation is very limited and without a projection from the outside face of the external wall.

4.2.5 The underside of foundation is located at 490mm below ground level.

4.2.6 The foundation is seated in a fill over a brown made ground/fill material.

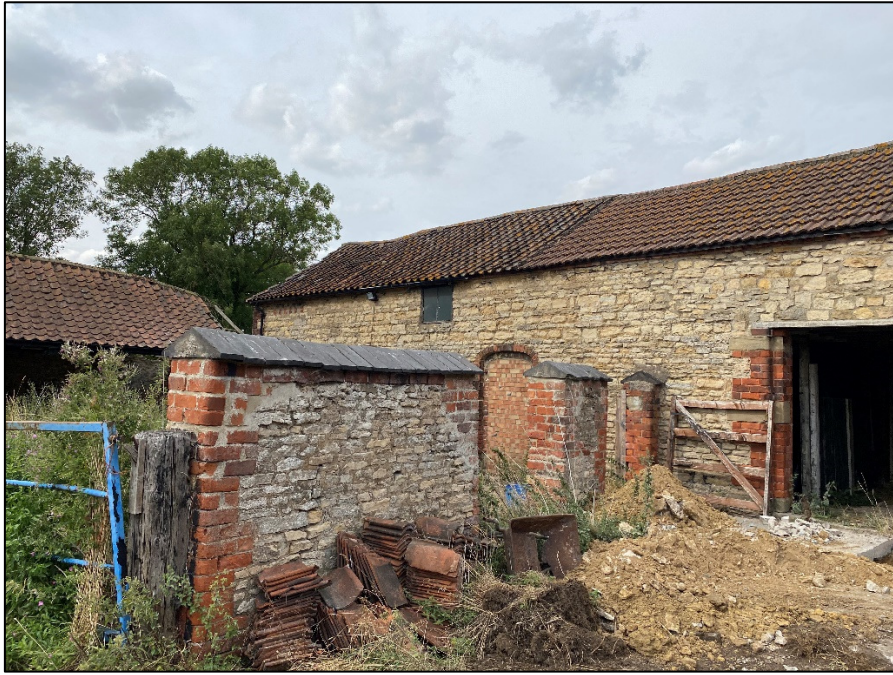
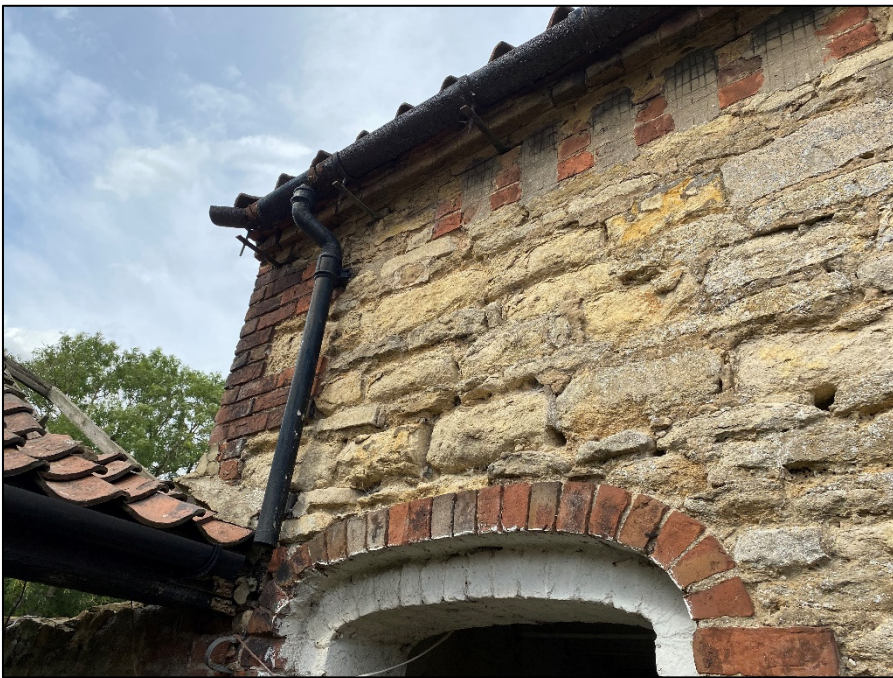
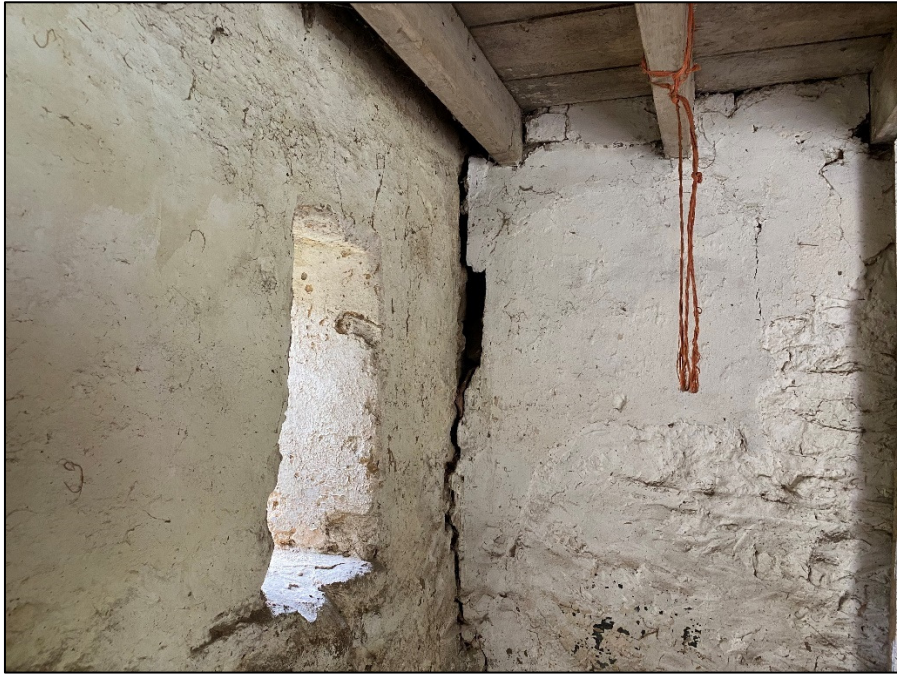
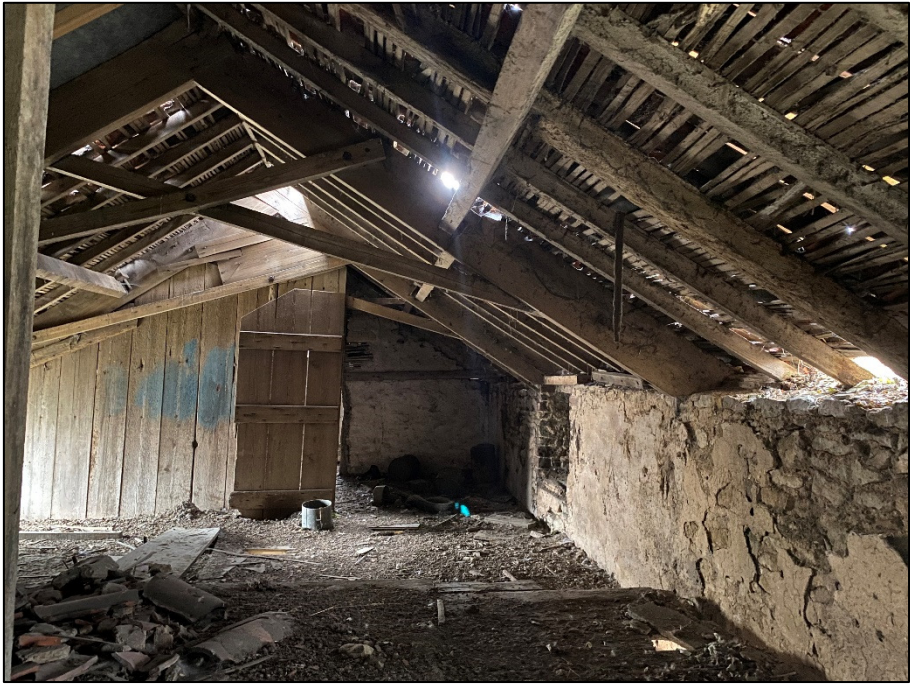
Plate 9 – Building 3

4.3.1 Not inspected as in a derelict condition (we were advised by the owner of a previous fire?)

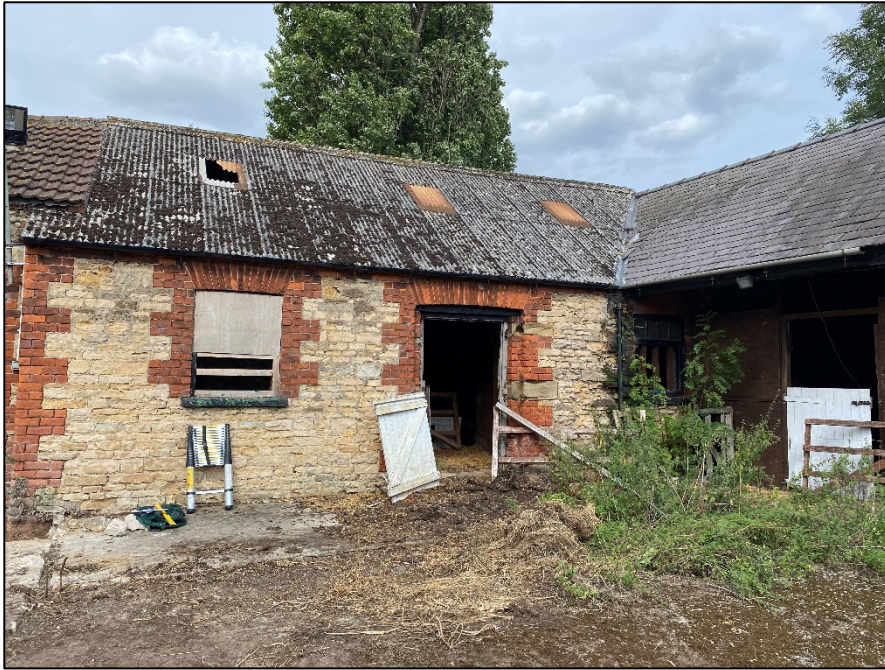
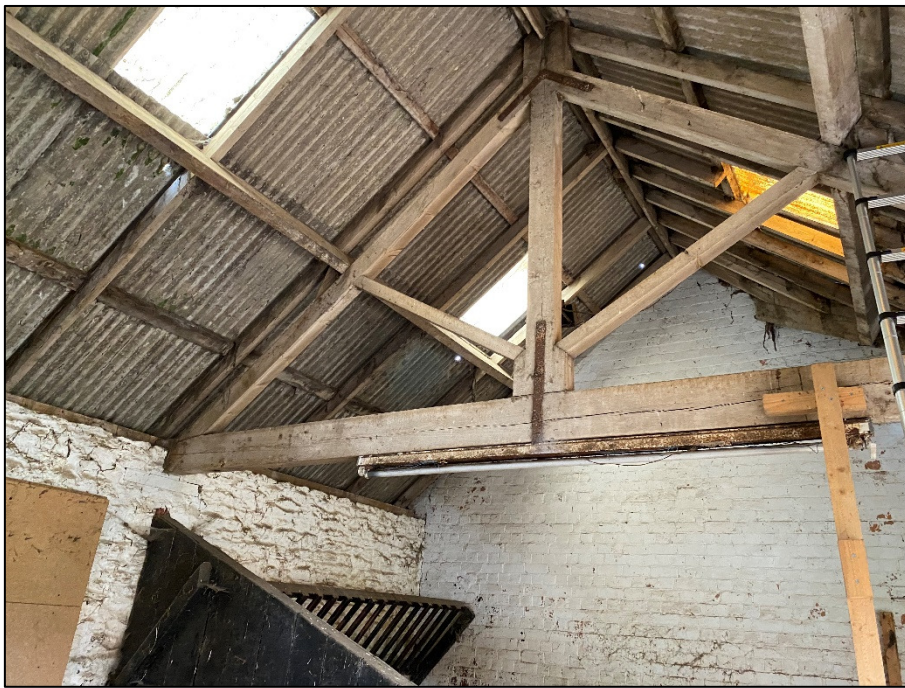
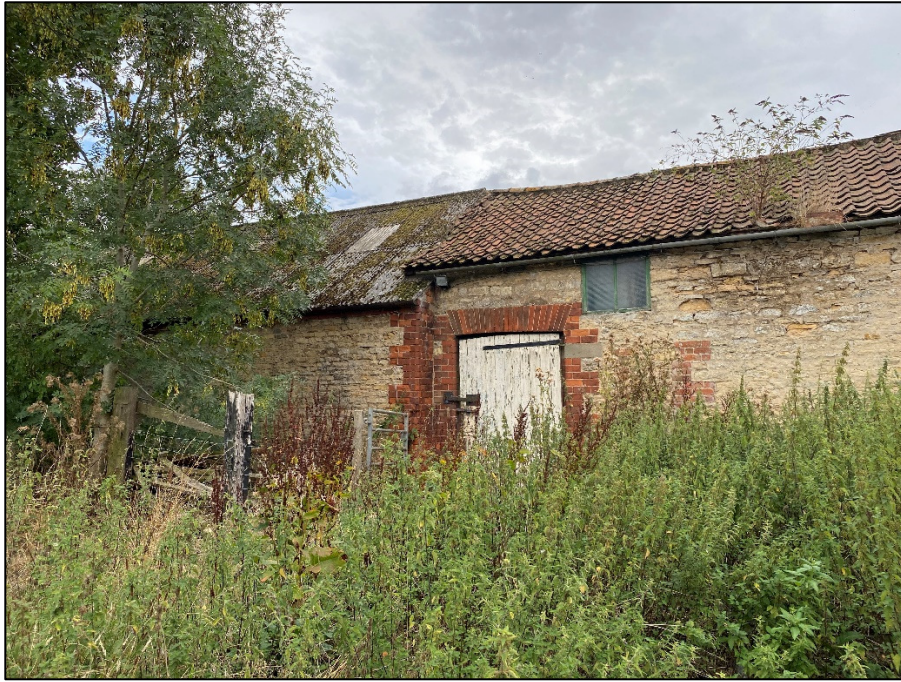
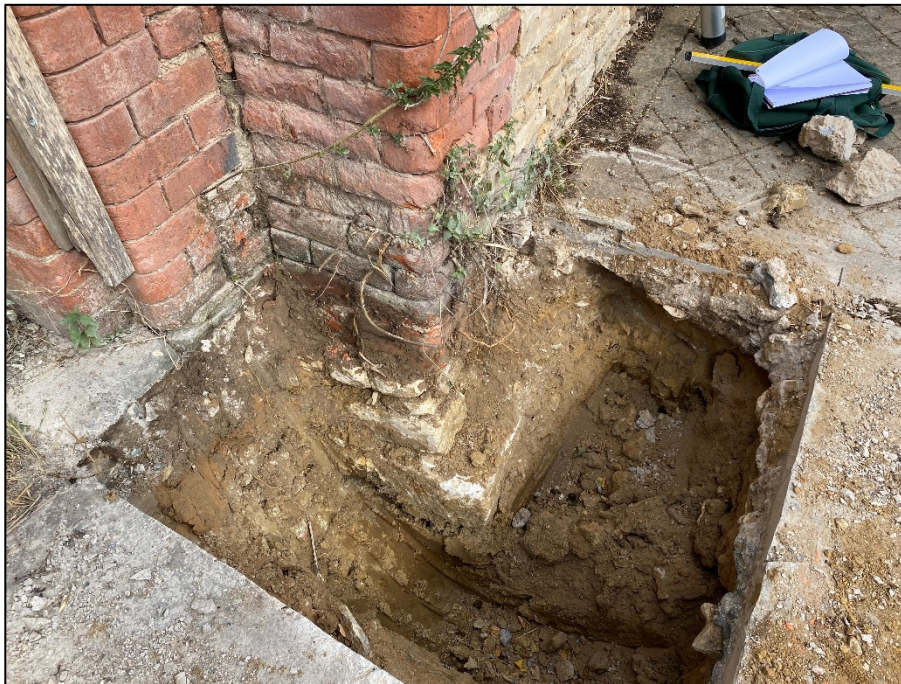
Plate 13 – Building 4

Large parts of the roof covering are missing, and the roof timbers are deformed and in poor order. There is much vegetation growth in evidence.

However, a cursory viewing revealed 10mm + cracking to the feature brick of the residual northeast corner adjacent to the stonework.

4.4.3 The existing foundation is poorly constructed stone blocking is without a projection from the outside face of the external wall.

4.4.4 The underside of foundation is located at 530 mm below ground level.

4.4.5 The foundation is seated in a brown made ground/fill material.

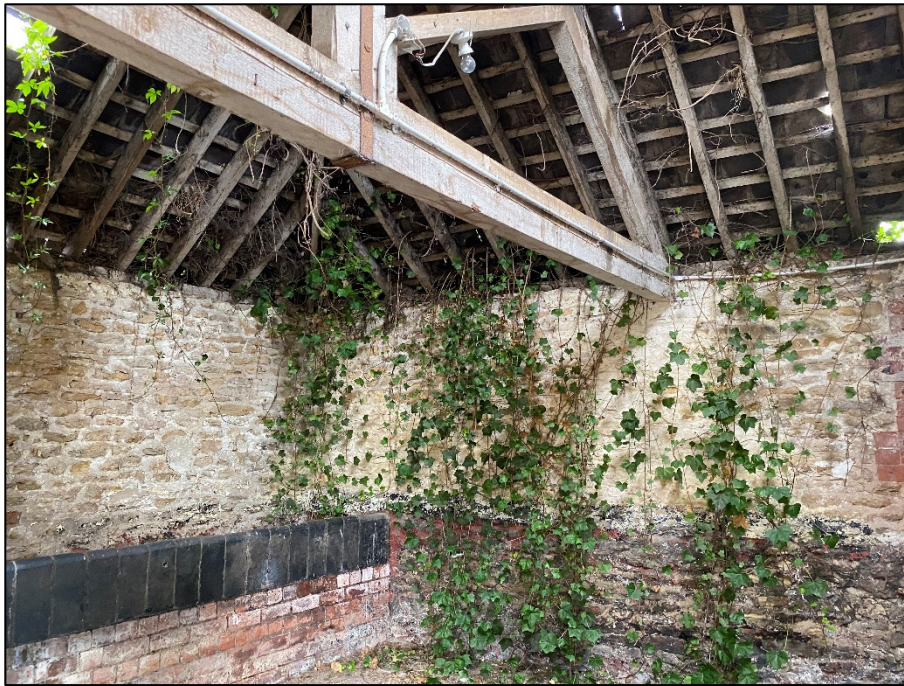
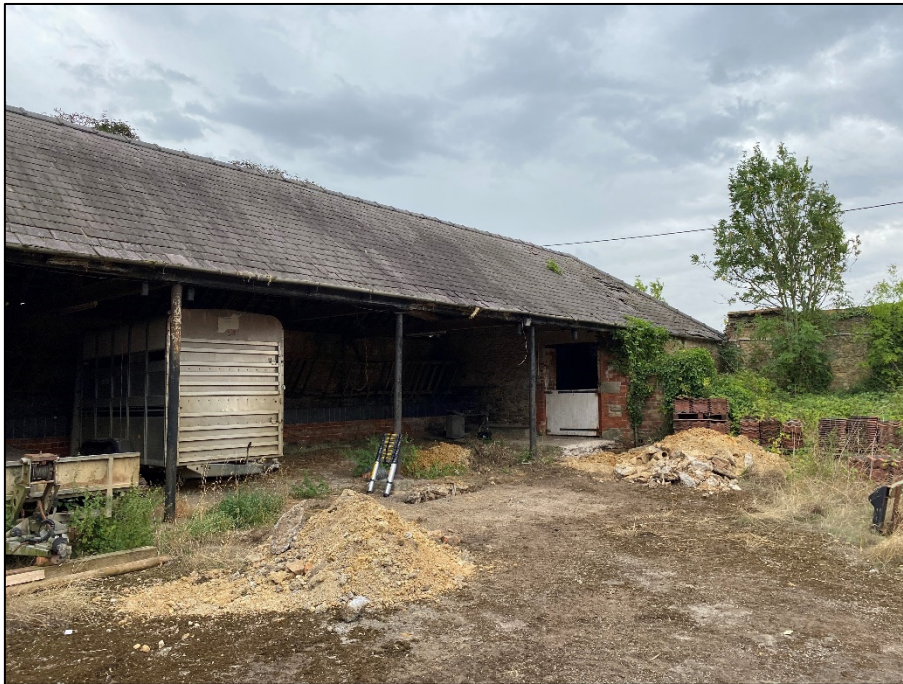
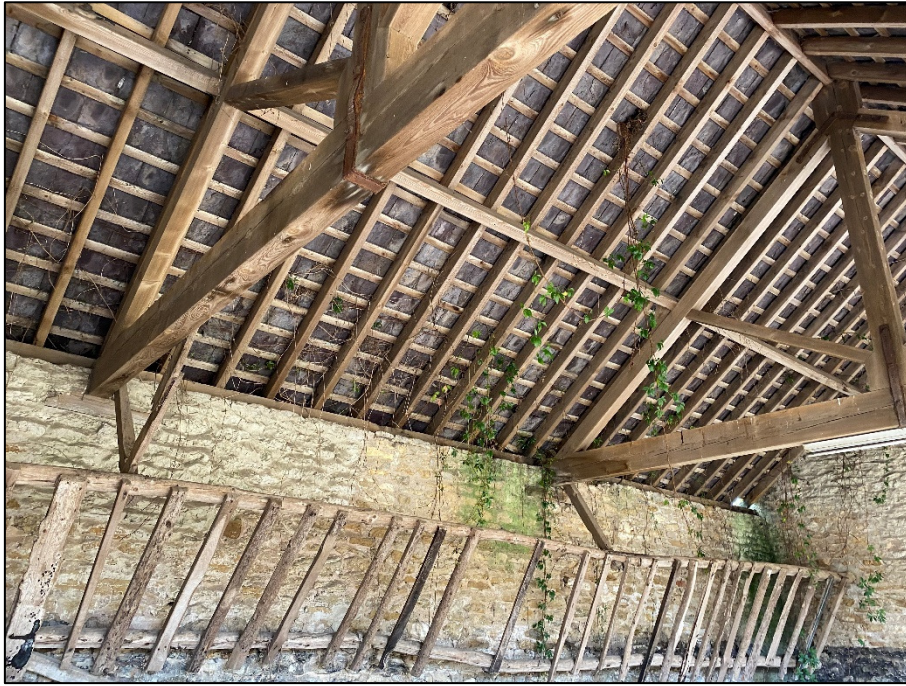
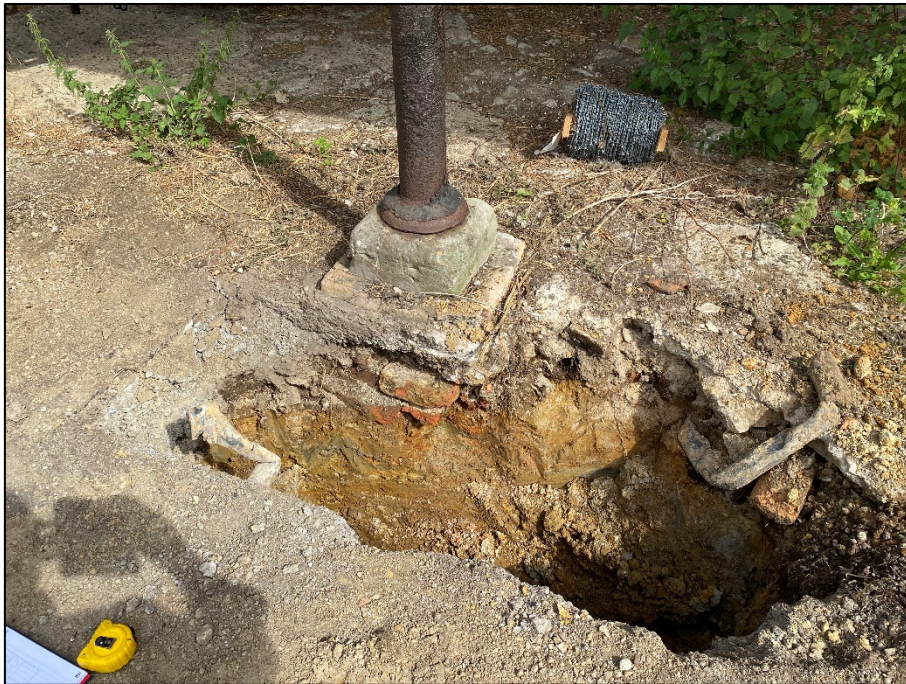
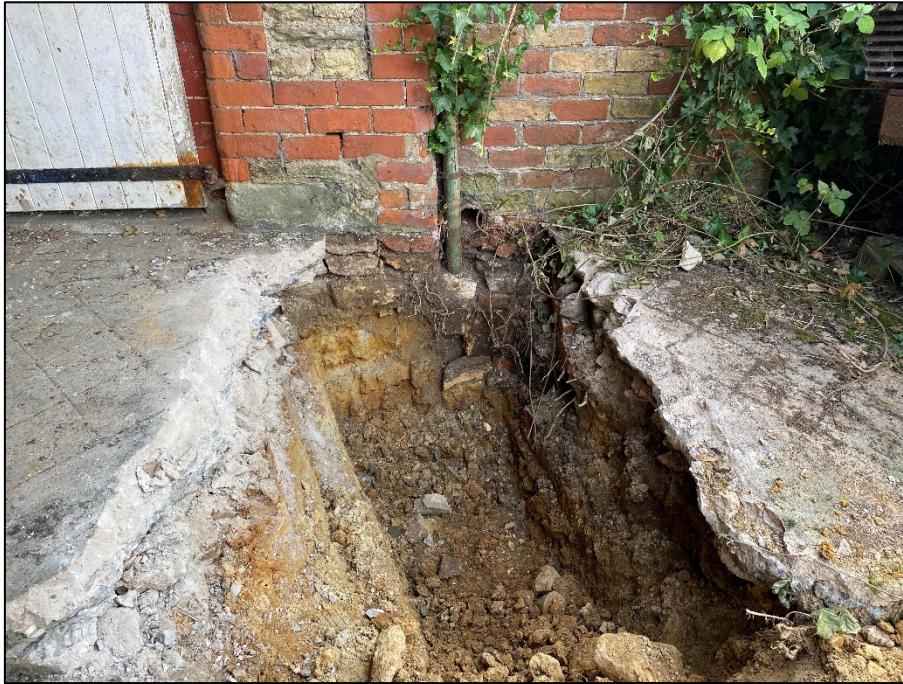
Plate 17 – Building 5

4.5.1 An inspection of the left side room revealed a 10mm wide vertical crack to the northeast corner.

4.5.3 In the adjoining storeroom, the rear wall leans out at 40mm in 1 metre and there is a 30mm wide vertical crack in the northeast corner. The front wall is damp but plumb.

4.5.5 In the right hand side room we noted loose stonework in the central room division wall and there is a 2mm wide vertical crack in the southwest corner.

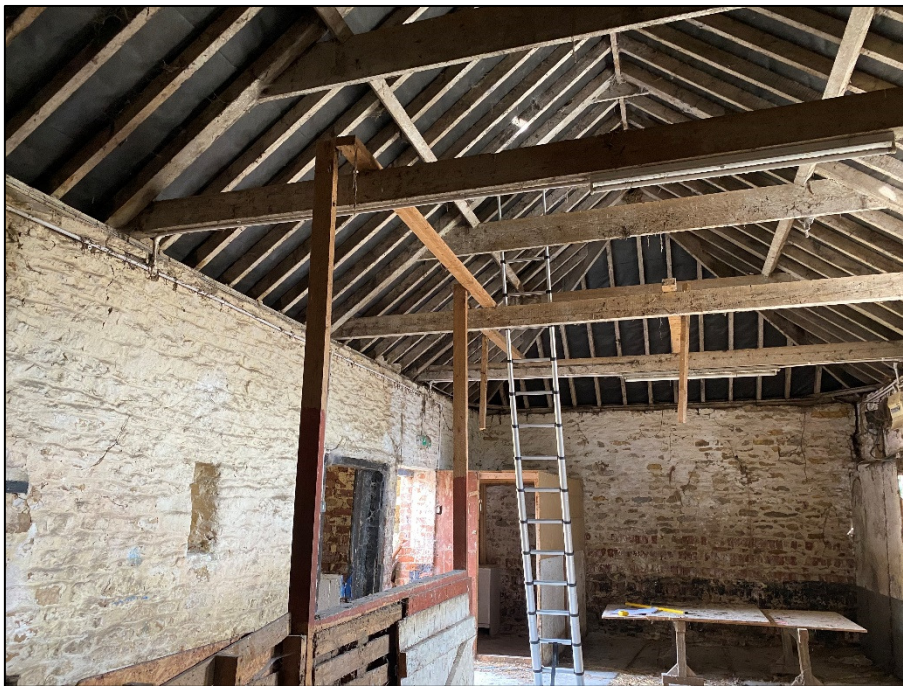
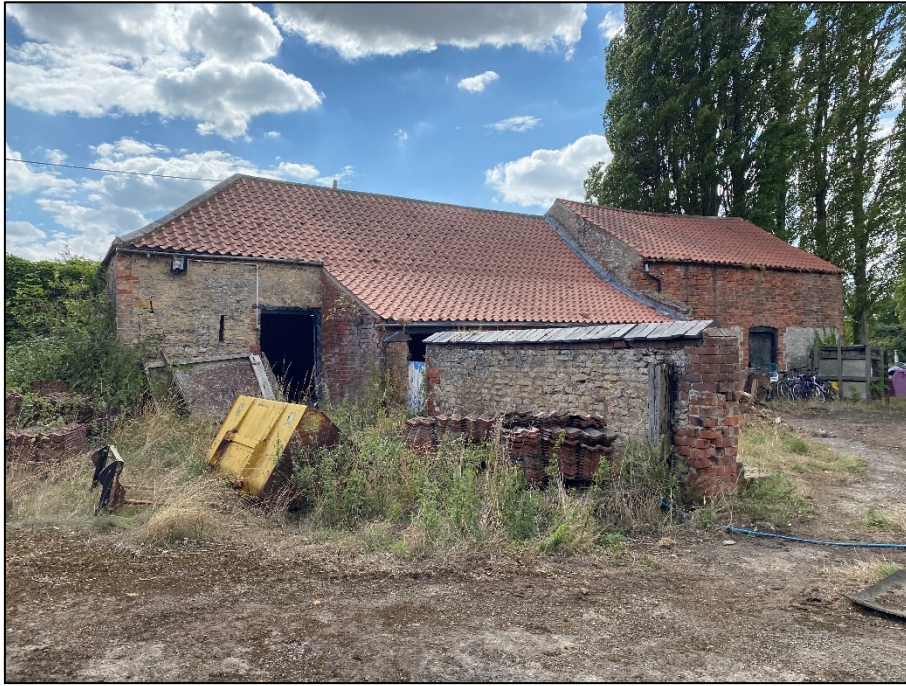
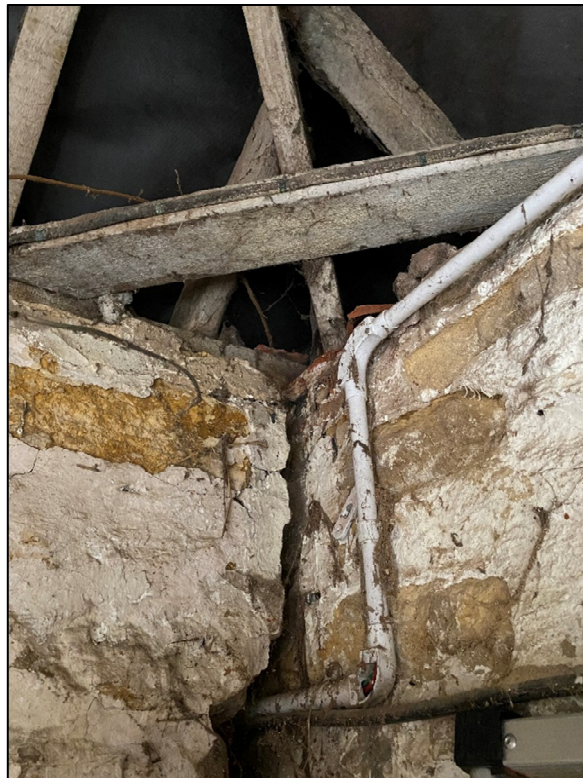
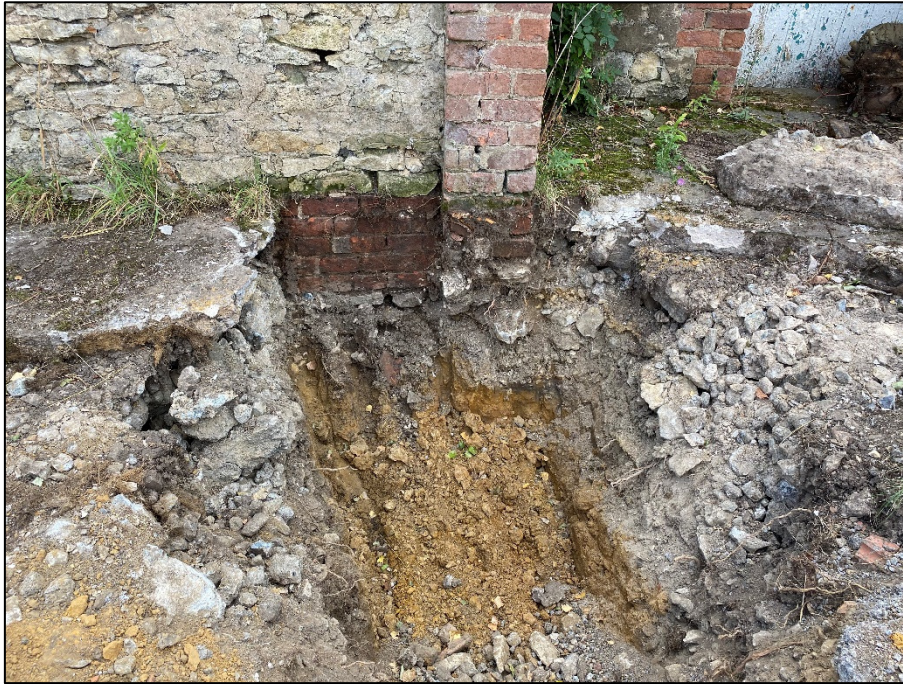
Plate 22 – Building 6

- 4.6.1 An inspection of the south elevation revealed longstanding cracks and erosion to the stonework together with weathered brickwork. The roof profile is uneven over the west aspect.
- 4.6.2 There is weathered masonry to the north elevation stonework, with a 10mm + stepped crack over the west door brick arch. The roof tiles/guttering are in a dilapidated condition in this location.

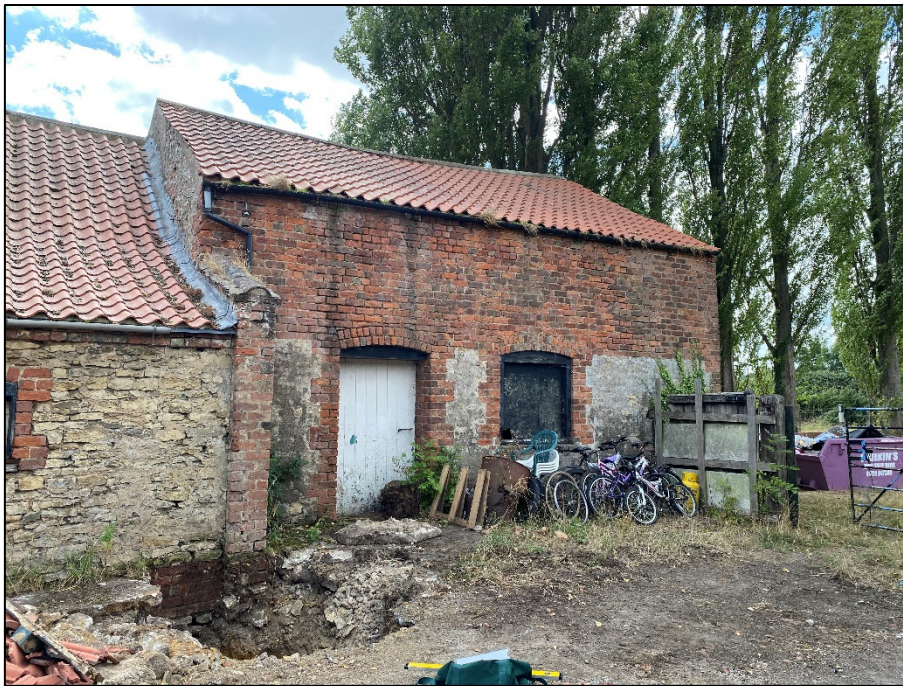
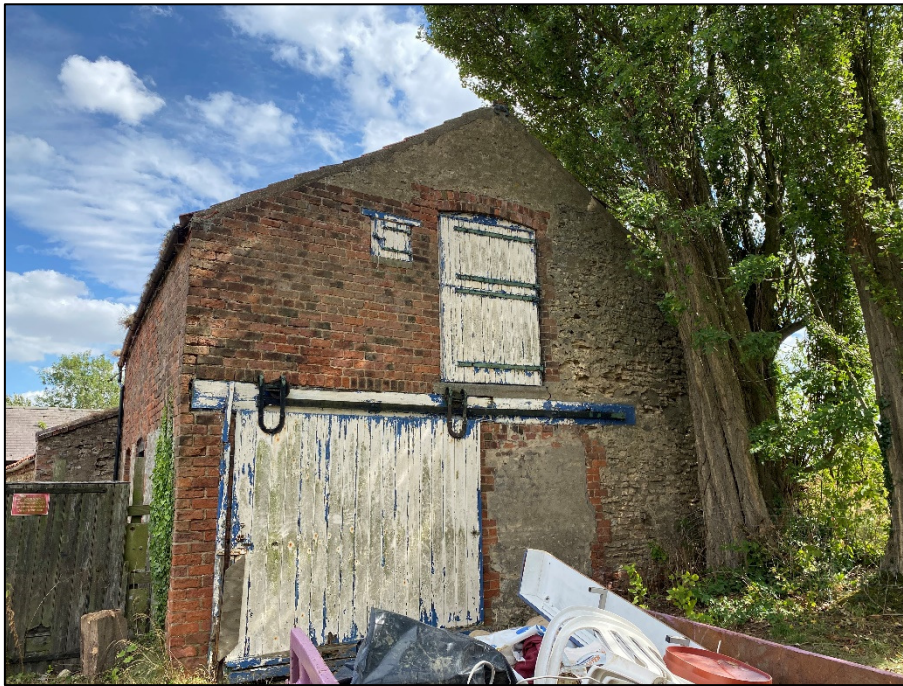
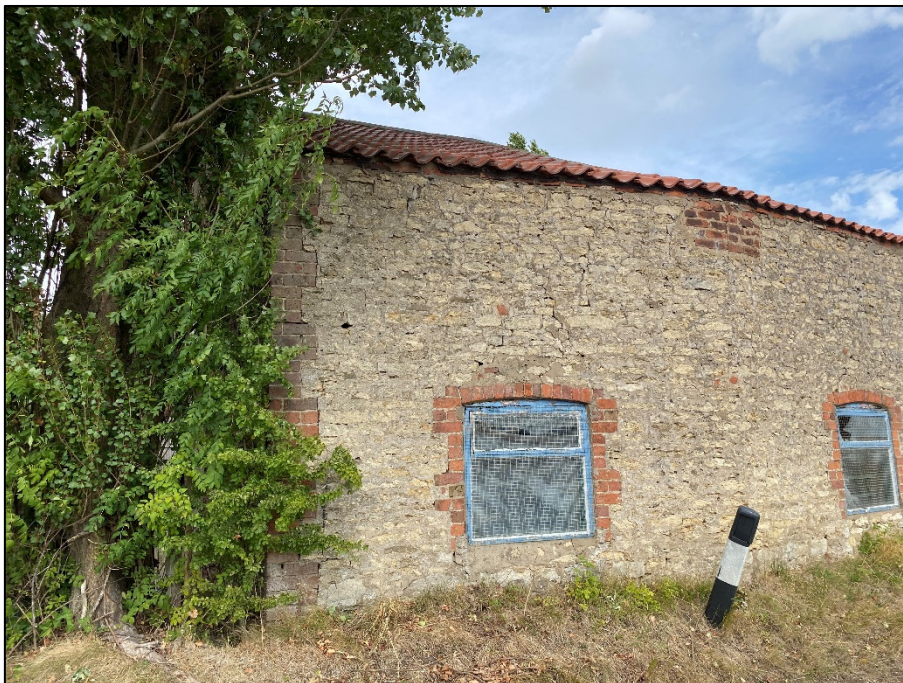
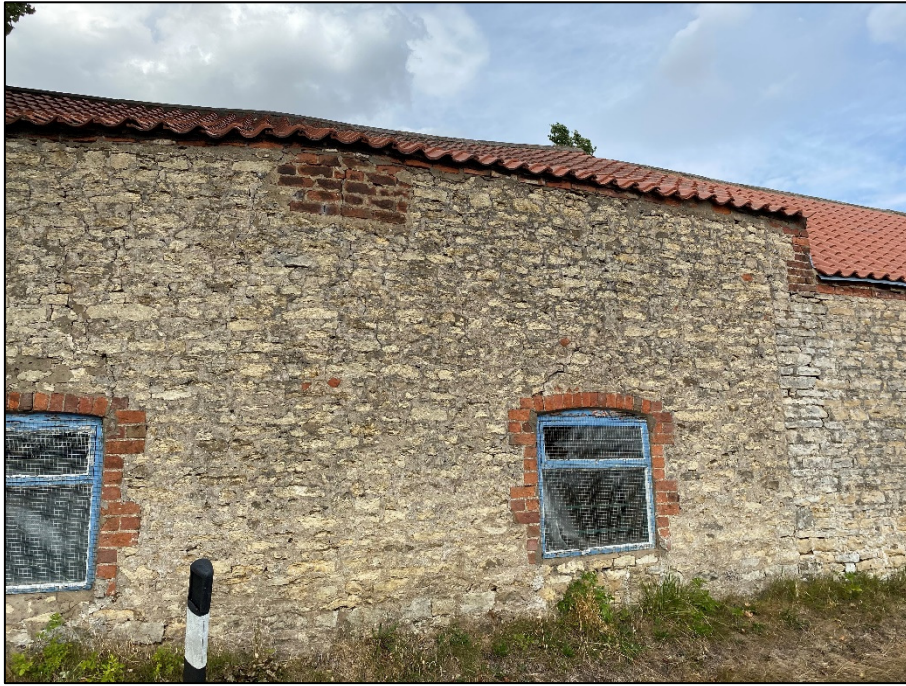
Plate 26 – Building 7

- 4.7.1 The main storeroom was inspected. This revealed rot to purlin ends embedded in the west division wall where pockets were noted in the masonry. The wall appears to be reasonably plumb although we noted 25mm plus tapered (at top) vertical cracks at its junction with the front and rear walls.

The rear wall is plumb but there is a 5mm wide tapered (at top) vertical crack in the southeast corner.

The east wall is plumb, but there is a 3mm wide stepped crack near the front (south) wall.

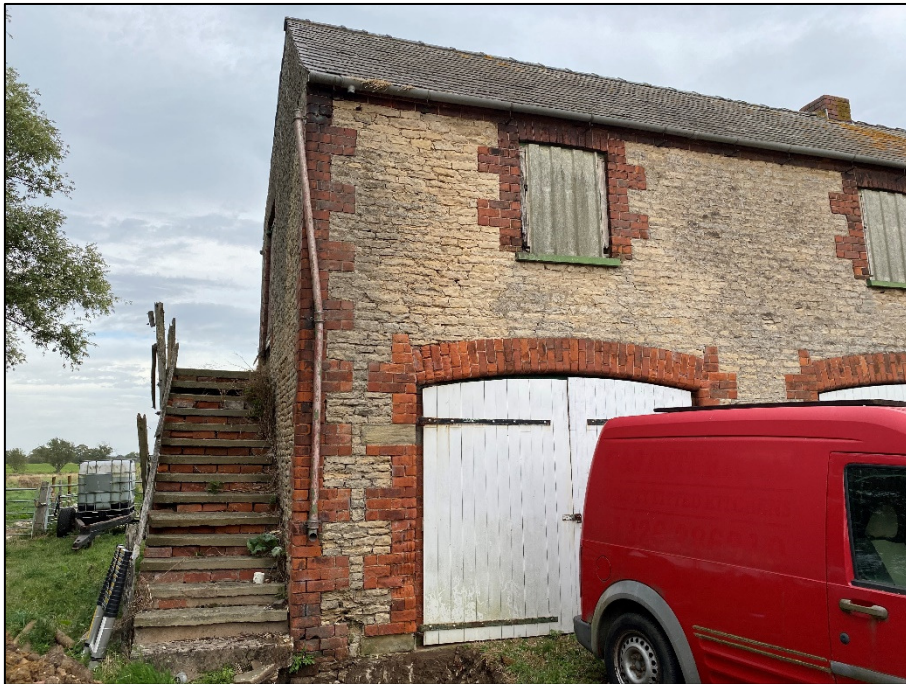
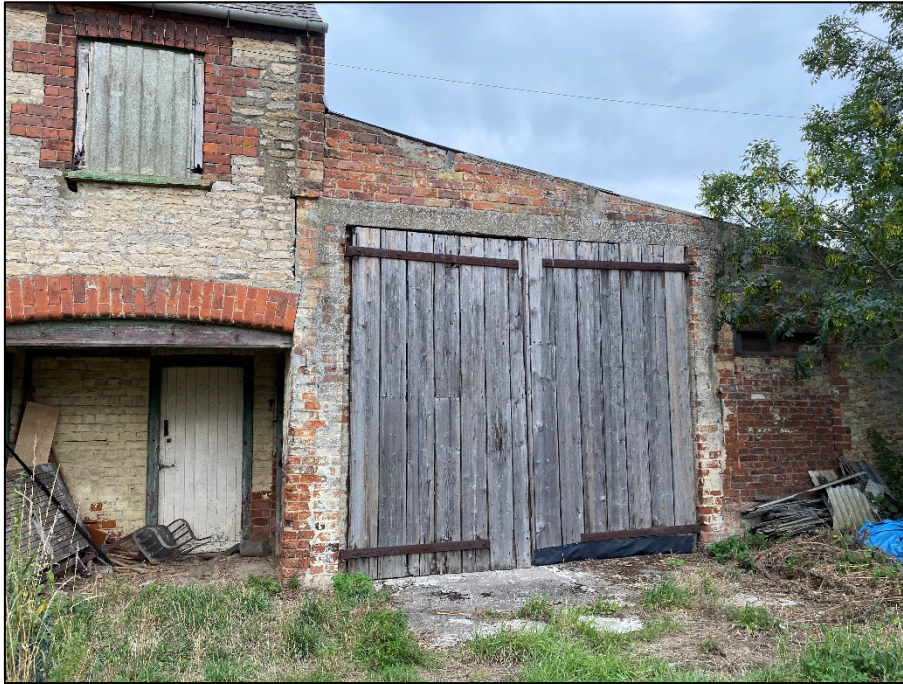
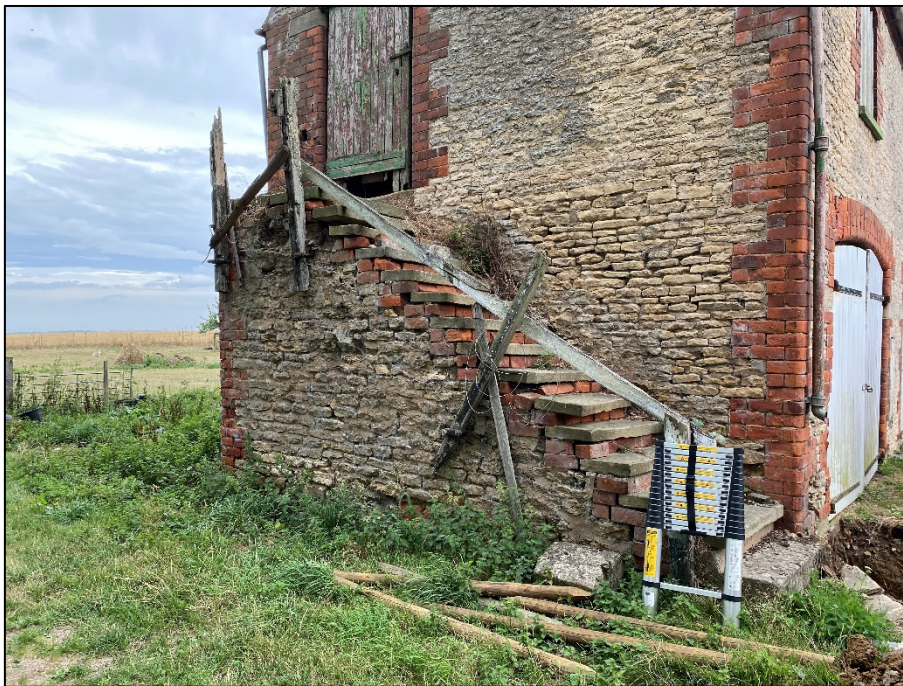
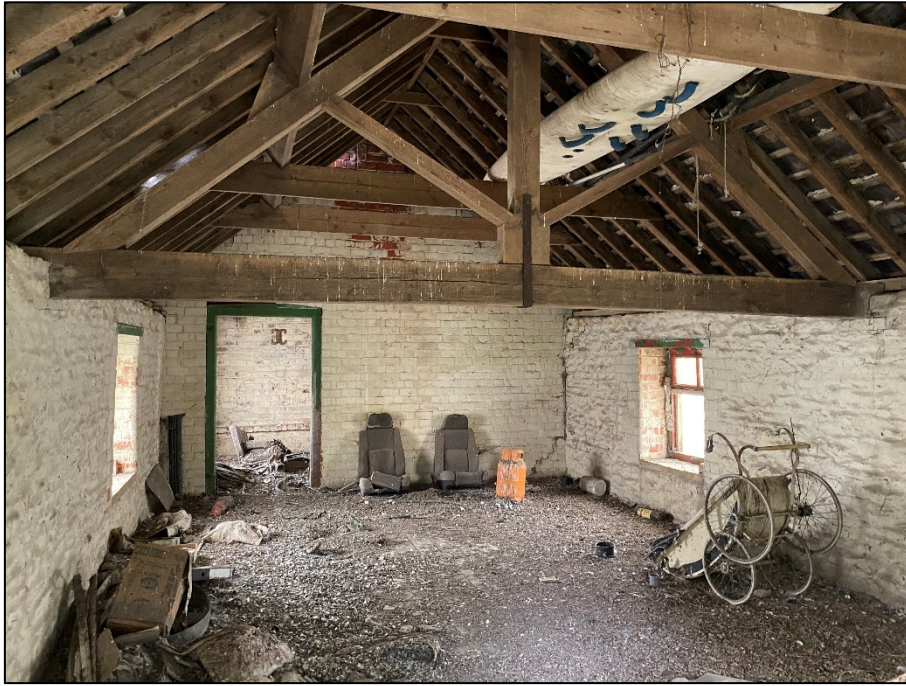
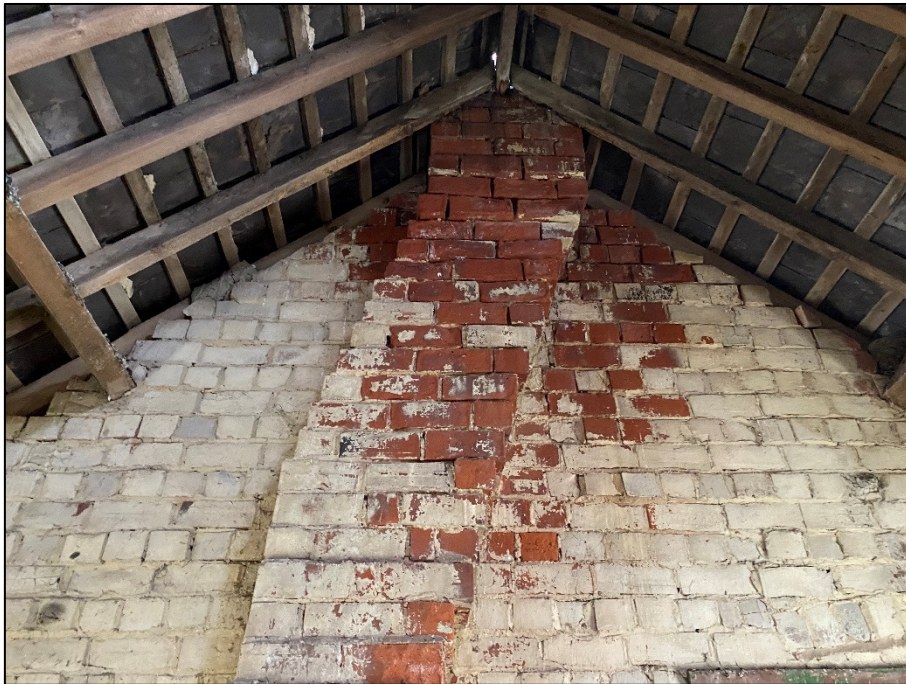
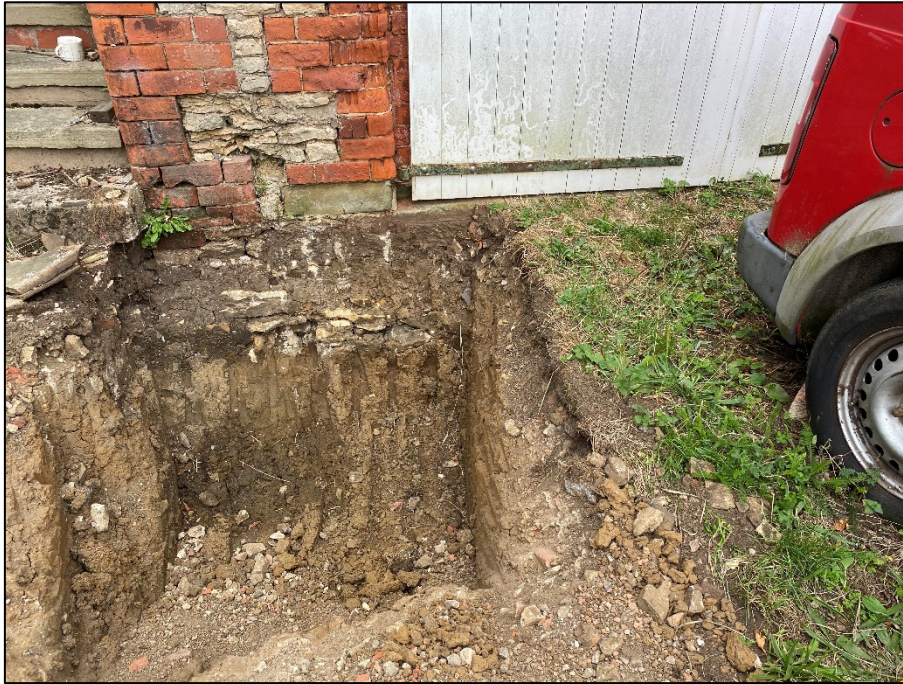
Plate 30 – Building 8

- 4.8.1 An inspection of the north and south walling revealed general weathering to the brickwork/stonework.
- 4.8.2 A single trial pit TP4 was excavated adjacent to the front, near Building 3 lobby.
This exposed the foundations and underlying subsoils to the property in this location.
- 4.8.3 The existing foundation is 200mm thick stone blocking which has a 200mm projection from the outside face of the external wall.
- 4.8.4 The underside of foundation is located at 700mm below ground level.
- 4.8.5 The foundation is seated in a hard brown sandy/gritty clay strata.
Shear Vane testing was not possible due to the subsoil's characteristics

- 2.6.6 Demolish the external stairway serving Building 8.
- 2.6.7 Repair all defective drainage and allow for testing on completion to confirm its integrity.
