STRUCTURAL APPRAISAL REPORT

GRANGE FARM

Report 20633-H-RP-001-R0

2 September 2022

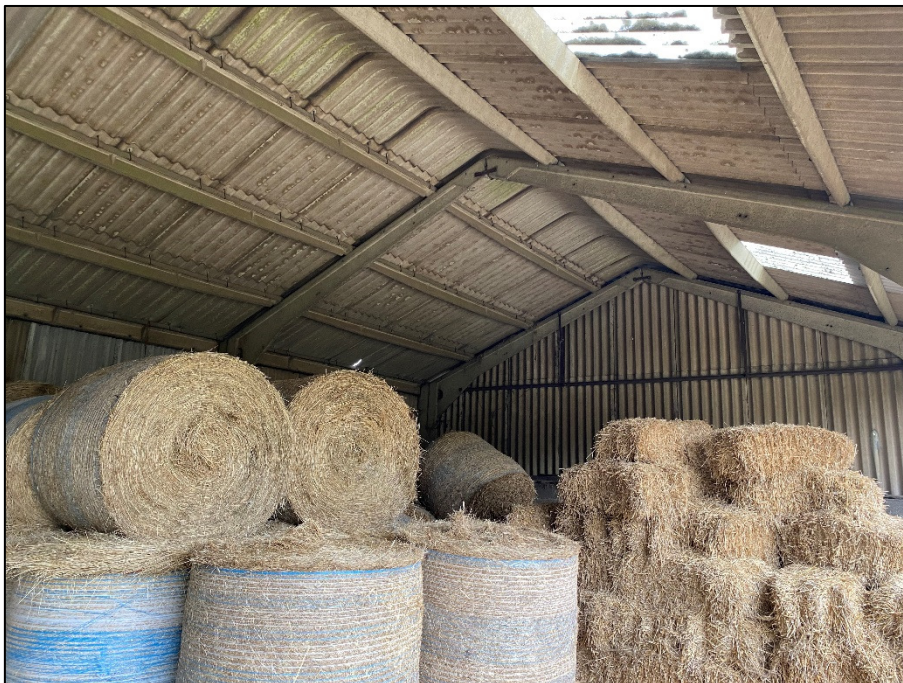
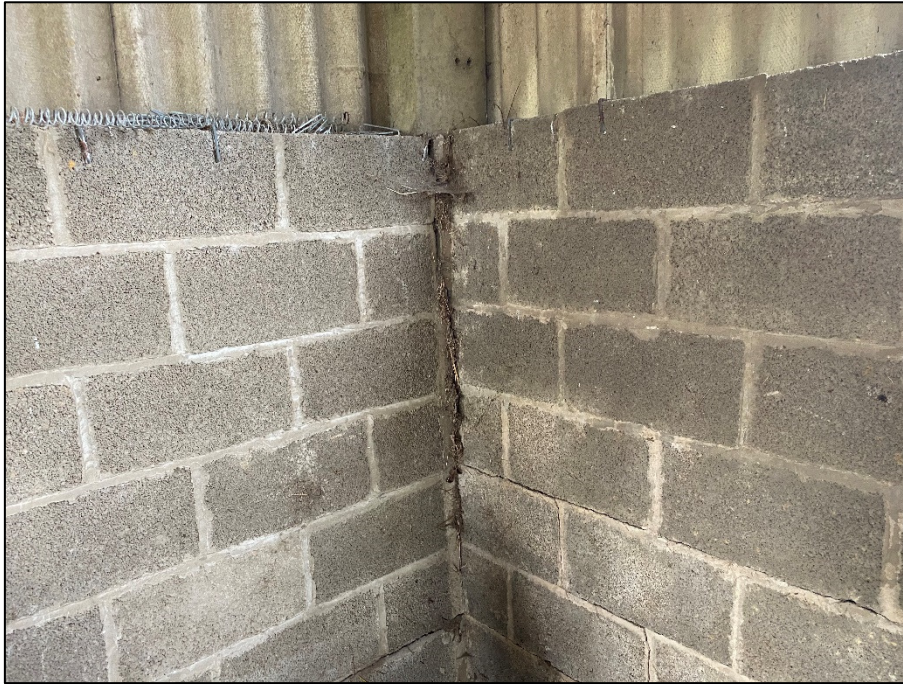
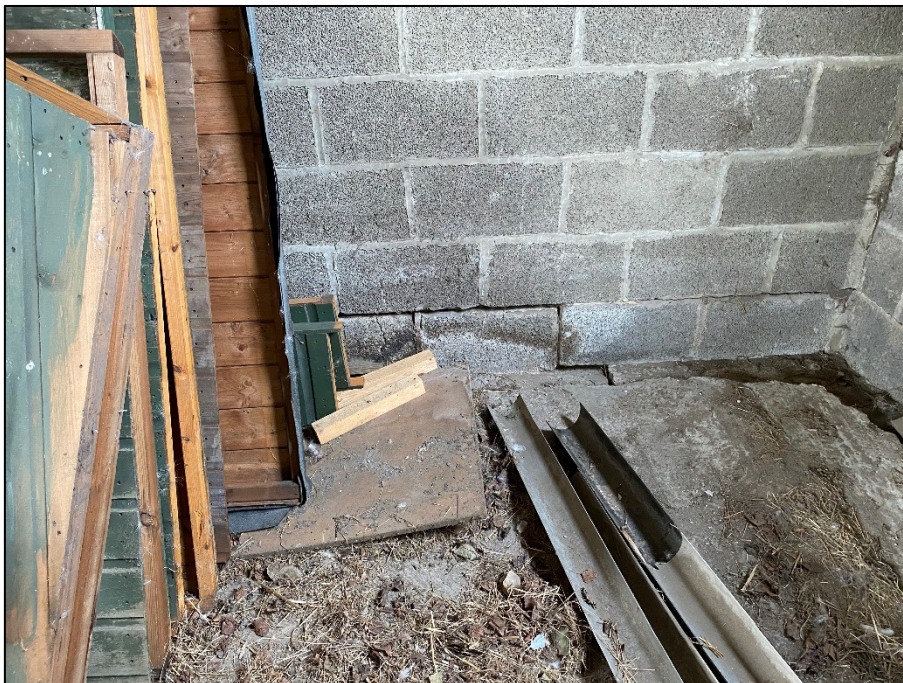
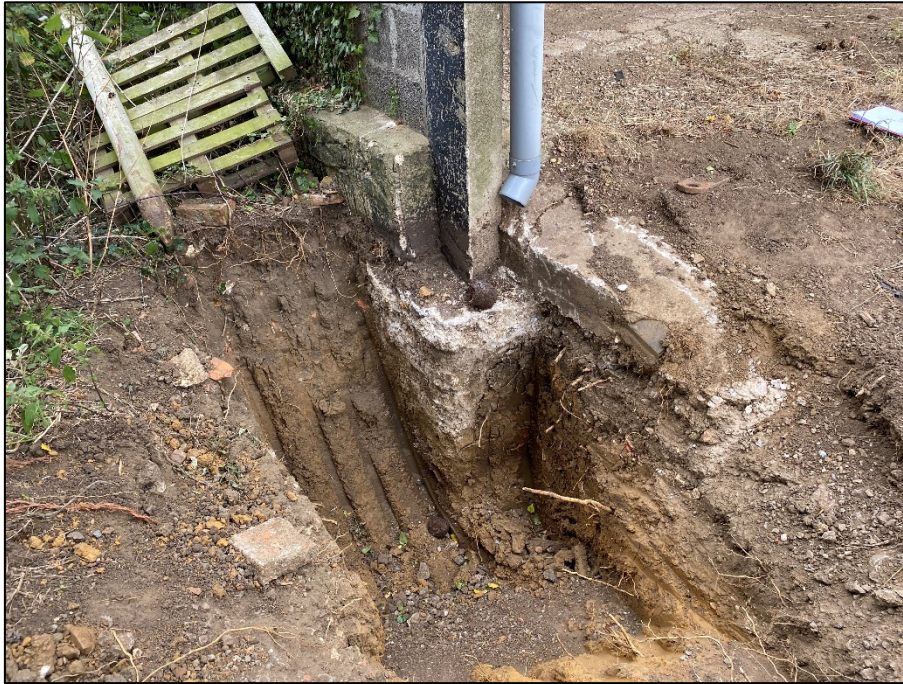
Plate 36 – Building 9

- 4.9.1 The north storeroom was inspected and revealed reasonably plumb external walls.
- 4.9.2 To the main stable there are 115mm diameter cast iron columns to the open west elevation.
We noted a heavy outward lean on the central south column.
We viewed the long east wall, and it is apparent that there is rot to the roof wall plate.
The wall generally leans in at a gradient of 20mm in 1 metre.

- 4.9.4 We inspected the south end store. This has a dished profile cobbled floor and the external walls were measured as 450mm thick.
All walls were seen to be reasonably plumb albeit uneven. There is much vegetation growth that is penetrating the building envelope.
We noted a 10mm wide vertical crack to the northeast corner and a 2mm wide stepped crack to the northeast corner.
