# Contents

# 1. Introduction

2.1.1. The site identified for survey is a small works yard situated to the rear of the main dwelling. The site is currently utilised for machinery and materials storage.

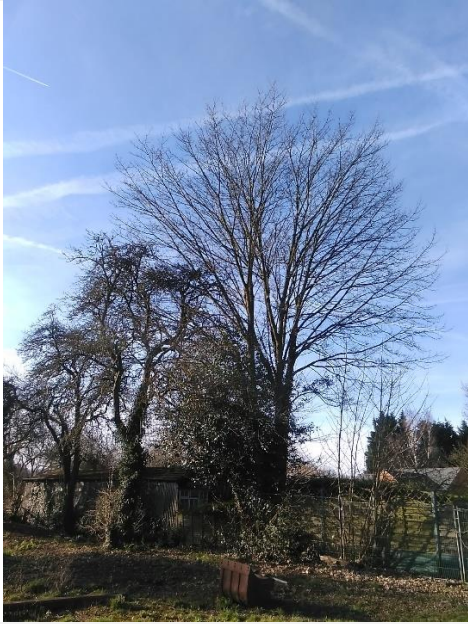
Image 1 – T3, T2 & T1 (left to right)

2.2.3. Tree T1 is a specimen of reasonable size and quality (see Appendix 4, image 1) that is partially visible in the middle distance from the immediate surrounding area. This tree has a low to moderate visual amenity value. The remaining trees surveyed convey little or no visual amenity value.

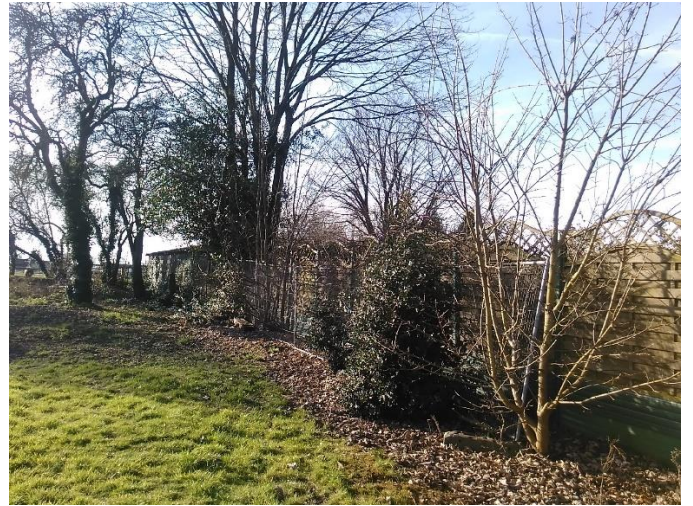
Image 4 – G1 (foreground)

G1	A Group		5	140 <sup>a</sup>		1.7	2	2	2	2	C2	>40 yrs	Good		One coppice sycamore with light regrowth, and young/semi-mature self-set holly and sycamore. All with stem diameters >150mm.	n/a
G2	A Group	Semi-mature	5	140 <sup>a</sup>		1.7	2	2	2	2	C2	>40 yrs	Good	Fair	Remnant of lapsed hawthorn hedge. Predominately multi stemmed with congested crowns. All with stem diameters >150mm.	n/a

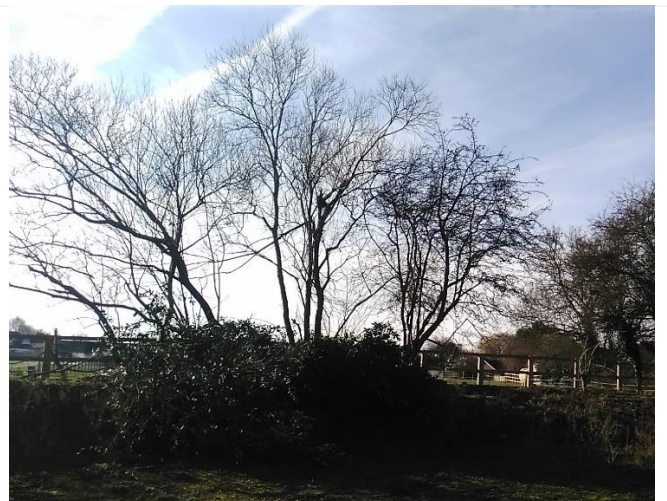
Image 6 – G3

Tree ID	Common Name	Maturity	Height (m)	Stem Diameter (mm)		RPA Radius (m)	Crown Spread (m)				Retention Category	Life Expectancy	Physiological Condition	Structural Condition	Comment	Recommendations
				1	2		N	E	S	W						
G3	A Group	Semi-mature	6	170 <sup>a</sup>		2.0	3	3	3	3	C2	>40 yrs	Good	Poor / Fair	Remnant of lapsed hawthorn hedge. Now predominately structurally compromised goat willow with one multi stemmed hawthorn.	n/a
G4	A Group	Semi-mature	5	130 <sup>a</sup>		1.6	2	2	2	2	C2	>40 yrs	Fair	Fair	Remnant of lapsed hawthorn hedge. Predominately multi stemmed with congested crowns. All with stem diameters >150mm.	n/a
