Appendix 10A: Annex C

Client Name: VPI Immingham LLP

Site Location: VPI Site Undeveloped Land

Project No. 60668866

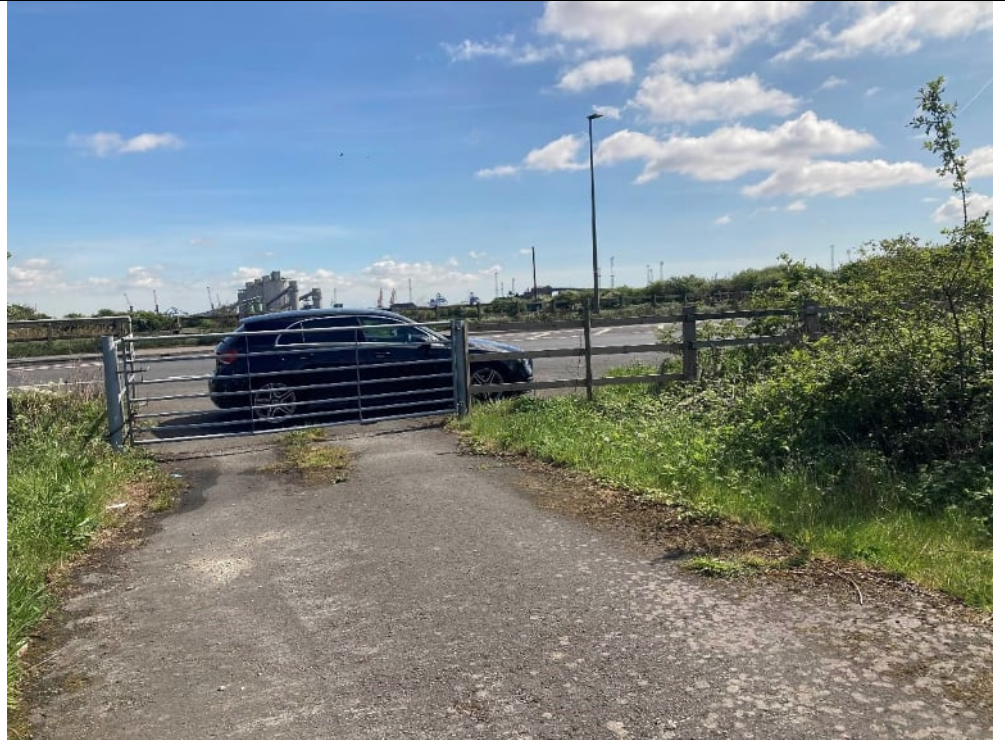
Photo No.
1

The site was accessed through a lay-by located off Rosper Road in the east of the site. A hardstanding track is located through the site, orientated east to west.

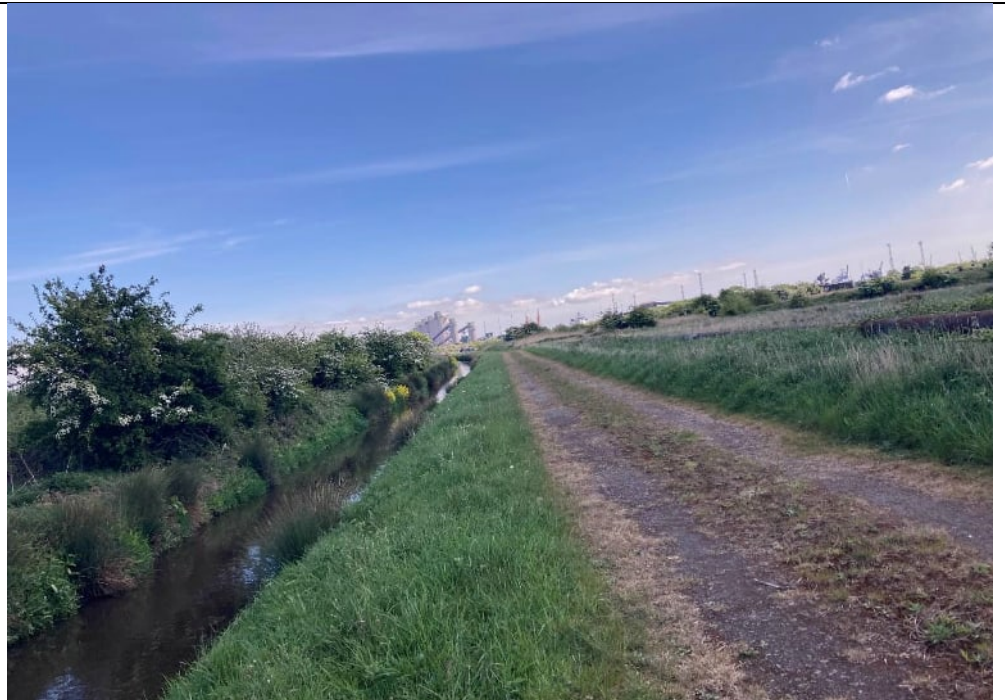
Photo No. 2

Hardstanding track running through the site towards the west, parallel to the drain through the site.

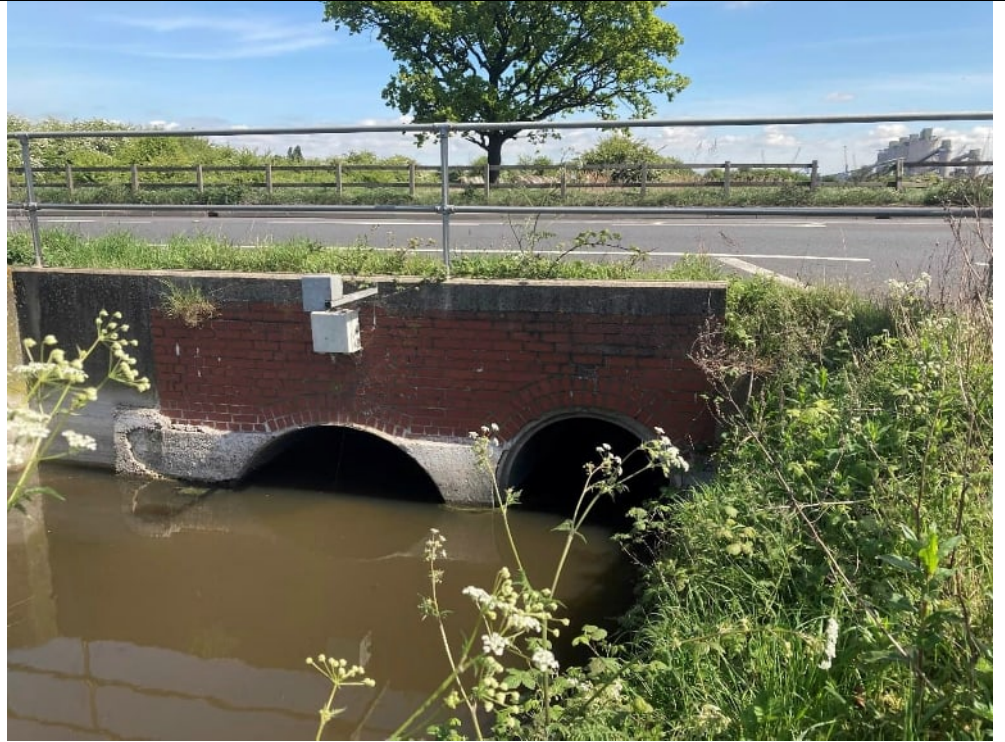
Photo No.
3

Culverted area of drain through the site which flows from west to east beneath Rosper Road.

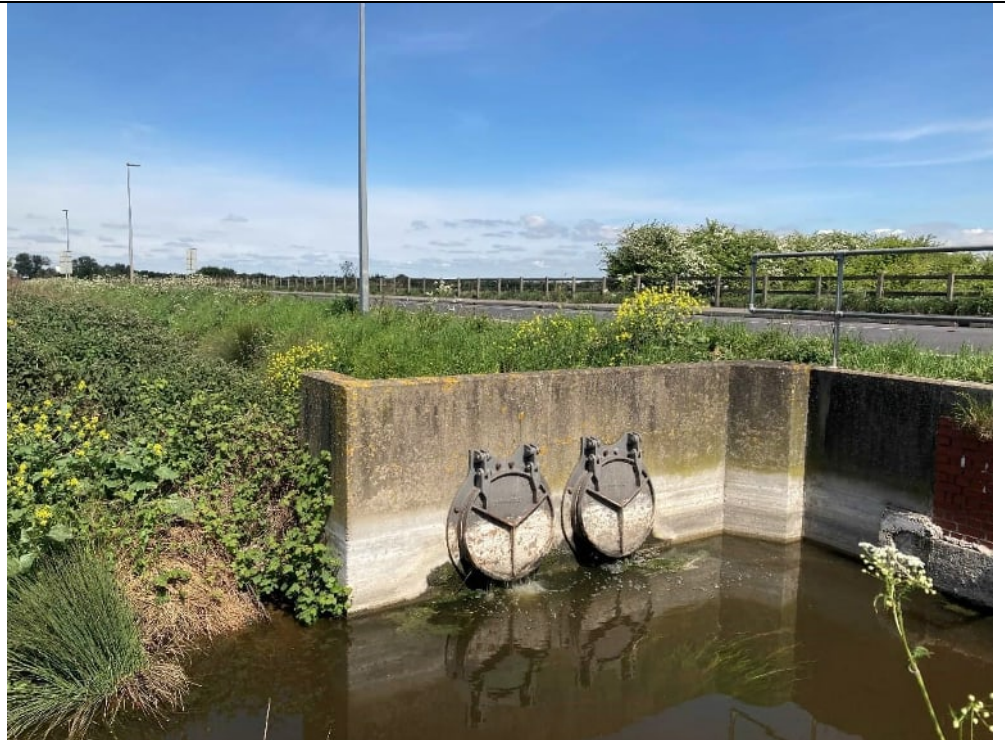
Photo No.
4

Porthole like features set within the concrete surrounding the drain. Water flows from this feature into the drain.

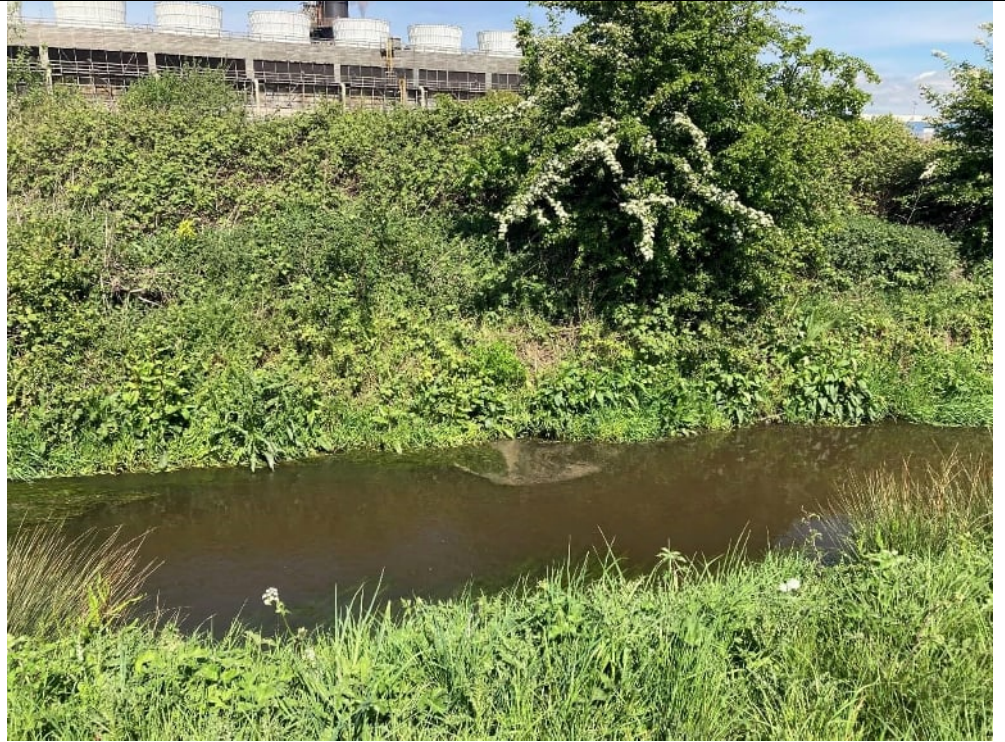
Photo No.
5

Steep bank of the northern side of the drain comprising of overgrown vegetation.

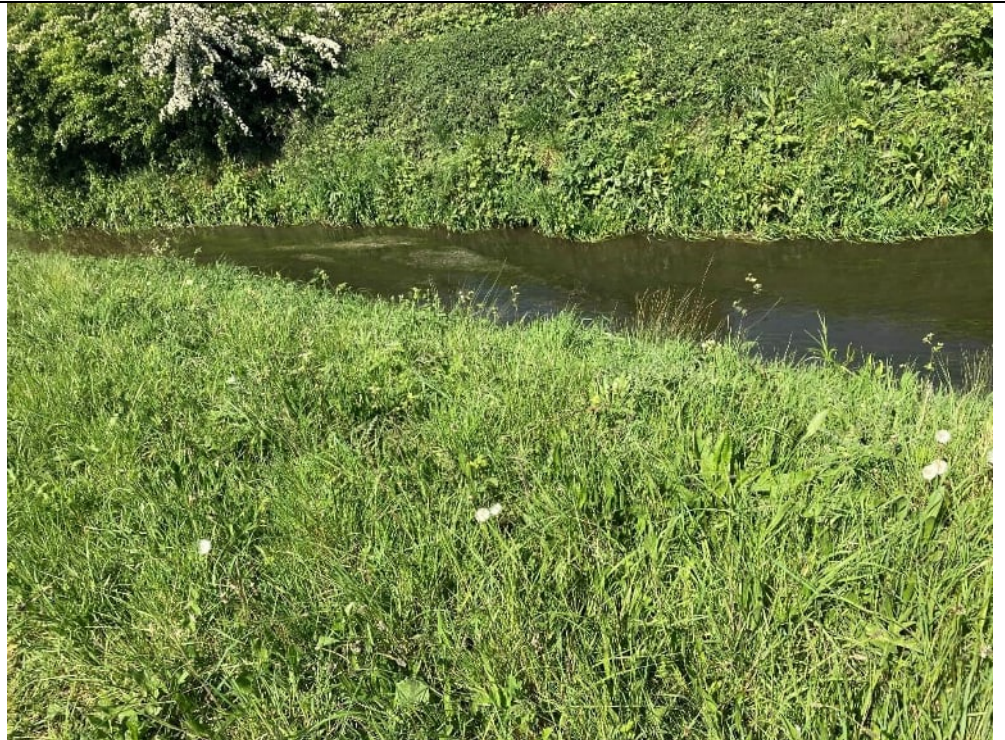
Photo No.
6

Gentle slope on the southern side of the drain.

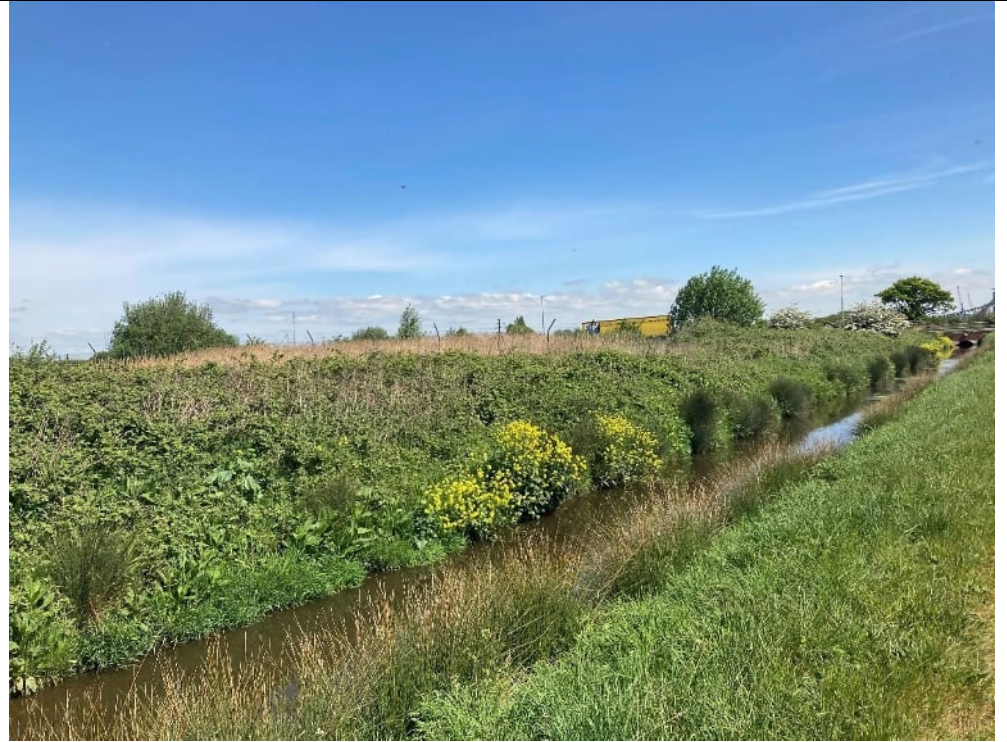
7

View of the drain looking towards the east of the site.

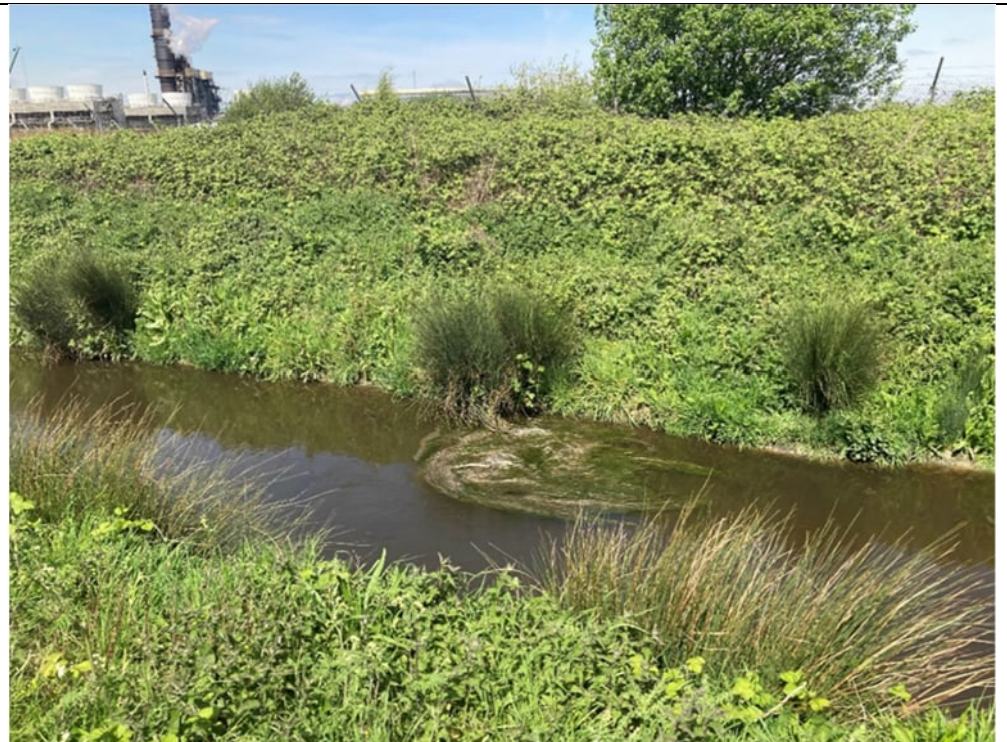
8

Area of silt collected around dense vegetation within the drain in the eastern half of the site.

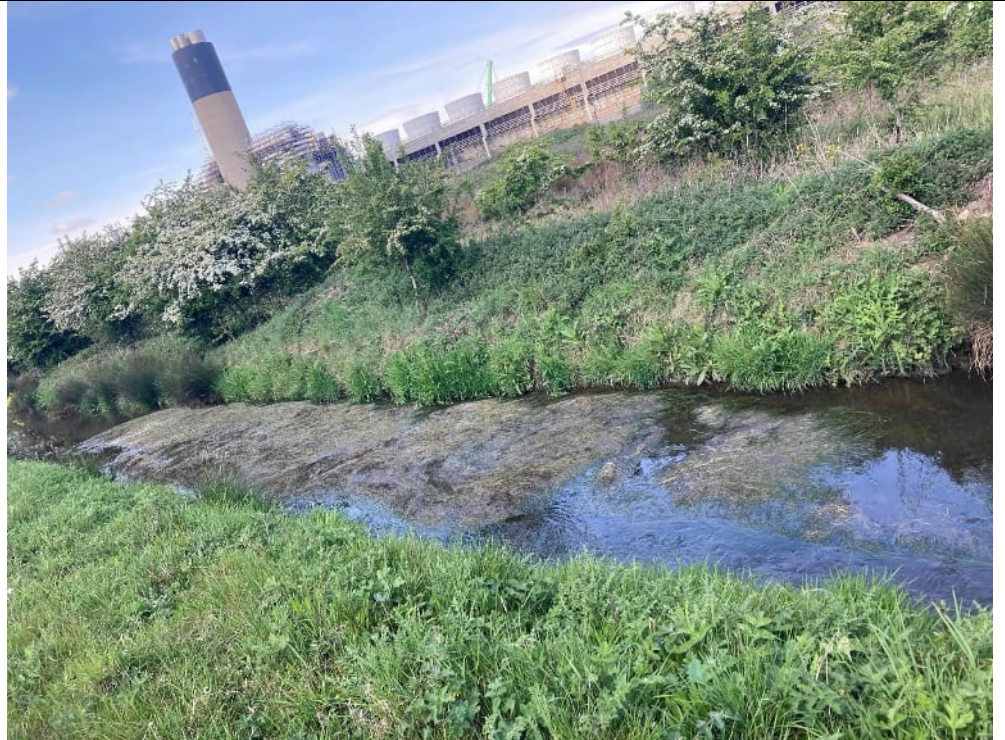
Photo No.
9

Area of silt and dense vegetation in the western half of the site. Infrastructure associated with the oil refinery to the north is visible in the background.

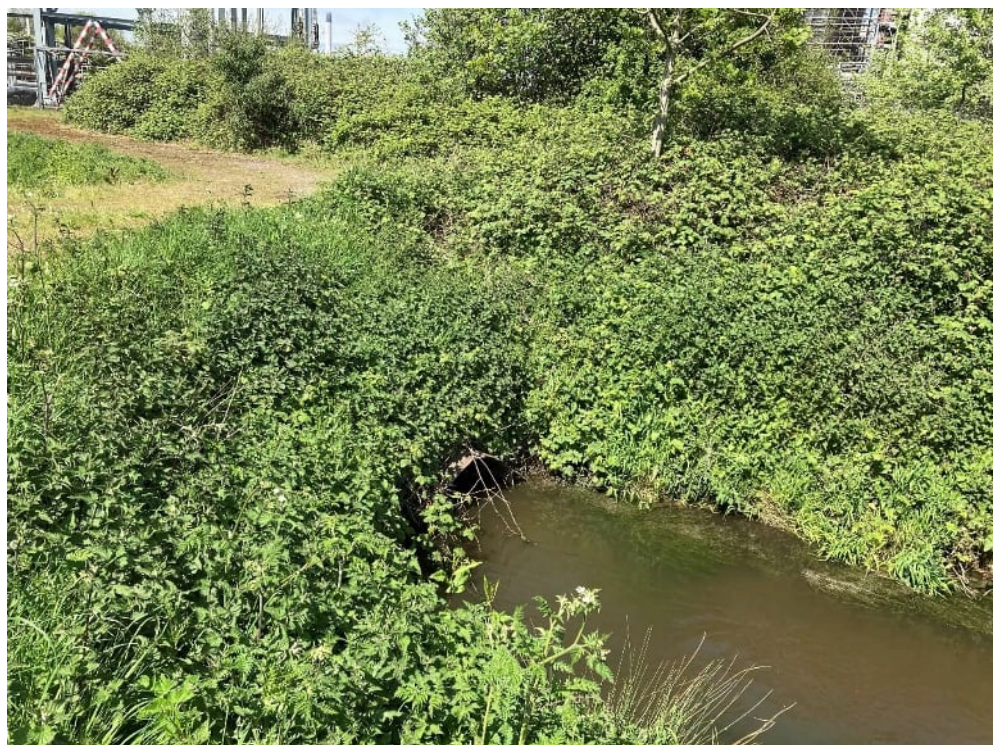
Photo No.
10

Culverted area of the drain beneath the hardstanding track in the western area of the site.

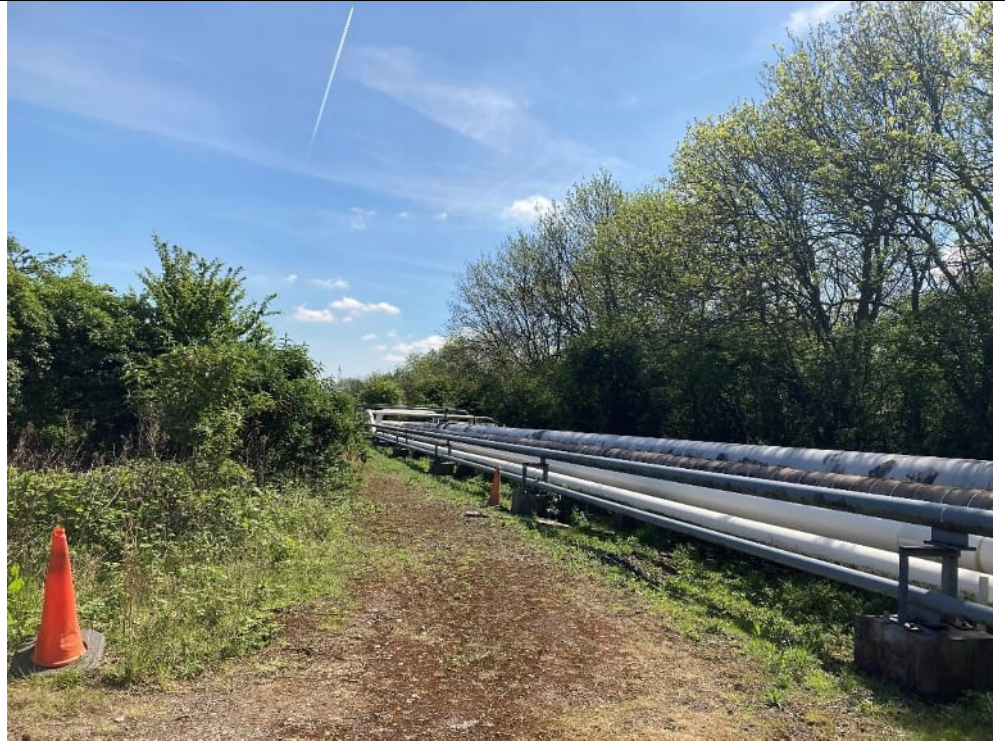
Photo No.
11

Series of northwest to southeast trending pipelines adjacent to the site border in the western half of the site.

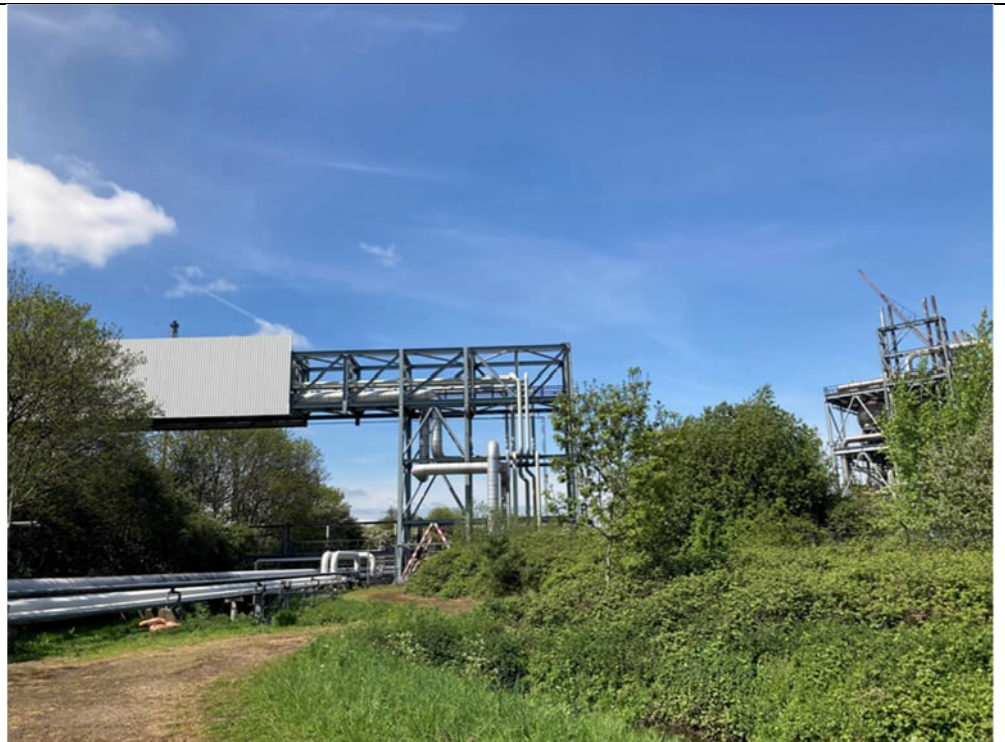
Photo No.
12

Overhead pipelines crossing the site from the railway.

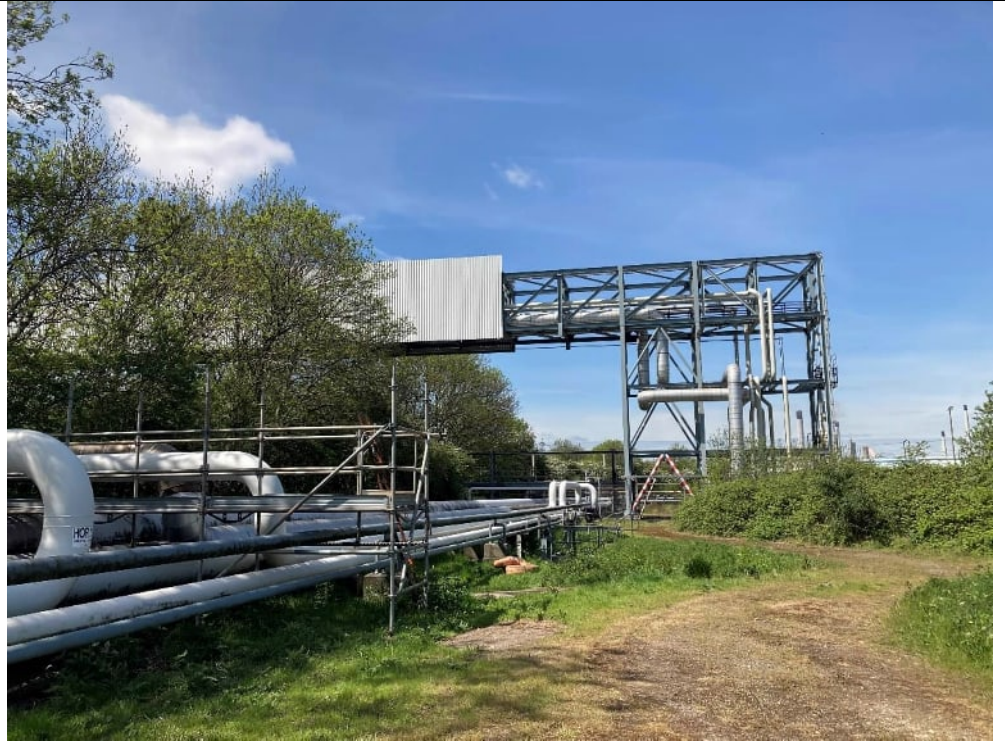
Photo No.
13

Description
View of pipelines on the ground surface and overhead pipelines.

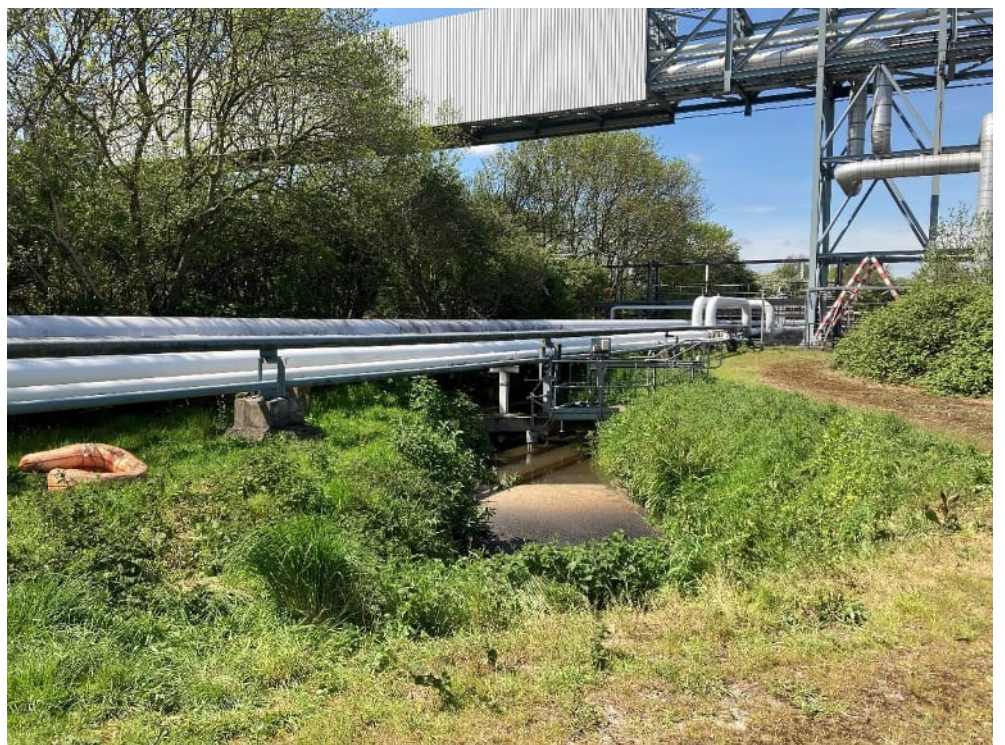
Photo No.
14

Description
Orange coiled pipe near the pipelines. The drain emerges from the underground section from the hardstanding track area.

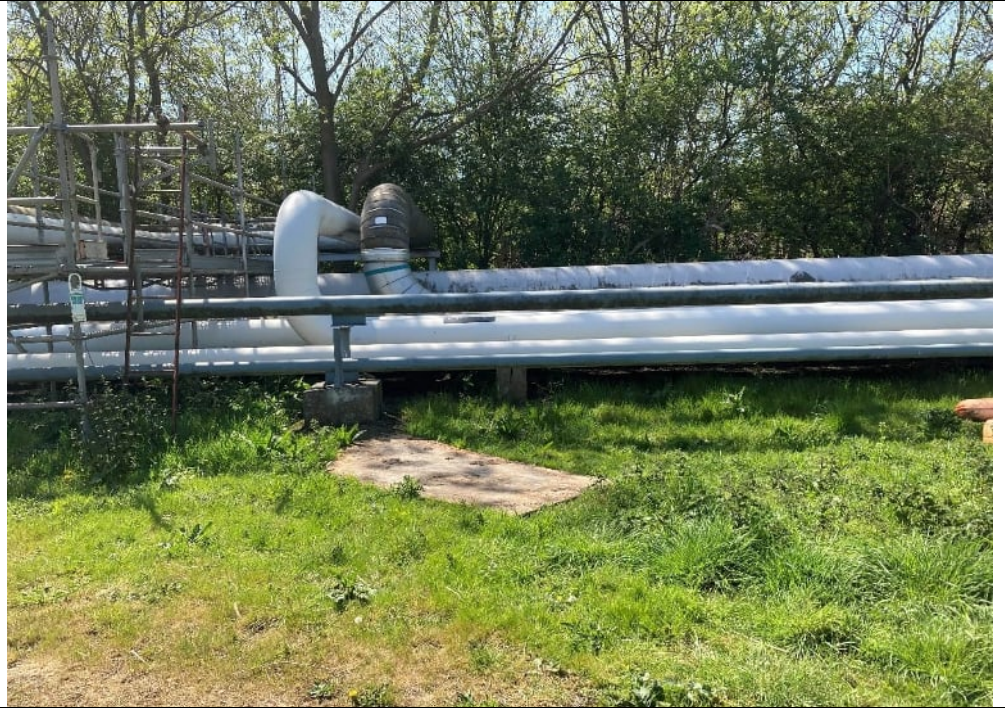
Photo No.
15

Description
Sheet of material in front of the pipelines.

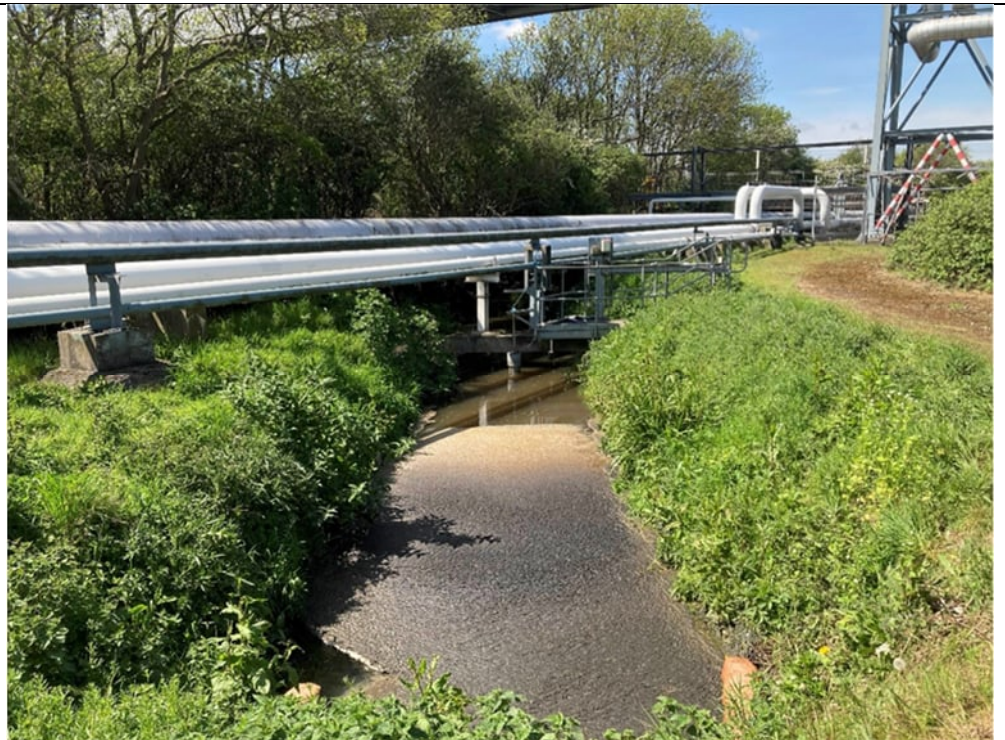
Photo No.
16

Description
Area of thick white to dark brown deposits within the drain. The drain flows towards underground to the east as shown in Photo 10.

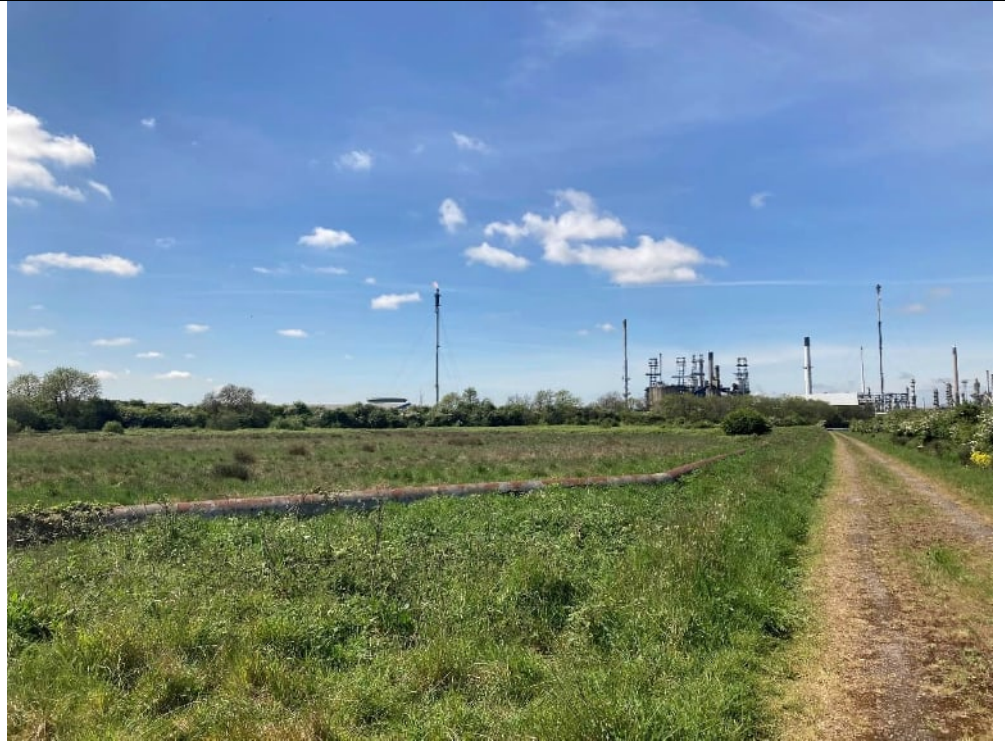
Photo No.
17

Description
Rusty pipeline orientated east to west through the site. The Phillips site is visible in the background.

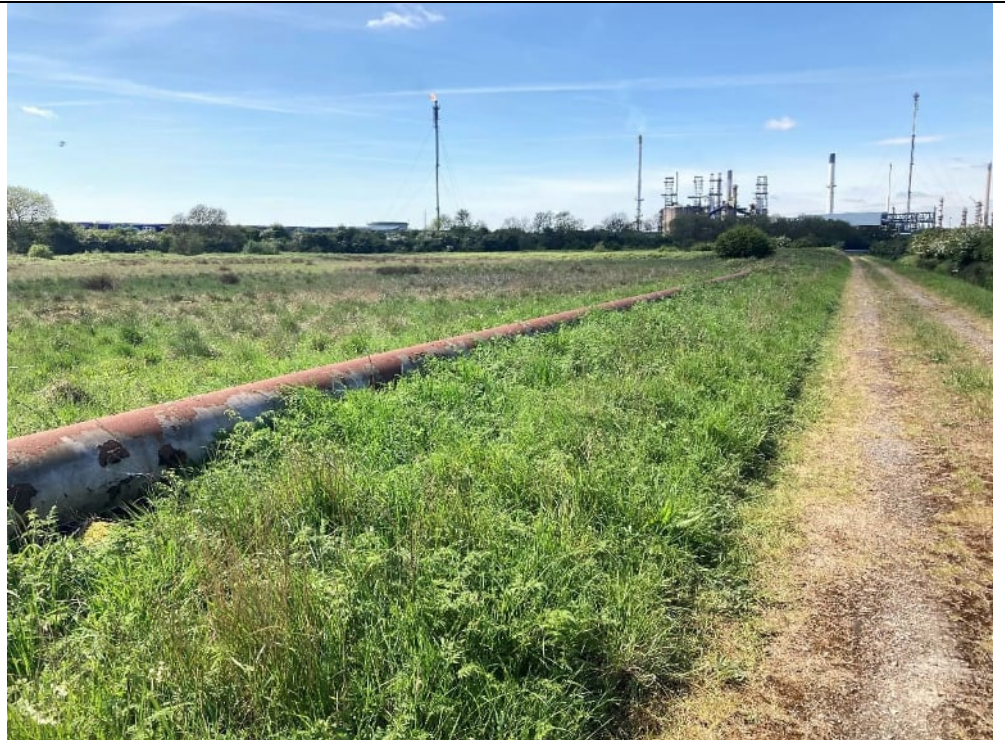
Photo No.
18

Description
Close up view of the rusty pipeline through the site.

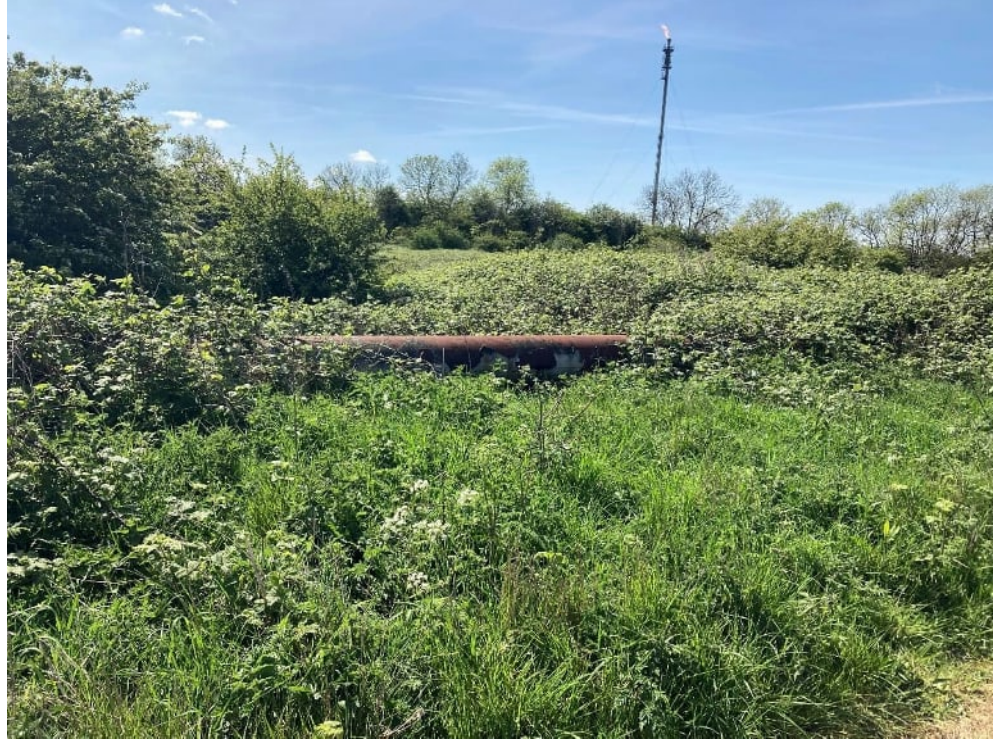
Photo No.
19

Description
Overgrown vegetation concealing parts of the rusty pipeline through the site.

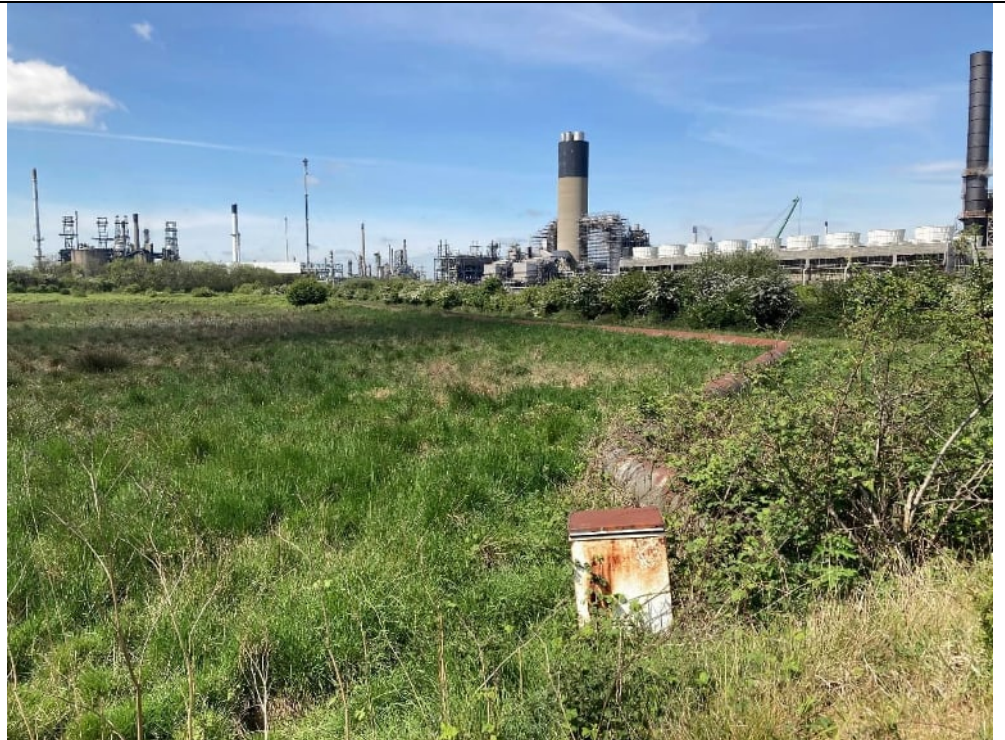
Photo No.
20

Description
Rusty refrigerator fly tipped in front of the rusty pipeline in the site.

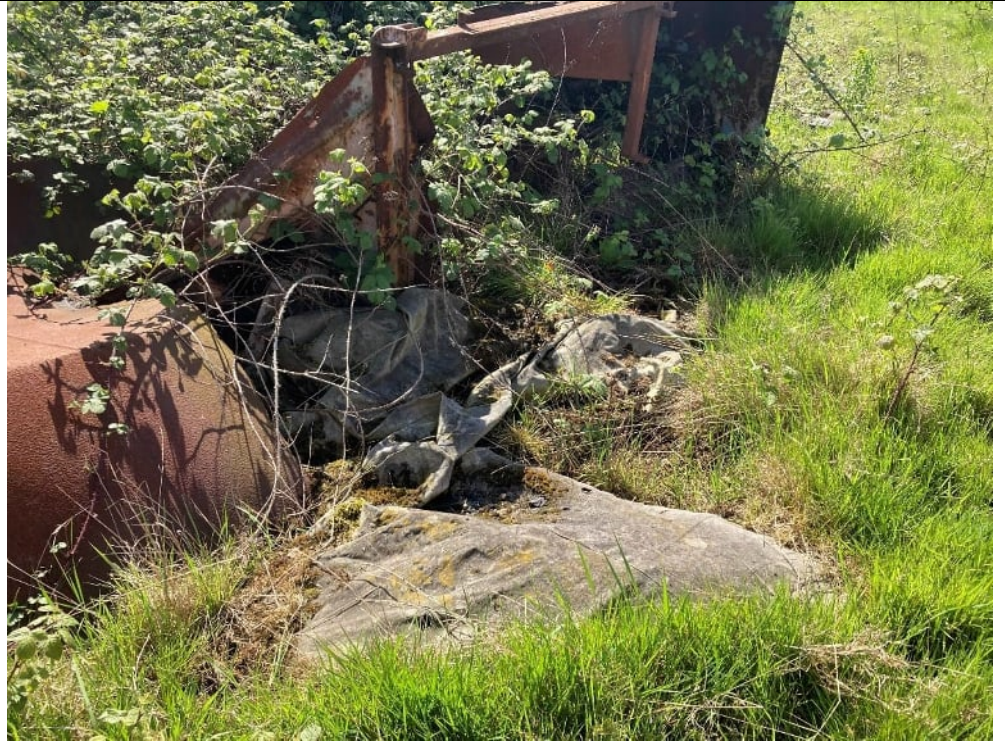
Photo No.
21

Rusted metal waste fly tipped in the centre of the site. Material sheeting is visible in the foreground.

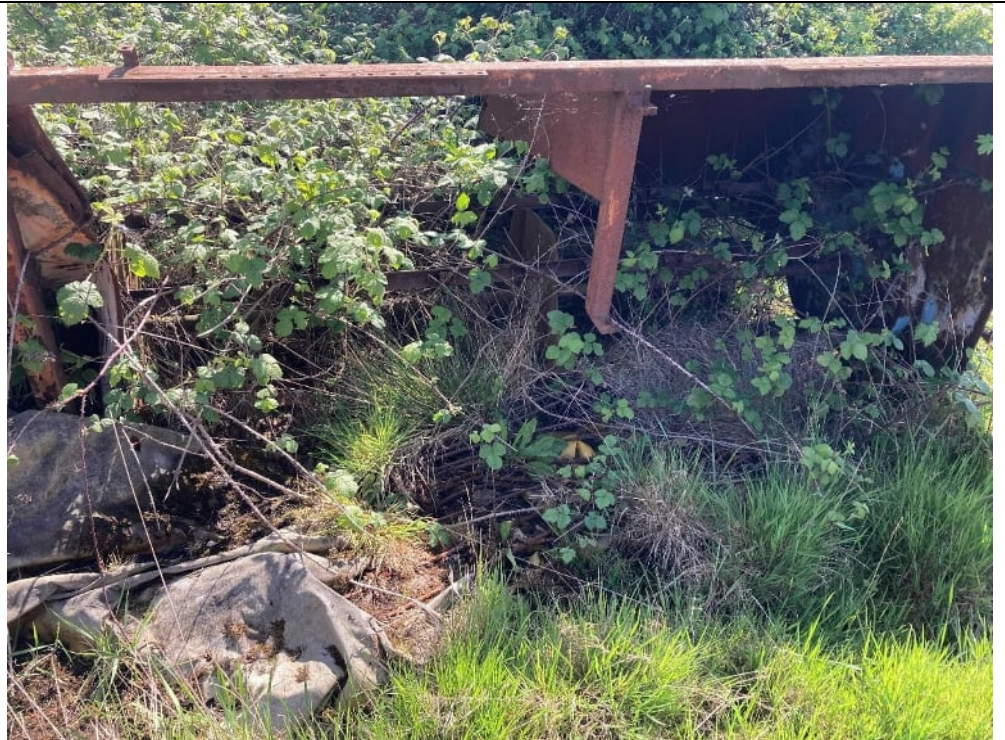
Photo No.
22

Close up view of fly tipped waste in the centre of the site.

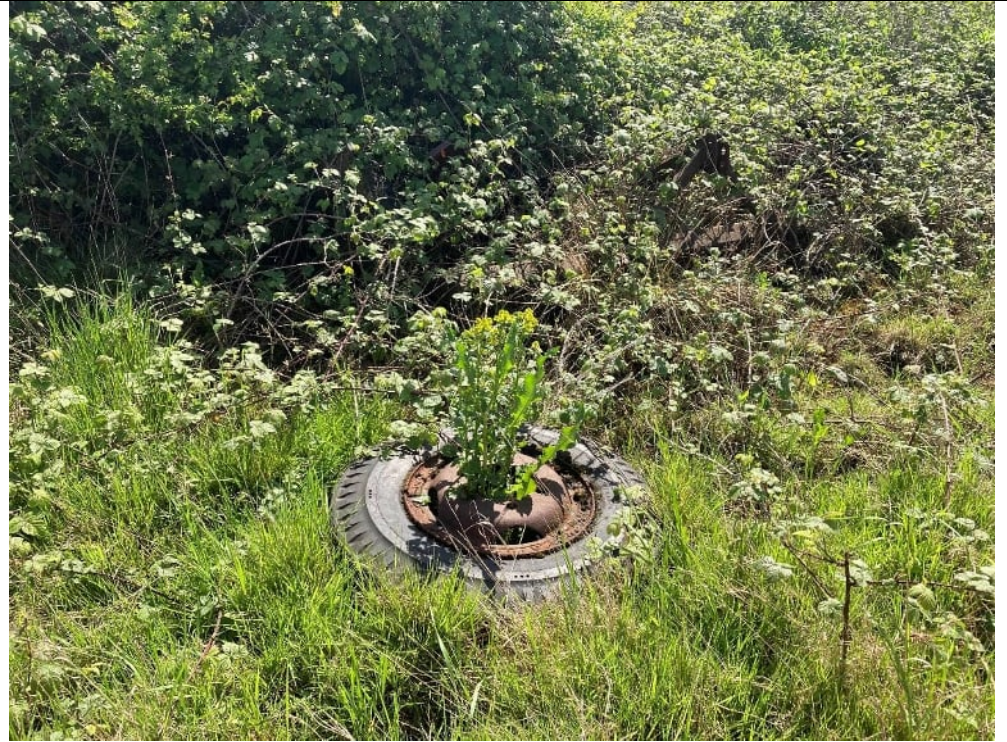
Photo No.
23

Rusty tyre located in the centre of the site with vegetation growing through it.

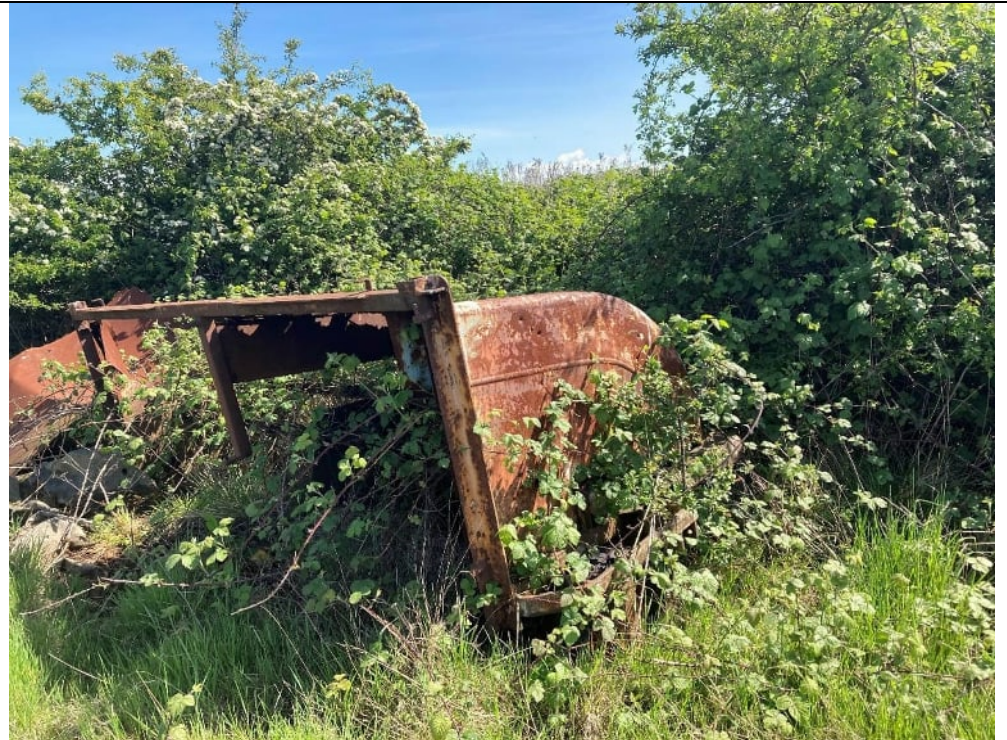
Photo No.
24

Further fly tipped waste on site.

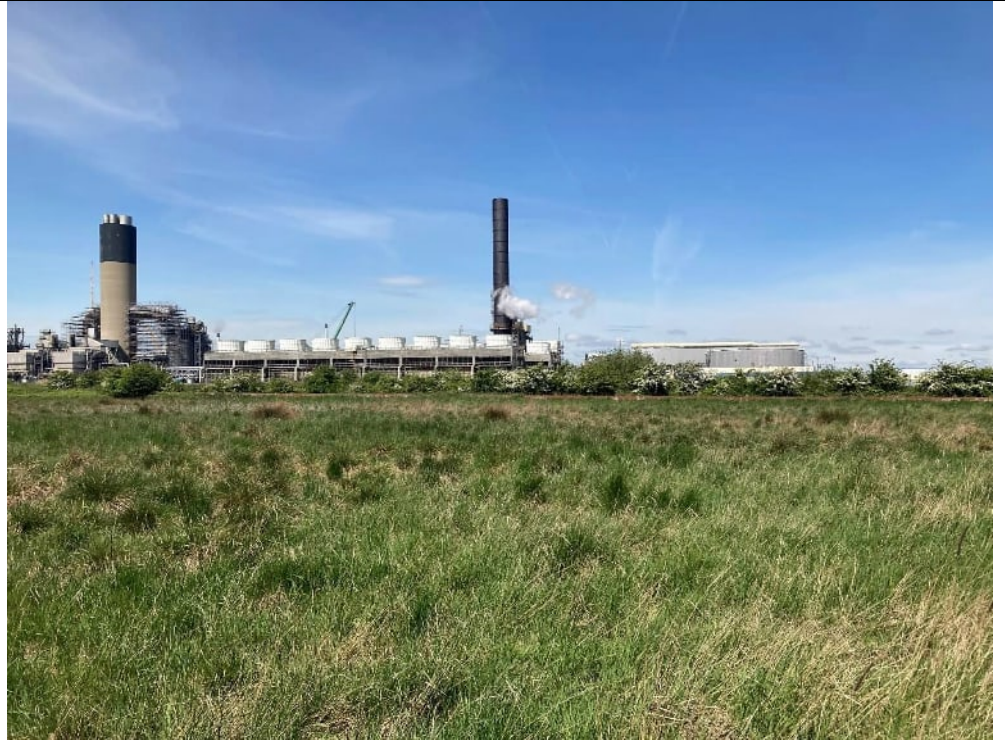
Photo No.
25

Grassland area within the centre of the site. The rusty pipeline and infrastructure associated with the VPI CHP Plant can be seen in the background.

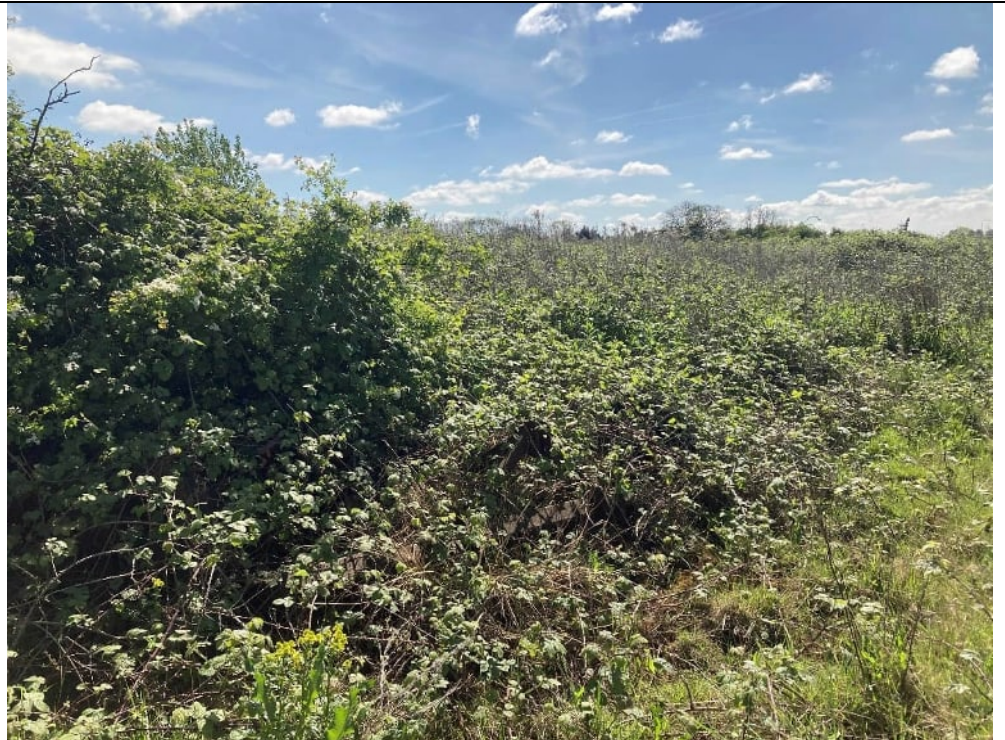
Photo No.
26

Overgrown vegetation in the eastern half of the site. This prevented access to the eastern border of the site.

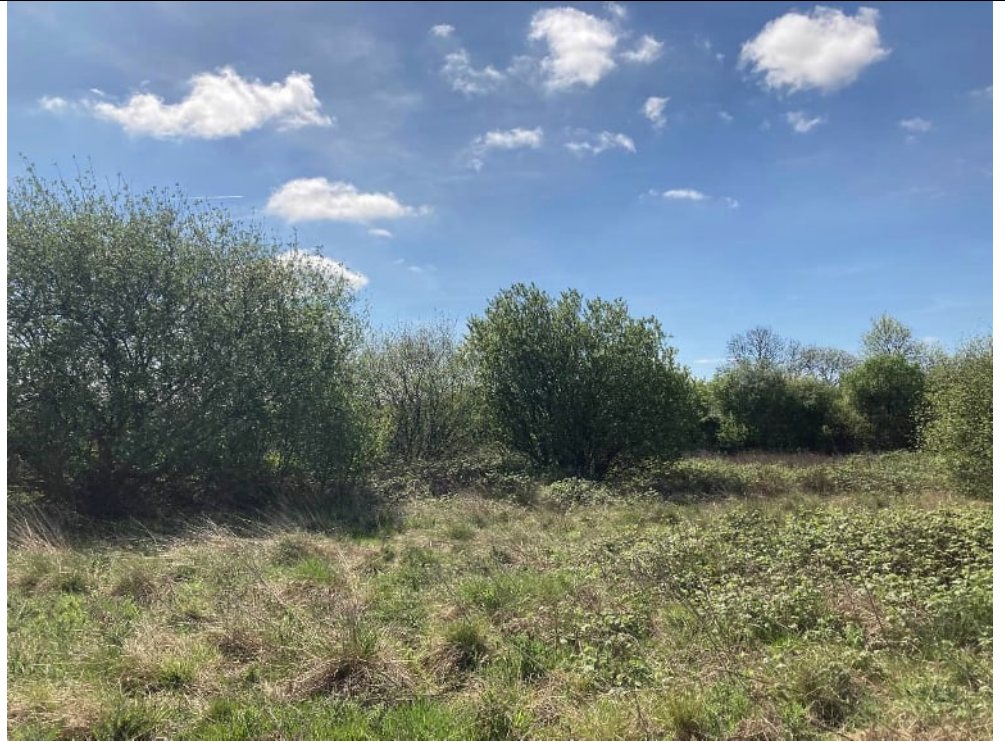
Photo No.
27

Description
Row of mature trees through the centre of the site.

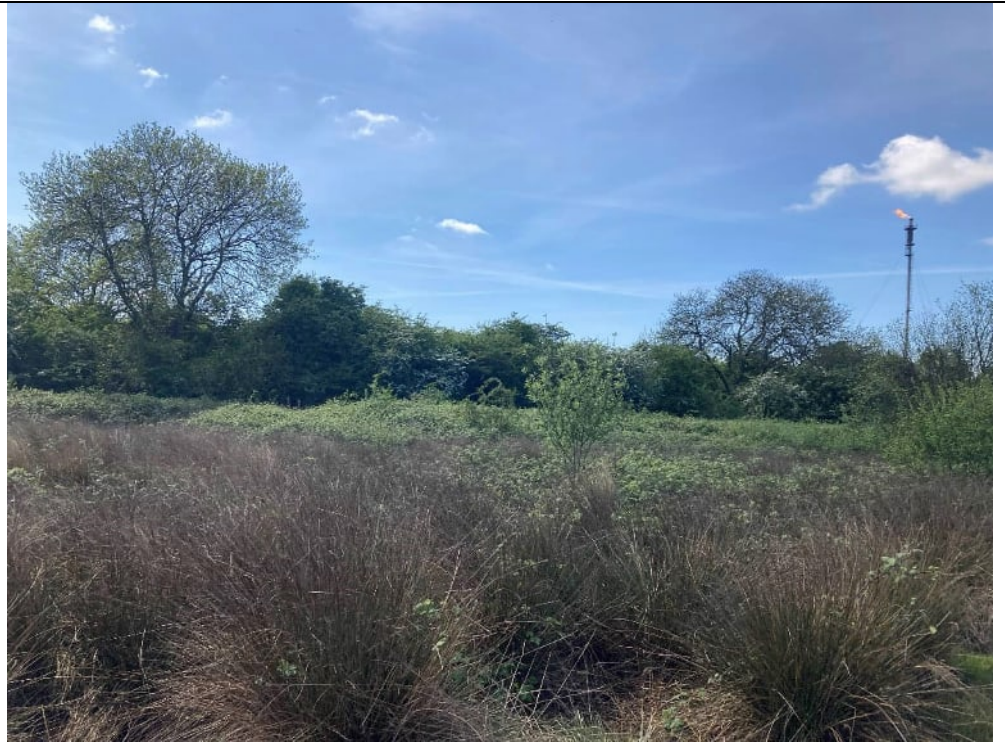
Photo No.
28

Description
Waist height vegetation in the foreground and trees alongside the site border shown in the background.

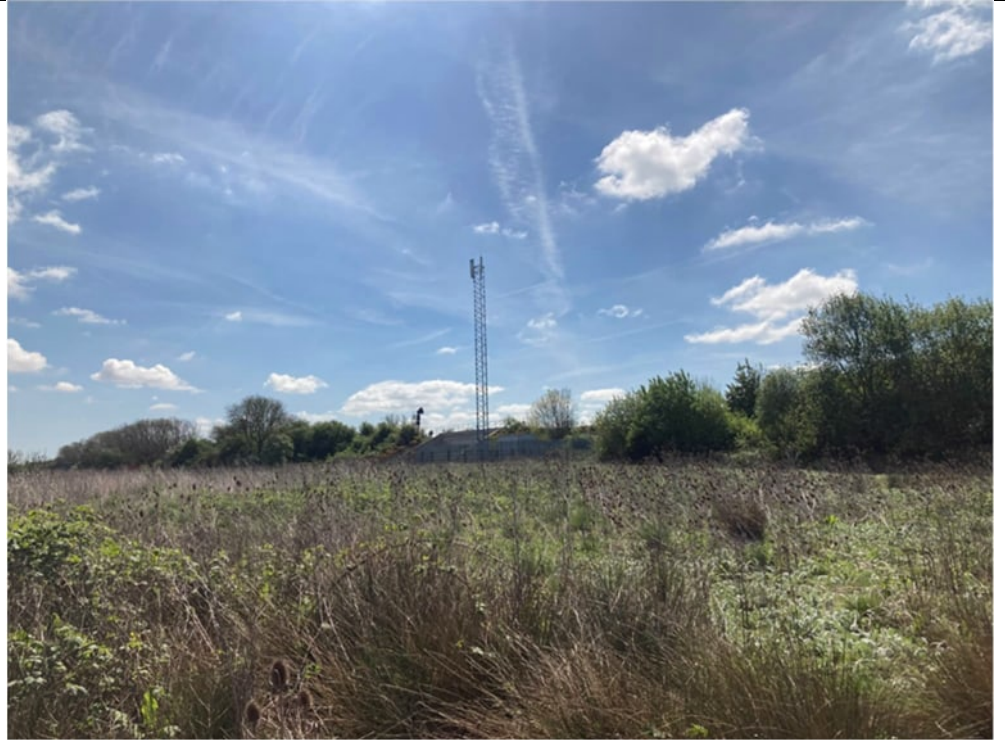
Photo No.
29

Waist height vegetation in the southern half of the site.

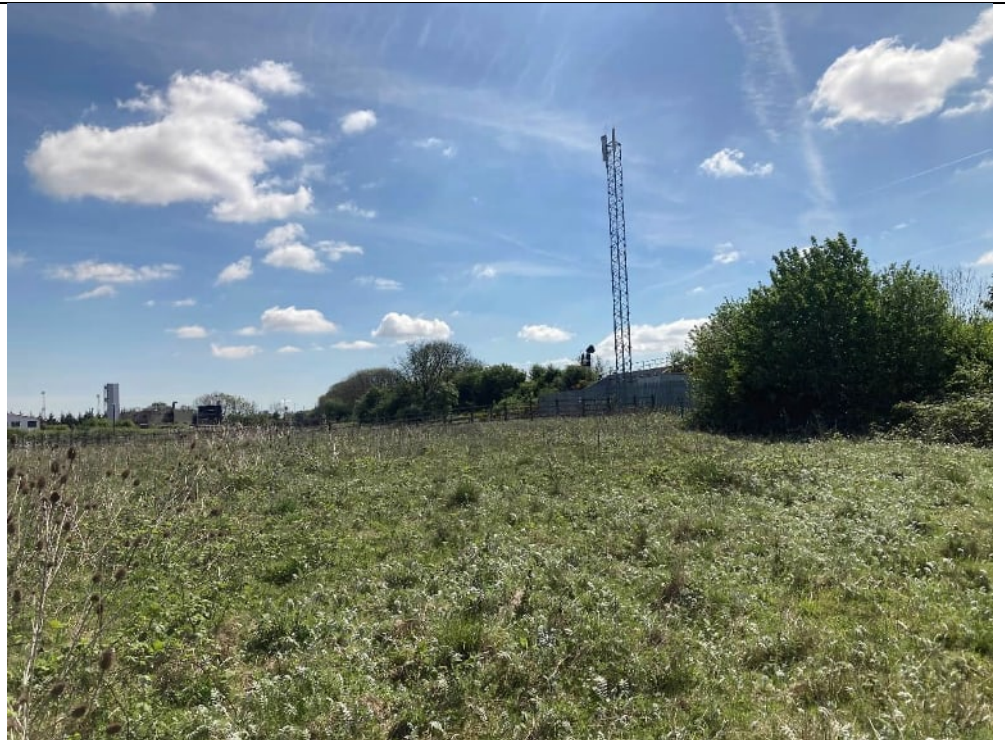
Photo No.
30

View towards the southern site boundary. The vegetation is less overgrown in this area.
