Appendix 10A: Annex C

Client Name: VPI Immingham LLP

Site Location: VPI Site Undeveloped Land

Project No. 60668866

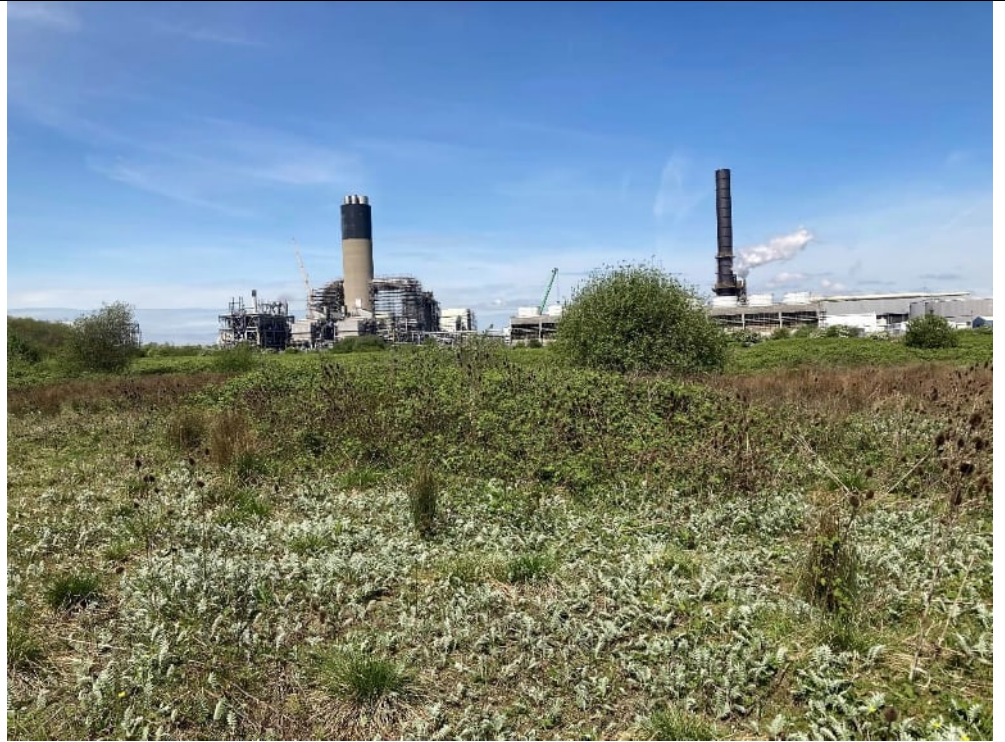
Photo No.
31

View towards the north of the site showing the vegetation across the site. The existing VPI CHP Plant is shown in the background.

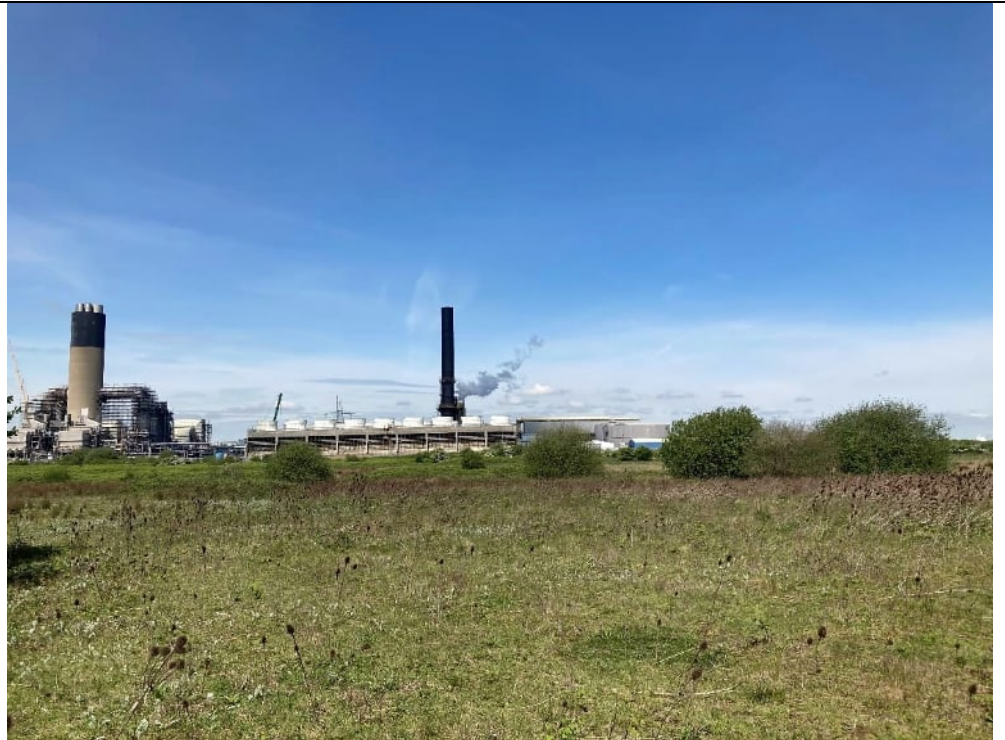
Photo No.
32

View from the south of the site looking north. The existing VPI site is visible in the background.

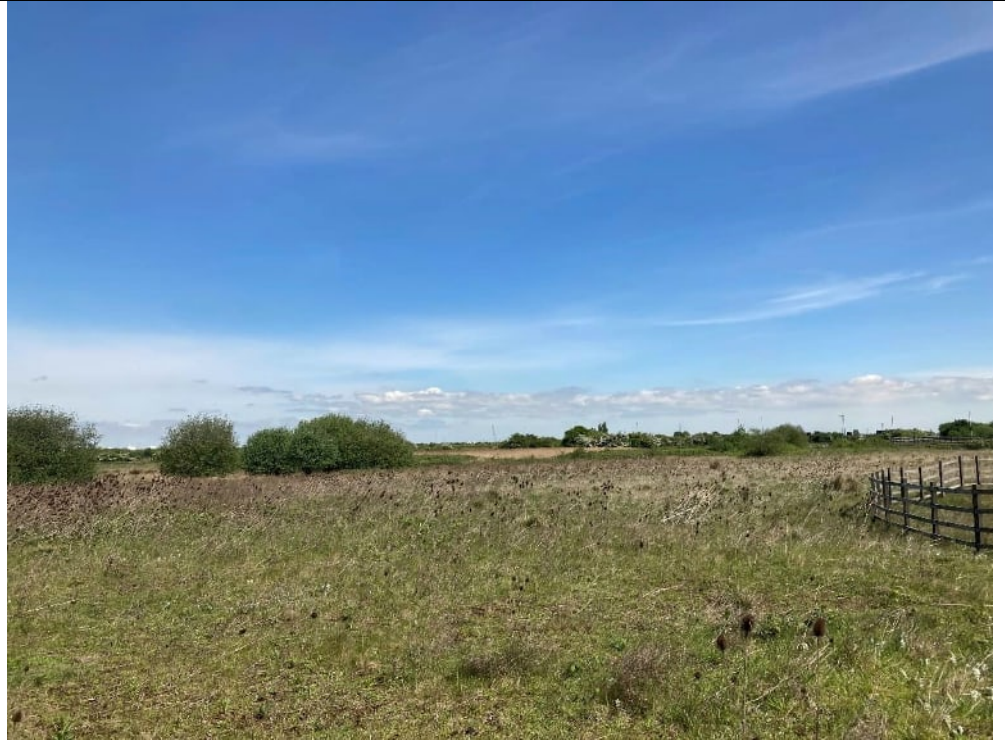
Photo No.
33

Description
View from the south of the site looking east. This area of the site is less overgrown.

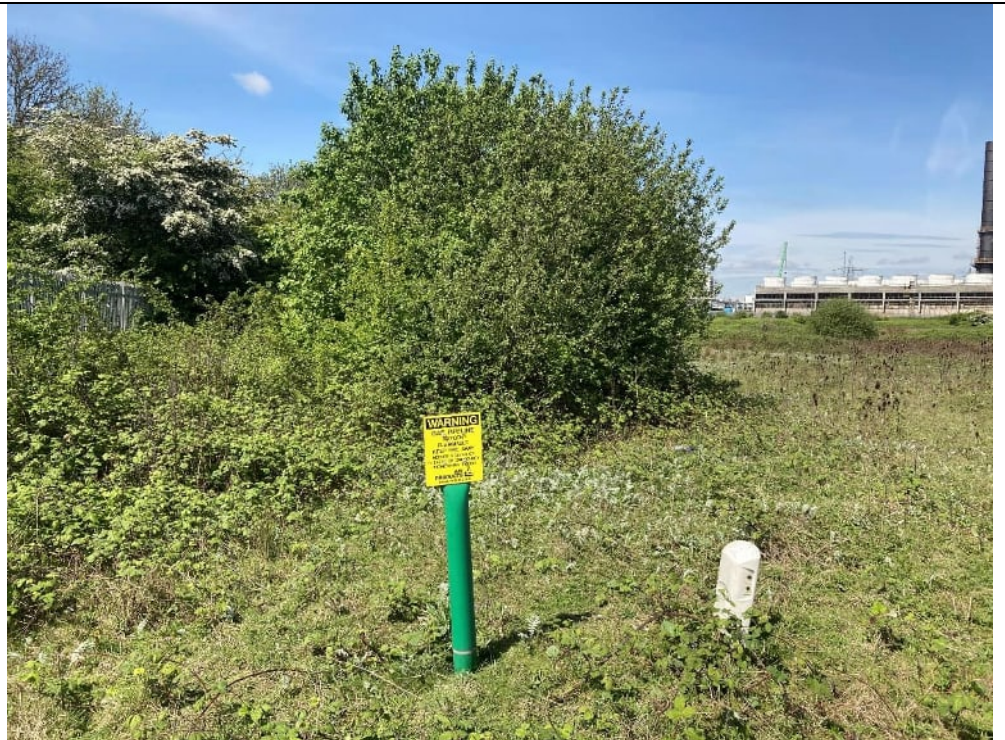
Photo No.
34

Description
Vertical gas pipeline in the south of the site.

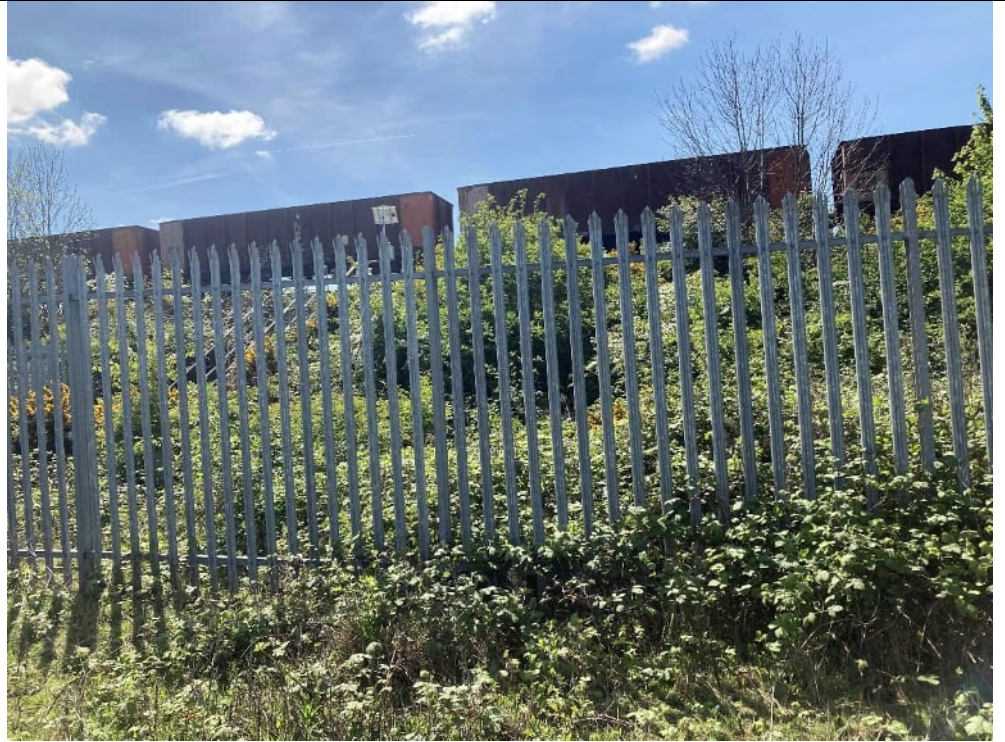
Photo No.
35

View from southern site border towards railway embankment.

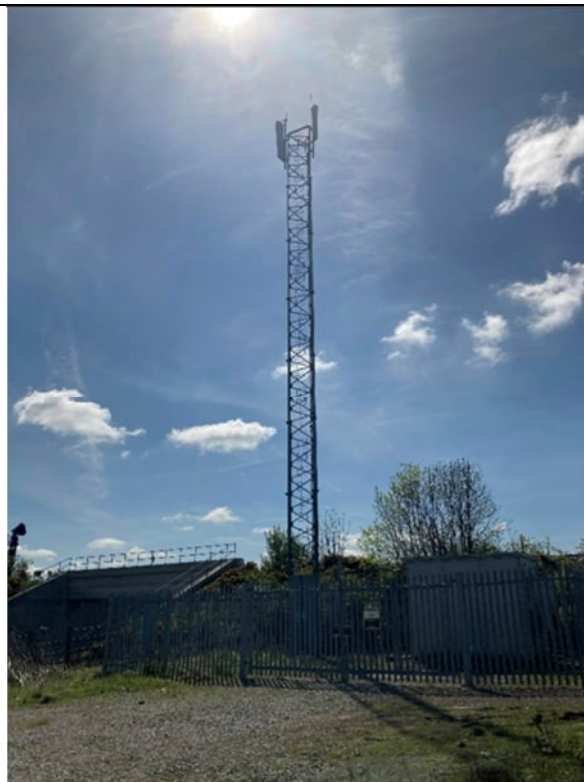
Photo No.
36

Tall structure and small building that are fenced off. This is located immediately southeast from the site border.

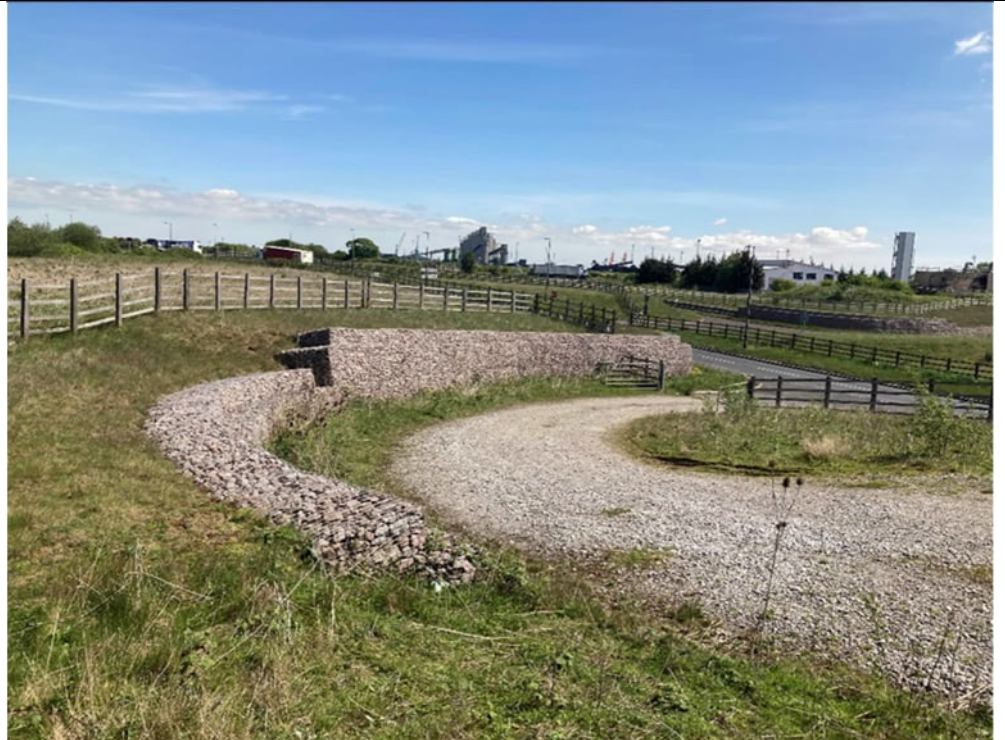
Photo No.
37

Gravel track leading to the tall structure and railway embankment to the south of the site. Gabion retaining structures are located adjacent to the track.

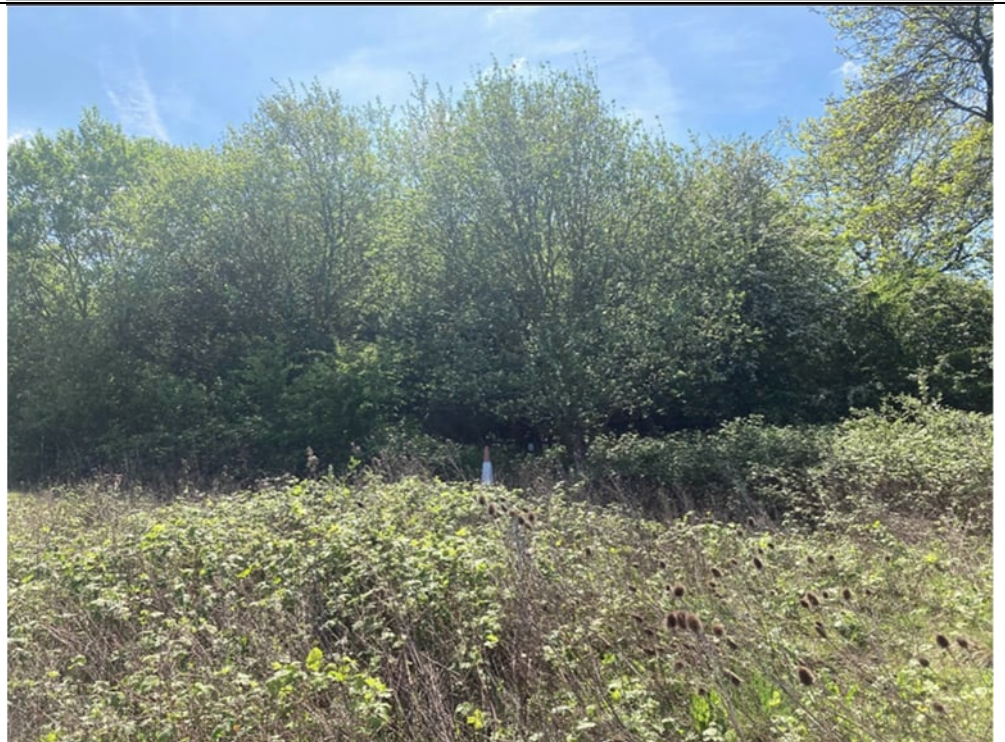
Photo No.
38

View towards the western site boundary. A cone and concrete service posts are visible in the background.

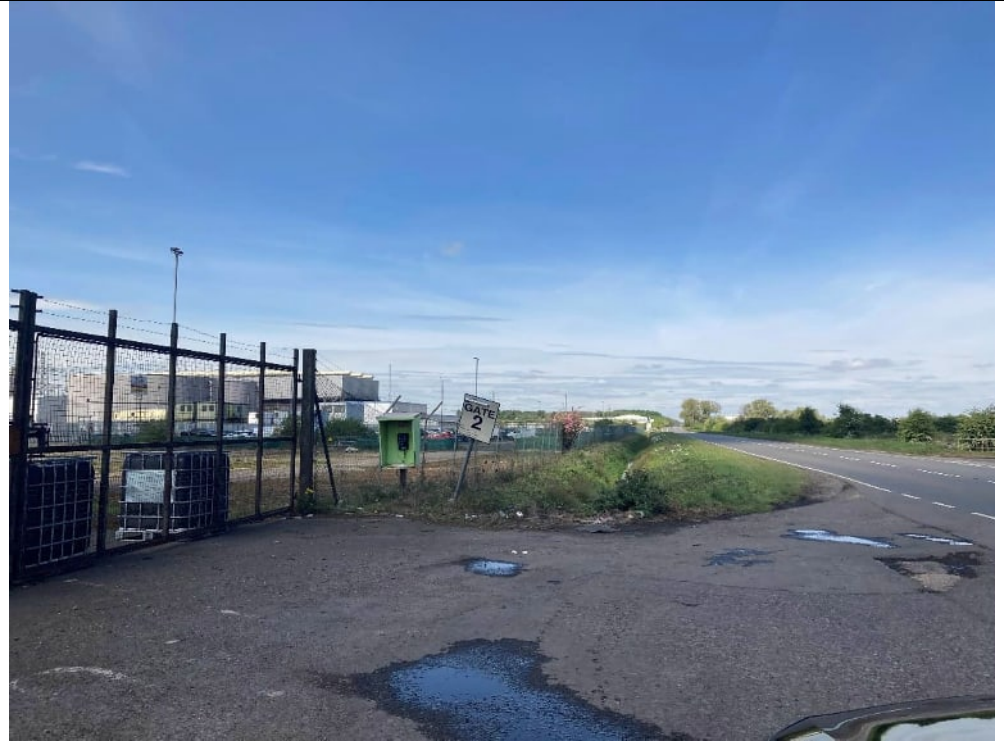
Photo No.
39

Lay-by area off Rosper Road that was used to view the inaccessible northern area of the site.

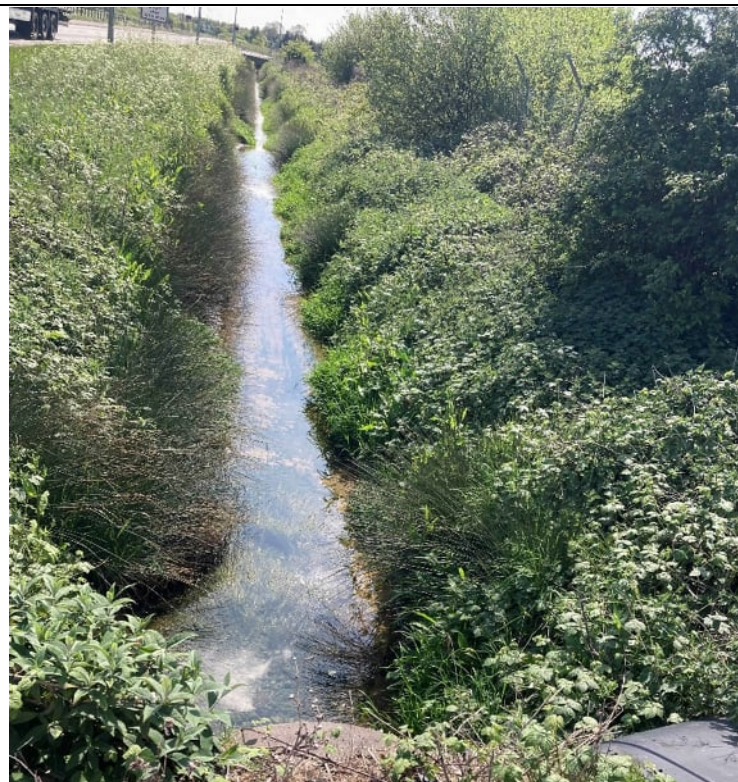
Photo No.
40

Drain that flows parallel to the eastern site border. The drain flows underground at this location underneath the lay-by area.

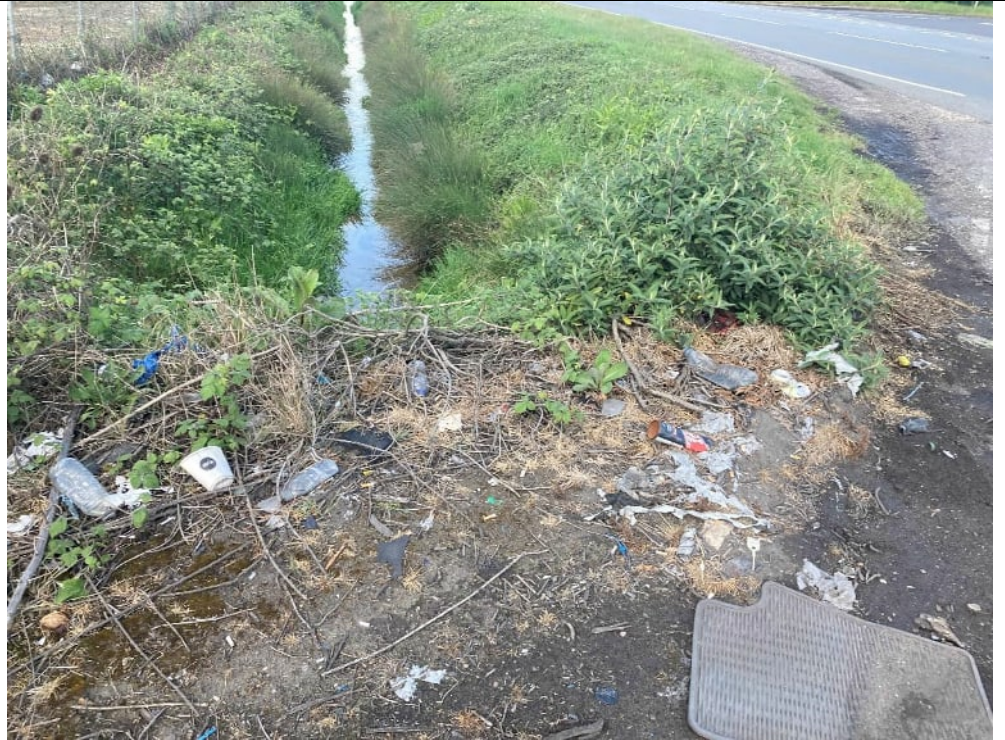
Photo No.
41

View of the drain as it emerges from the underground section in the lay-by area. Litter is located across the lay-by area at the site border.

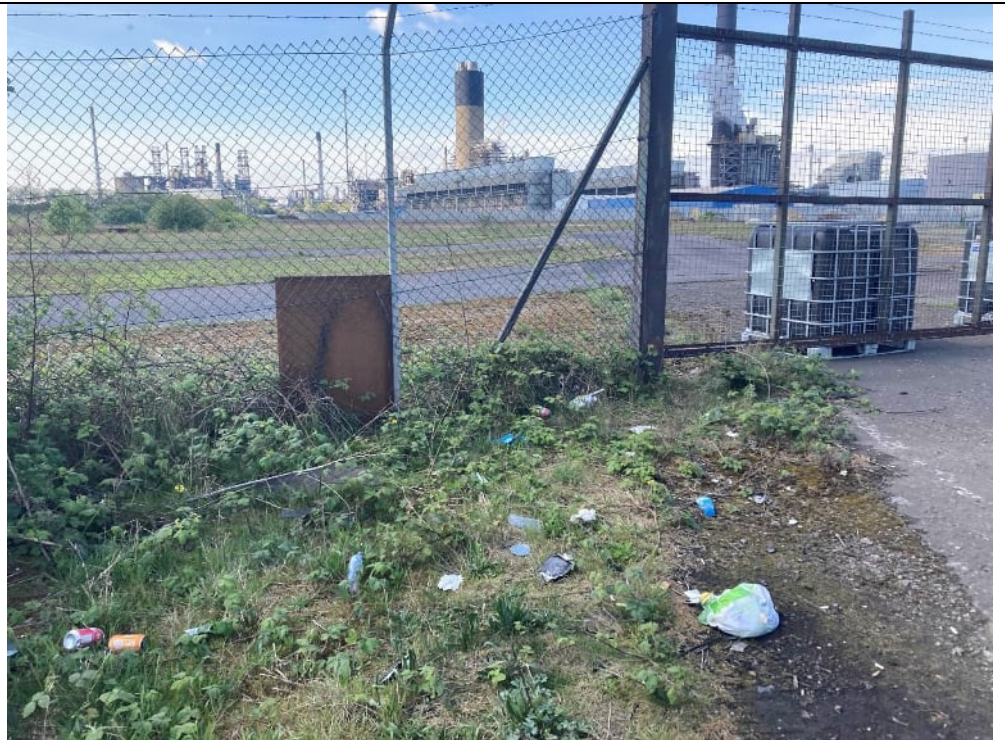
Photo No.
42

Litter deposited near the eastern site border. The border is marked by the tall, wired fencing.

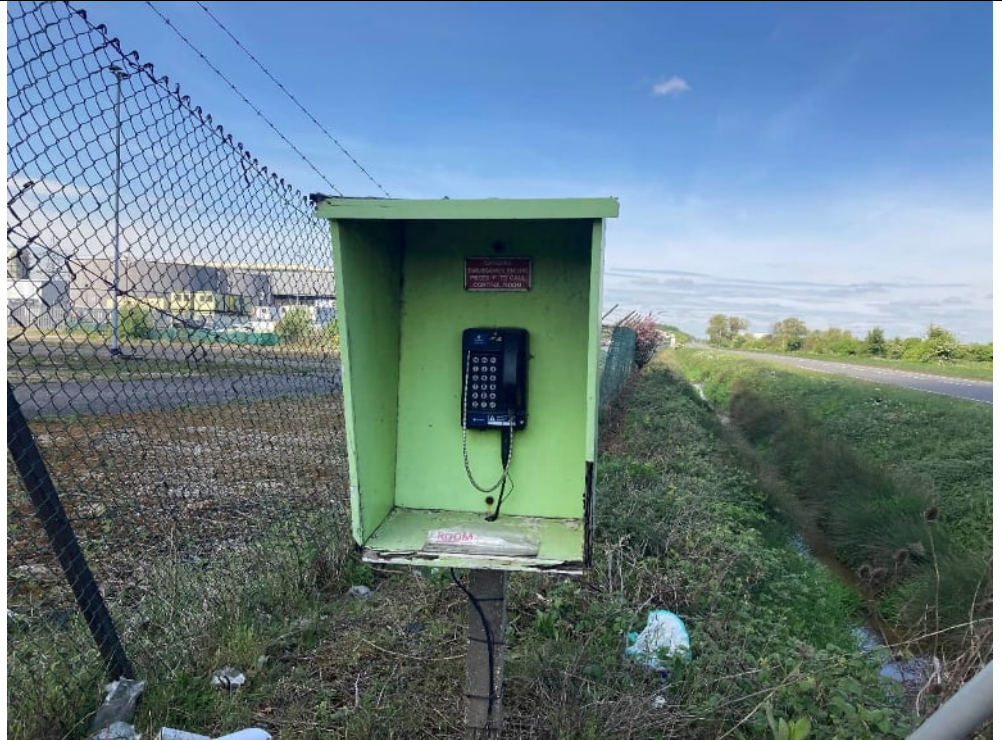
Photo No.
43

A green telephone box is located adjacent to the site border. A notice reads 'Caverns Emergency Phone'.

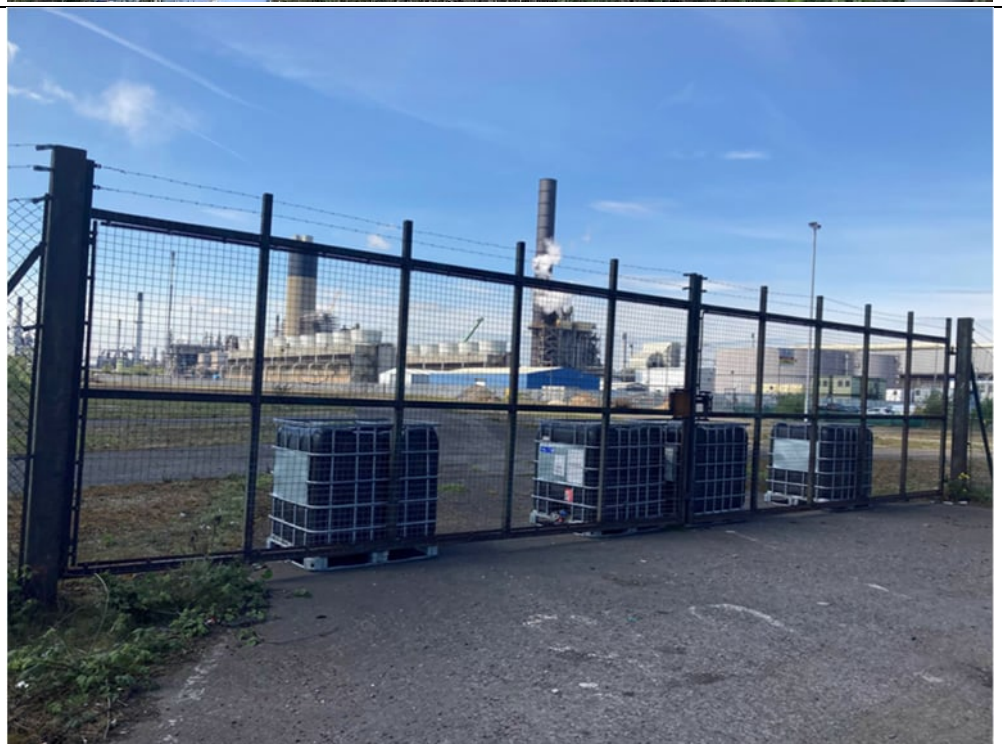
Photo No.
44

Four IBCs filled with gravel located inside the site boundary. The existing VPI CHP Plant is visible in the background.

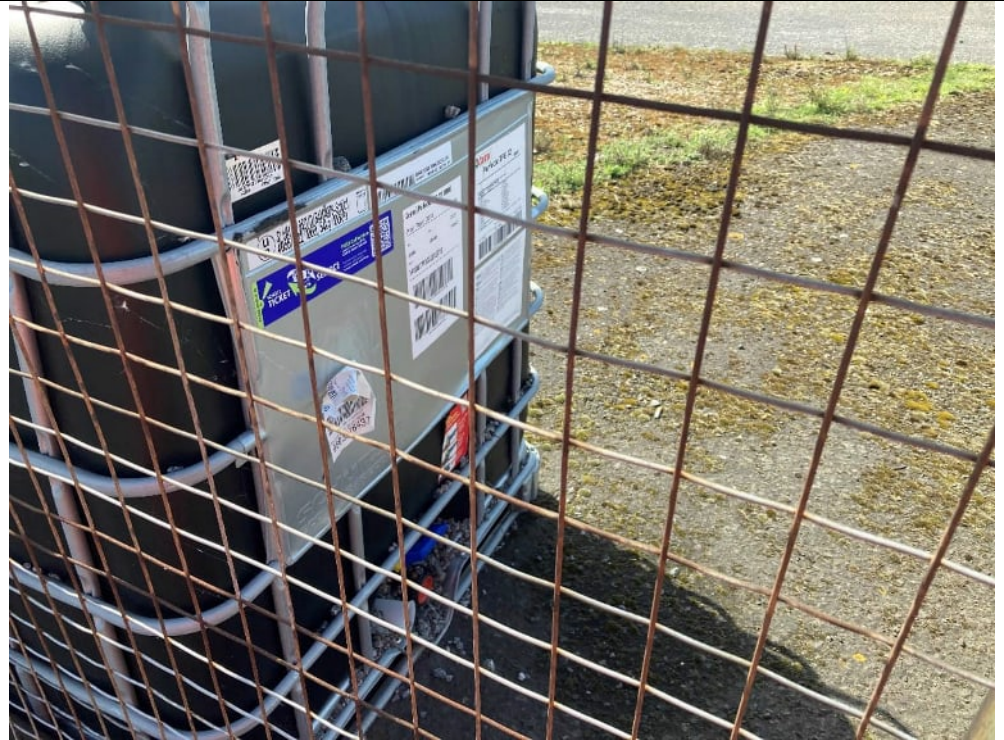
Photo No.
45

View of an IBC filled with gravel.

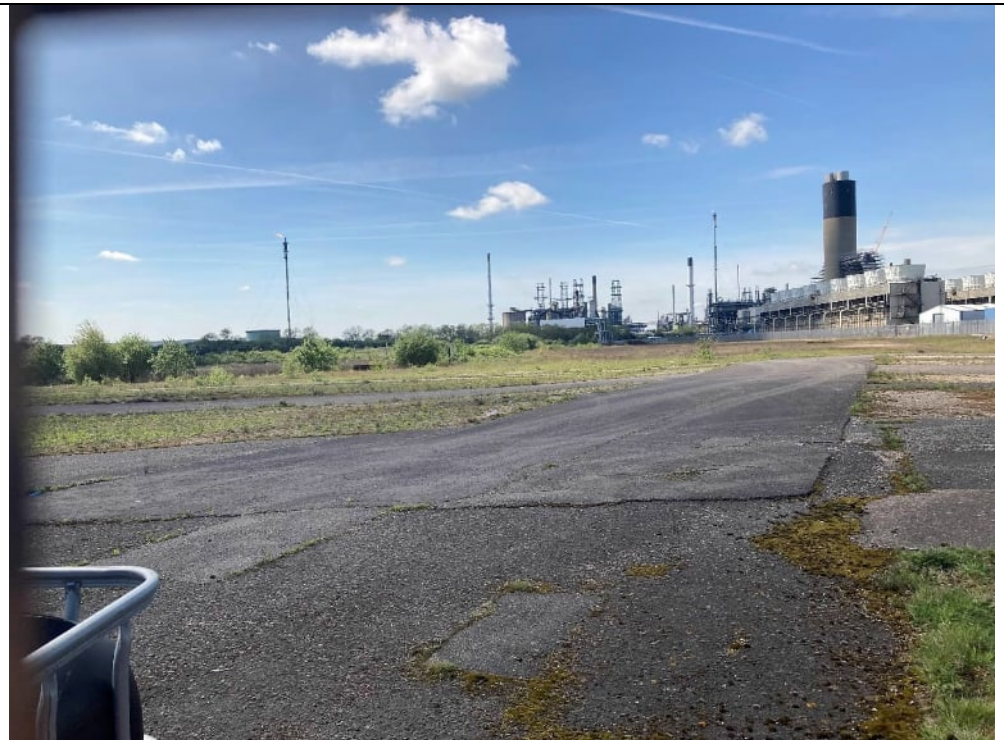
Photo No.
46

Hardstanding area within the northern half of the site. Grassland vegetation and small trees are visible in the background.

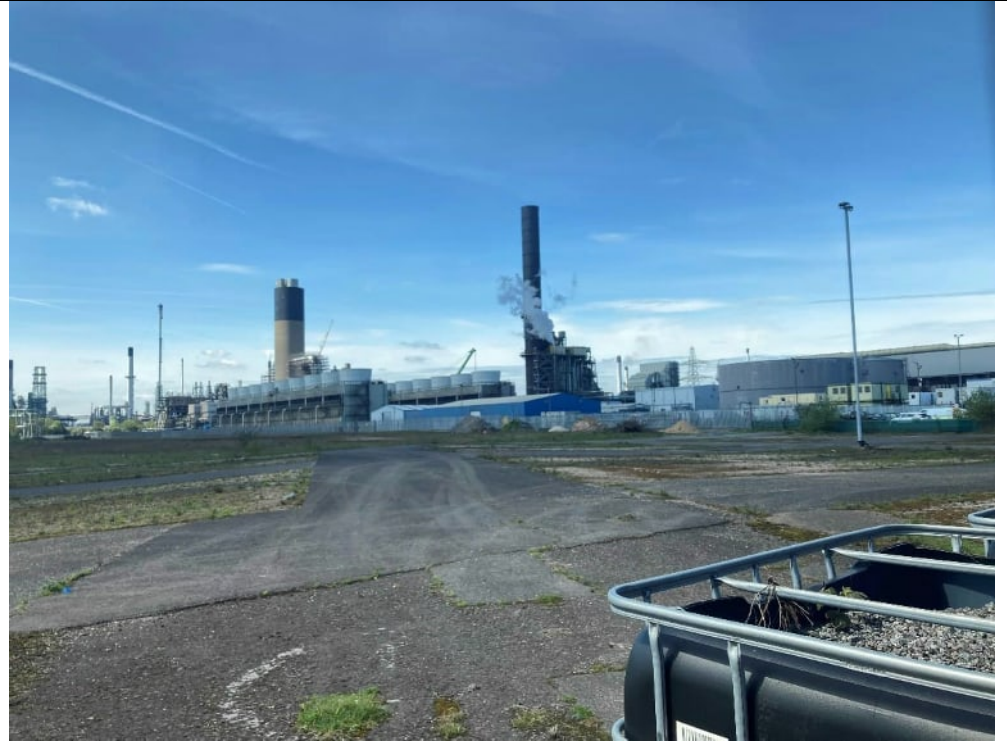
Photo
No.
47

Material stockpiles of an unknown source are located to the north of the undeveloped area. Floodlights are also located within this area.
