Arboricultural Safety Report

Report No: 220110

Site Address: The Old Vicarage
Beck Hill
Barton-Upon-Humber
DN18 5EY

Survey Date: 10th January 2022 & 24th February 2022

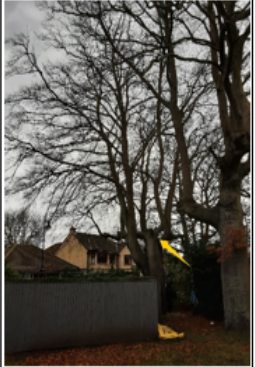
TA 03401 21945

Ref.	Species	Description	Measurements	Survey Notes	Condition	Hazard Category	Inspect Period	Recommendations	Photo	Grid Ref
T001	Common Beech (<i>Fagus sylvatica</i>)	Owned by the homeowner. Roadside tree near houses on Beck Hill. Tree in hedge. Target # - building Target # - footpath. Target # - road. Target # - street lights. Target # - overhead wires.	Height (m): 22.8 Crown Radius (m): 10 Life Stage: Over Mature Life Exp.: 10+ Years	Vigour: Good * Load Factors Wind Exposure: Partial. Crown Size: Large. Crown Density: Dense. Main crown union at 3m with <i>Ganoderma australe</i> visible to the southwest at 3m and northwest at 3.5m with associated decline within the upper crown. A large cavity at 3.5m following the loss of a main scaffold branch some time ago. Pruning works have been carried out within the lower to mid crown with multiple cavities as a direct result. Deadwood to circa 15cm diameter following decline.	Poor	High	1 Year	<p>Mitigation Actions 1: Climbing inspection to determine the extent of decay within the cavity at 3.5m. Decision made following findings. Timescale: 10-Apr-2022 (3 Months)</p> <p>Mitigation Actions 2: Decay not acceptable - reduce in height by 7m to leave a finished height of 15.8m and reduce lateral spread by 3m to leave finished lengths of 7m. Prune to keep flowing lines with no internodal cuts. Works are to retain the tree long term Timescale: 10-Jul-2022 (6 Months)</p> <p>Long term Recommendations: Decay acceptable - monitor for decline annually Timescale: 10-Jan-2023 (1 Year)</p>

Arrow shows cavity

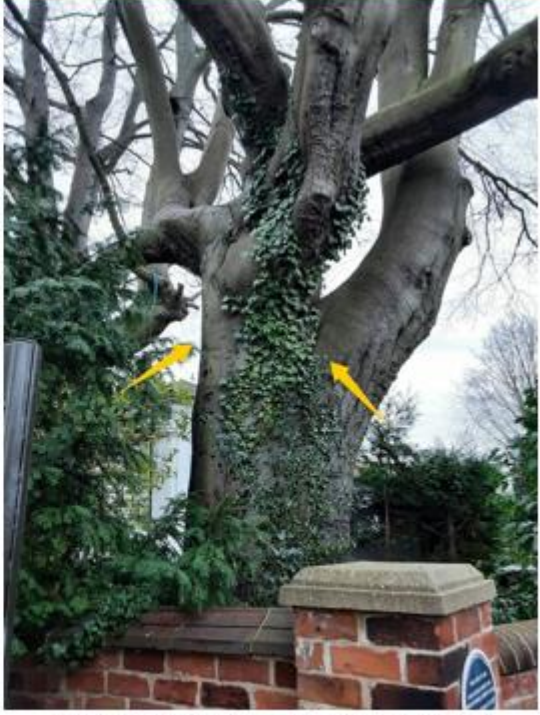
<p>Fungi locations. Picture taken from the southwest.</p>

Recommendation	Photo
<p>Tree: T001 Site: The Old Vicarage</p> <p>Common Beech</p> <p>Climbing inspection to determine the extent of decay within the cavity at 3.5m. Decision made following findings.</p>

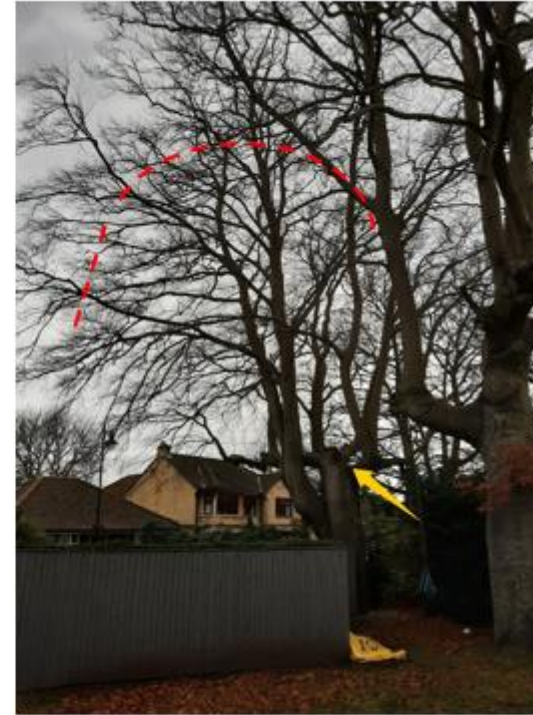
Arrow shows point of decay

Decay not acceptable - reduce in height by 7m to leave a finished height of 15.8m and reduce lateral spread by 3m to leave finished lengths of 7m.
Prune to keep flowing lines with no internodal cuts. Works are to retain the tree long term

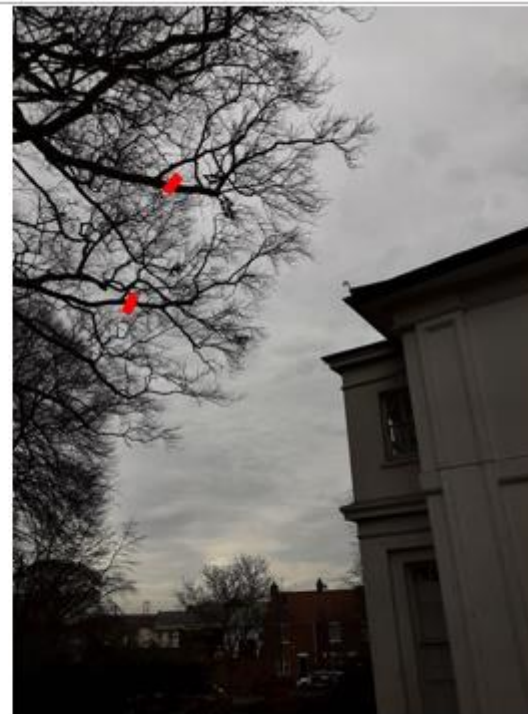
Points to reduce to

Climbing inspection to determine condition around pruning stubs with decay.
Reduce lateral spread toward the property by 2m to clear.
Remove deadwood at the same time

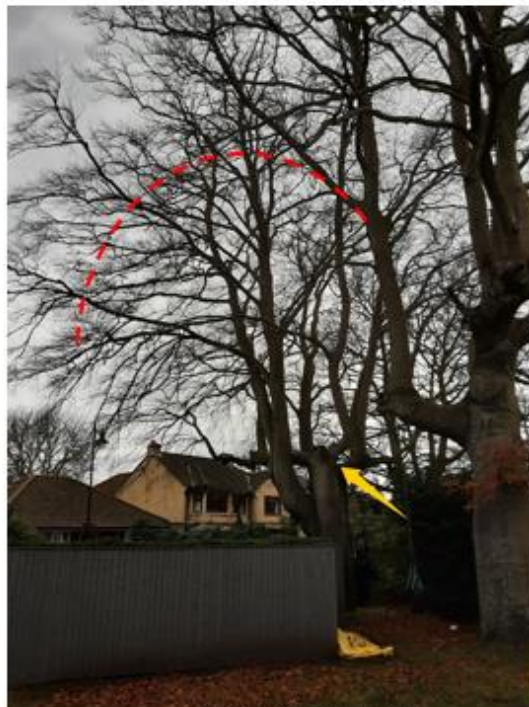
<p>Arrow shows point of decay</p>

Recommendation	Photo
<p>Tree: T001 Site: The Old Vicarage</p> <p>Common Beech</p> <p>Reduce in height by 7m to leave a finished height of 15.8m and reduce lateral spread by 3m to leave finished lengths of 7m. Prune to keep flowing lines with no internodal cuts. Works are to retain the tree long term and continue to give mutual support to T2.</p>

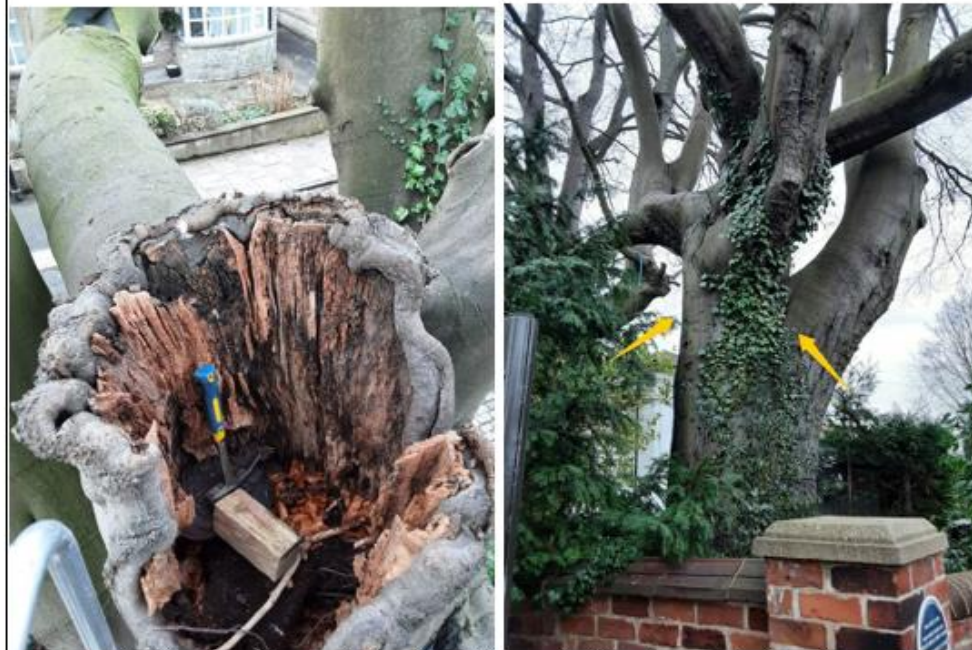
Fungi locations. Pictures taken from the aerial inspection & from the ground to the southwest.

Tree: T001
Site: The Old Vicarage
Common Beech
Monitor for decline annually

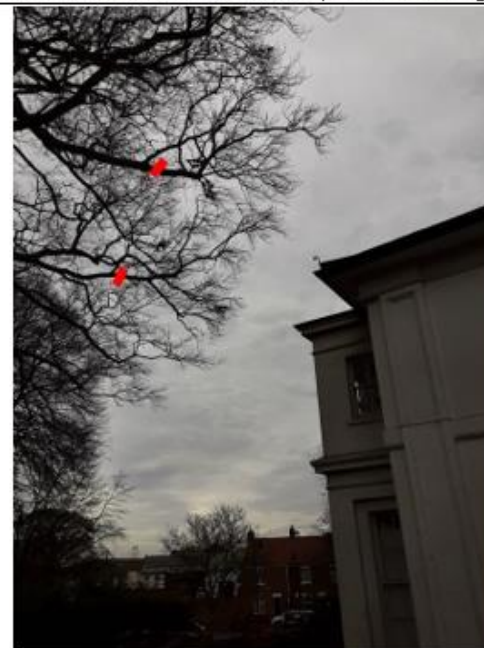
Points to reduce back to.

Reduce lateral spread toward the property by 2m to clear.
Remove deadwood at the same time
