Former Dixel Tyres Scunthorpe

DEMOLITION SURVEY

ASBESTOS SURVEY REPORT

SURVEY REFERENCE NO: S.J.01699
CLIENT: N & R Demolition
SITE ADDRESS: Former Dixel Tyres Brigg Road
Scunthorpe DN16
CONTACT: Tony Hardman (07579773037)
SURVEY TYPE: Demolition Survey
SURVEY DATE: 20th June 2023
SURVEY LEADER: Martin Dennett
SURVEYOR(S): Martin Dennett
REPORT ISSUE DATE: 27th June 2023
REPORT PREPARED BY: M Dennett
REPORT REVIEWED BY: M Dennett

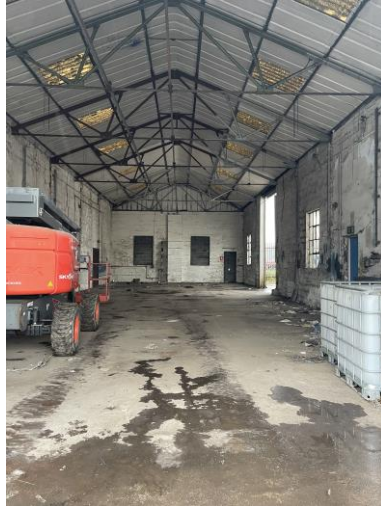
Client	N&R Demolition	Building	Dexel Tyres
Location	Building 1	Floor	Ground
Area/Volume	280m2	Description	Double Skin Trafford Cement Roof

Product Type	Damage Deterioration	Surface Treatment	Asbestos Type	Total Score	Risk Category	Analysis
1	0	1	3	5	C	Chrysotile Crocidolite

No asbestos detected – No further action	
Asbestos found within the material – Remove prior to Demolition	√

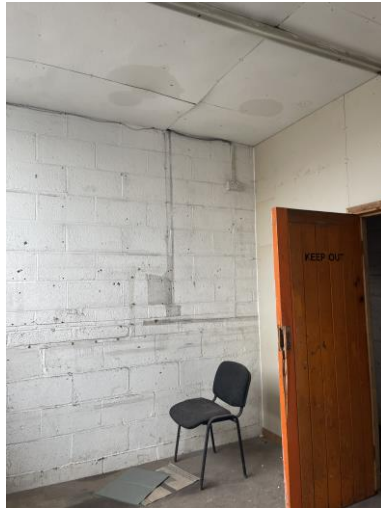
Client	N&R Demolition	Building	Dexel Tyres
Location	Building 2 Reception	Floor	Ground
Area/Volume	All	Description	Ceiling Board

Product Type	Damage Deterioration	Surface Treatment	Asbestos Type	Total Score	Risk Category	Analysis
0	0	0	0	0	E	NAD

No asbestos detected – No further action	√
Asbestos found within the material – Remove prior to Demolition

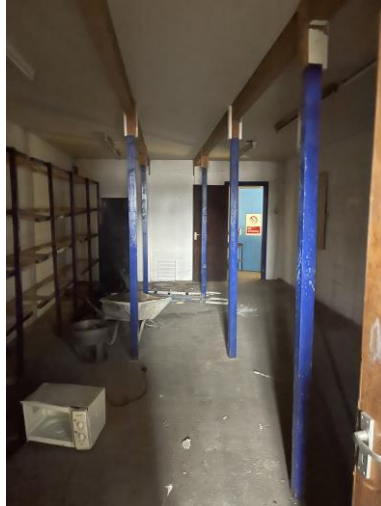
Client	N&R Demolition	Building	Dexel Tyres
Location	Building 2 Store	Floor	Ground
Area/Volume	N/Q	Description	No Suspect Materials Seen

Product Type	Damage Deterioration	Surface Treatment	Asbestos Type	Total Score	Risk Category	Analysis
0	0	0	0	0	E	NAD

No asbestos detected – No further action	√
Asbestos found within the material – Remove prior to Demolition

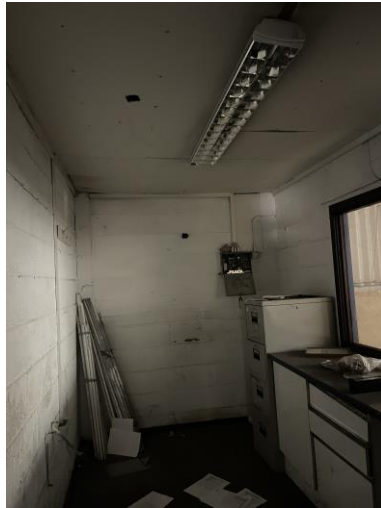
Client	N&R Demolition	Building	Dexel Tyres
Location	Building 2 Office	Floor	Ground
Area/Volume	N/Q	Description	Ceiling Board

Product Type	Damage Deterioration	Surface Treatment	Asbestos Type	Total Score	Risk Category	Analysis
0	0	0	0	0	E	NAD

No asbestos detected – No further action	√
Asbestos found within the material – Remove prior to Demolition

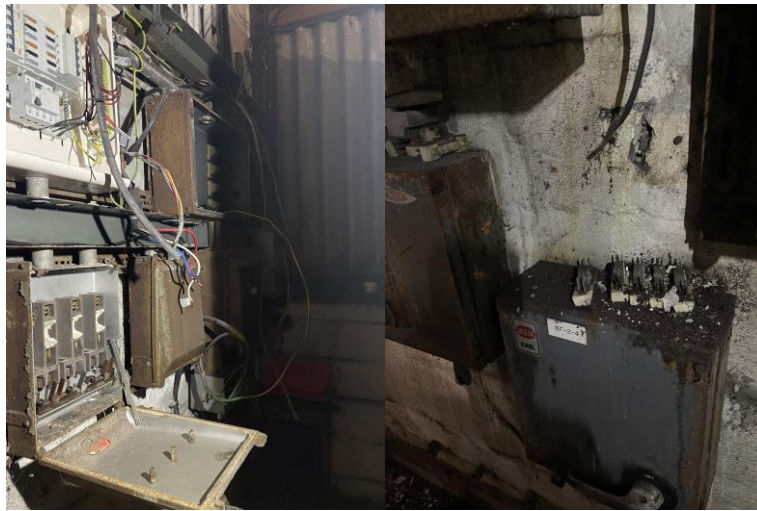
Client	N&R Demolition	Building	Dexel Tyres
Location	Building 2 Warehouse Electric Room	Floor	Ground
Area/Volume	All	Description	Old Fuse Box Door Gasket Flash Pads & Debris

Product Type	Damage Deterioration	Surface Treatment	Asbestos Type	Total Score	Risk Category	Analysis
1	0	0	1	2	D	Presumed Chrysotile

No asbestos detected – No further action	
Asbestos found within the material – Remove prior to Demolition	√

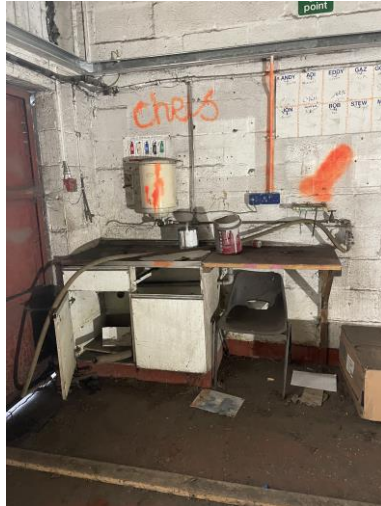
Client	N&R Demolition	Building	Dexel Tyres
Location	Building 2 Warehouse	Floor	Ground
Area/Volume	1No	Description	Sink Pad

Product Type	Damage Deterioration	Surface Treatment	Asbestos Type	Total Score	Risk Category	Analysis
0	0	0	0	0	E	NAD

No asbestos detected – No further action	√
Asbestos found within the material – Remove prior to Demolition

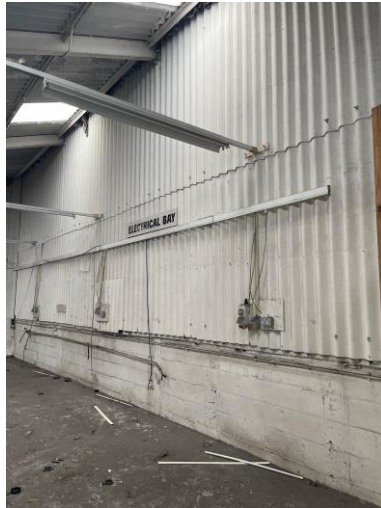
Client	N&R Demolition	Building	Dexel Tyres
Location	Building 3	Floor	Ground
Area/Volume	All	Description	Internal Cement Wall Between Units 2& 3

Product Type	Damage Deterioration	Surface Treatment	Asbestos Type	Total Score	Risk Category	Analysis
1	0	1	3	5	C	Chrysotile Crocidolite

No asbestos detected – No further action	
Asbestos found within the material – Remove prior to Demolition	√

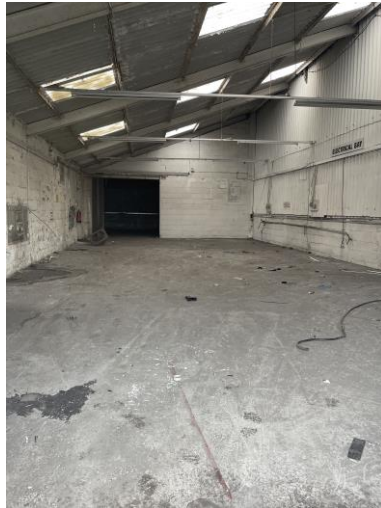
Client	N&R Demolition	Building	Dexel Tyres
Location	Building 3 Internal	Floor	Ground
Area/Volume	All	Description	No Suspect Materials Seen

Product Type	Damage Deterioration	Surface Treatment	Asbestos Type	Total Score	Risk Category	Analysis
0	0	0	0	0	E	NAD

No asbestos detected – No further action	√
Asbestos found within the material – Remove prior to Demolition

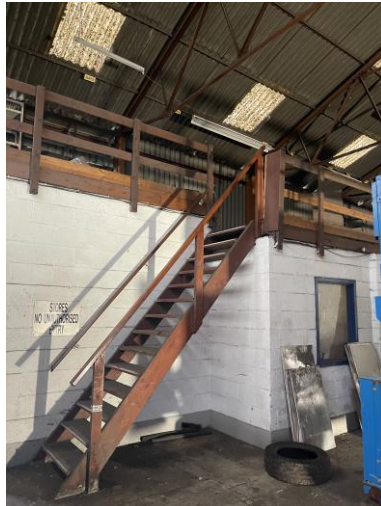
Client	N&R Demolition	Building	Dexel Tyres
Location	Mezzanine Floor	Floor	External
Area/Volume	N/Q	Description	No Suspect Materials Seen

Product Type	Damage Deterioration	Surface Treatment	Asbestos Type	Total Score	Risk Category	Analysis
0	0	0	0	0	E	NAD

No asbestos detected – No further action	√
Asbestos found within the material – Remove prior to Demolition

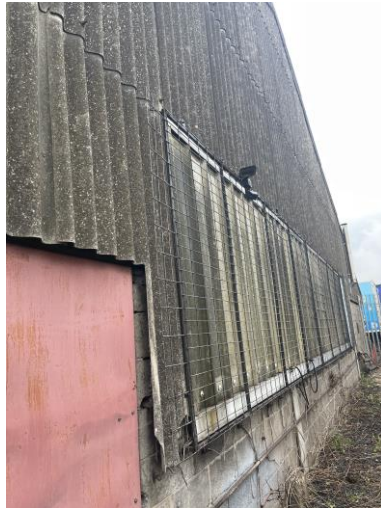
Client	N&R Demolition	Building	Dexel Tyres
Location	Building 2 & 3	Floor	External
Area/Volume	All	Description	Cement Roofs, Gable Walls

Product Type	Damage Deterioration	Surface Treatment	Asbestos Type	Total Score	Risk Category	Analysis
1	0	1	3	5	C	Chrysotile Crocidolite

No asbestos detected – No further action	
Asbestos found within the material – Remove prior to Demolition	√

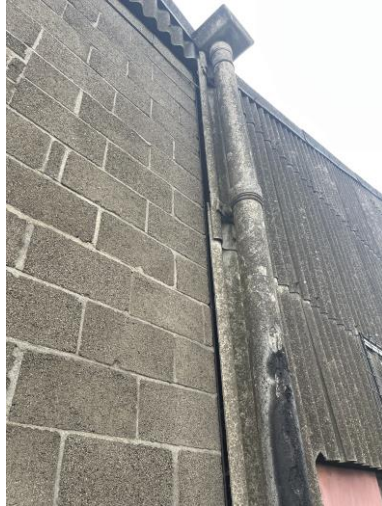
Client	N&R Demolition	Building	Dexel Tyres
Location	Building 1, 2 & 3	Floor	External
Area/Volume	All	Description	Cement RWPs & Gutters

Product Type	Damage Deterioration	Surface Treatment	Asbestos Type	Total Score	Risk Category	Analysis
1	0	1	3	5	C	Chrysotile Crocidolite

No asbestos detected – No further action	
Asbestos found within the material – Remove prior to Demolition	√

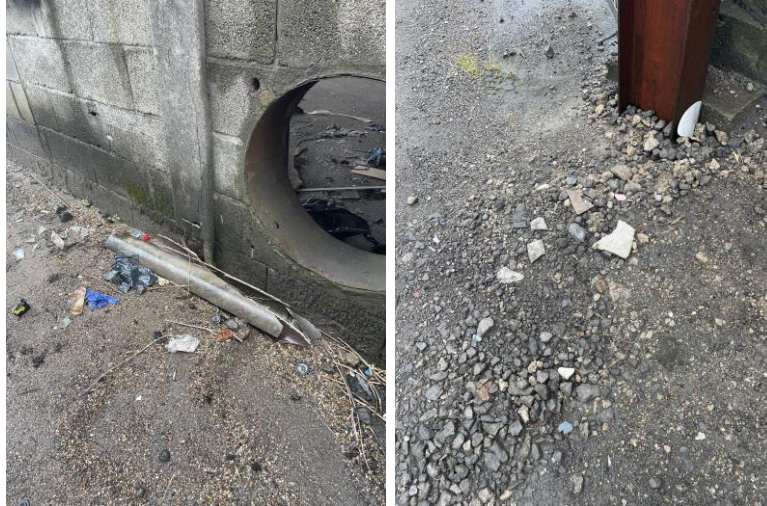
Client	N&R Demolition	Building	Dexel Tyres
Location	Building 1, 2 & 3	Floor	External
Area/Volume	All	Description	Cement Debris around Buildings

Product Type	Damage Deterioration	Surface Treatment	Asbestos Type	Total Score	Risk Category	Analysis
1	0	1	3	5	C	Chrysotile Crocidolite

No asbestos detected – No further action	
Asbestos found within the material – Remove prior to Demolition	√
