# ARBORICULTURAL REPORT

to BS 5837:2012 at:

*Land at*  
**Thornton Road,**  
**Goxhill,**  
**Barrow upon Humber,**  
**Lincolnshire**  
**DN19 7HN**

Reference: *AWA2379*

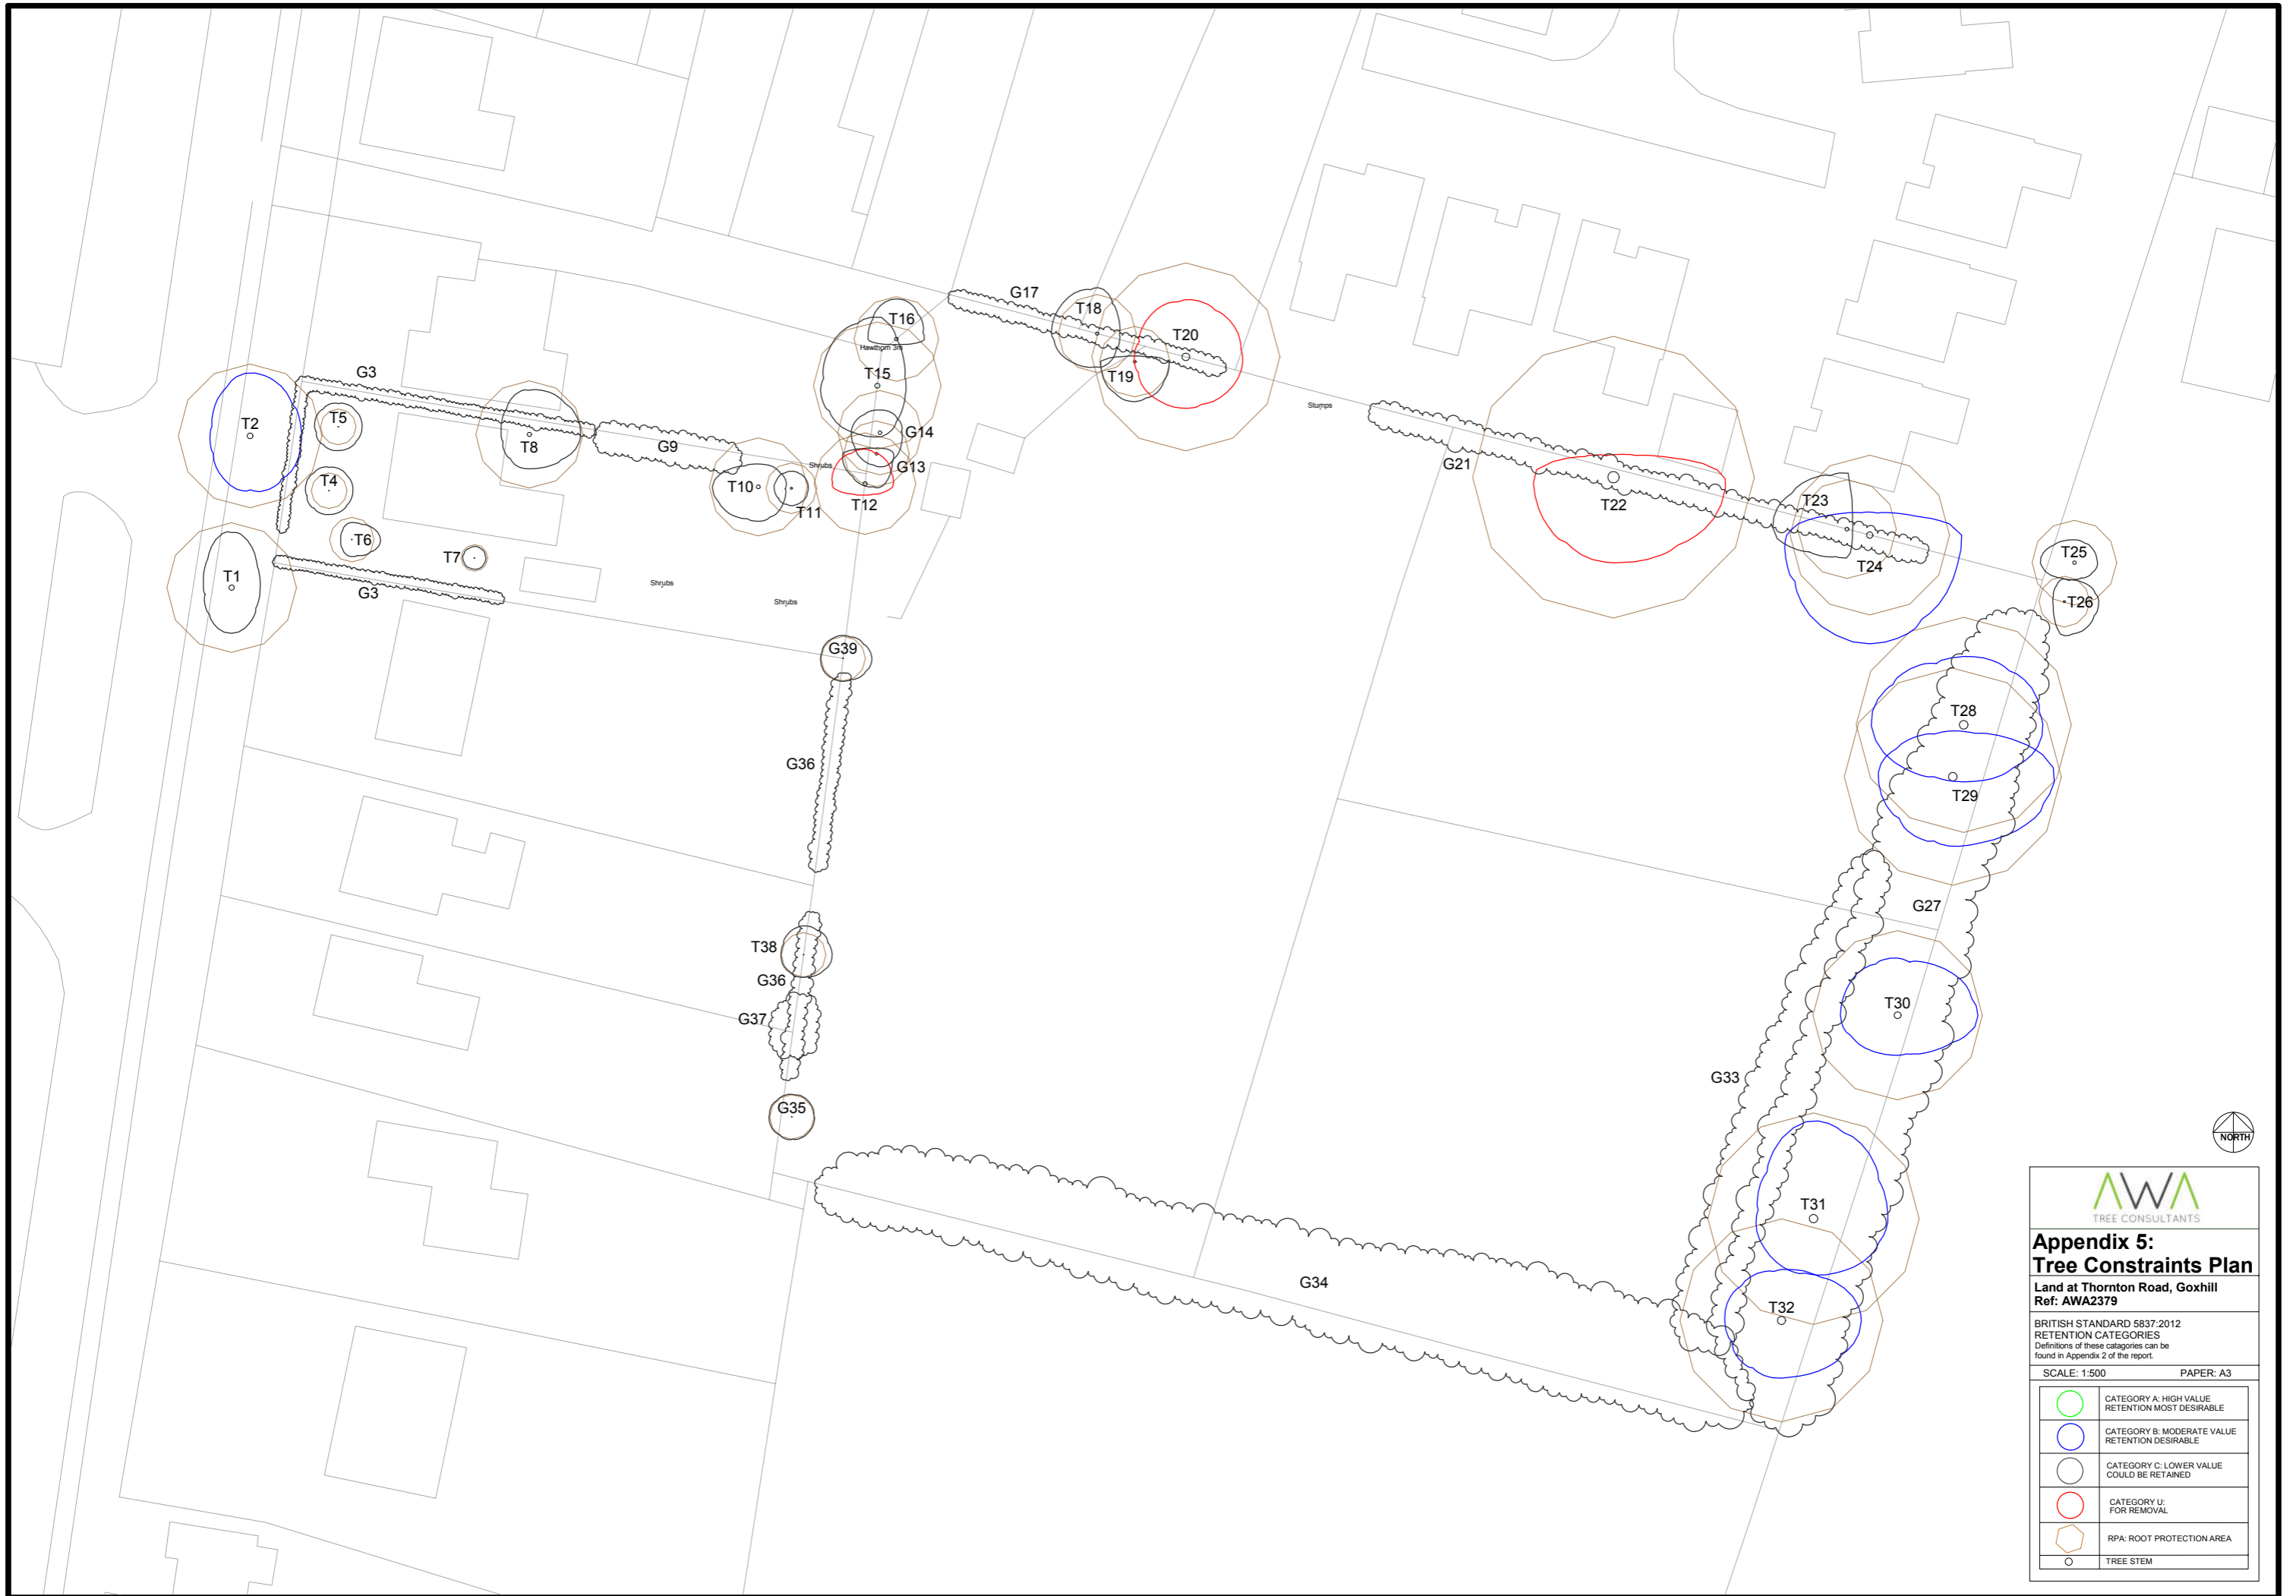
**Appendix 5:  
Tree Constraints Plan**

- 3.2.4 The site's most significant trees are the large Ash trees situated along the northern and eastern boundaries (T15, T23, T24, T28, T29, T30 and T31). These are prominent mature trees which provide moderate to high amenity value to the site and the surrounding properties. T29 has a rope swing tied to a large eastern limb and T31 has barbed wire wrapped around its main stem; the rope swing and barbed wire should be removed before they begin to cut into the cambium layers of the limb and stem.

- 3.2.5 The Field Maple T32 at the site's south eastern corner is a large mature tree in good overall condition which provides moderate amenity value to the site and the surrounding area.

- 3.2.6 Trees T20 and T22 are in poor overall condition and are recommended for removal regardless of development at the site due to their poor condition, and close proximity to existing residential properties. T20 has considerable dieback, major deadwood and occasional *Inonotus hispidus* fungal brackets to its crown, and moderate decayed cavities at the base of its main stem. T22 has a large *Perenniporia fraxinea* fungal bracket at the base of its main stem to the south, indicating the likelihood of extensive basal decay, and numerous large poor pruning wounds to the tree's lower crown which will further limit its future prospects.

- 3.2.7 The Cherries T1 and T2 are situated in a grass verge bordering Thornton Road at the site's western boundary. Both trees provide moderate amenity value due to their prominent roadside positions. T2 is in fair overall condition, while T1 is in poorer condition with a moderate decayed cavity to the southern side of its main stem at the base, and considerable deadwood and bark damage and decay in its lower crown.

- 3.2.8 Trees T4, T5, T6, T7, T8, T10, T11 and T12 are situated within the gardens of the vacant residential property at the site's western boundary. All the trees are of low value and should not pose significant constraints on development at the site. T12 appears to have been dead for some time and requires removal regardless of development at the site.

- 3.2.9 Linear boundary groups G3, G9, G17, G21, G27, G33, G34 and G36 provide screening between the site and the neighbouring properties and land. G3, G9, G17, G21 and G36 have been managed as hedges, while G27, G33 and G34 are unmanaged and naturalistic. G27, G33 and G34 could be brought under management if required by a new development at the site.

- 3.3.1 The higher value retention category 'B' trees and groups should be retained, where possible, and incorporated into any new development design.
- 3.3.2 Where suitable, those category 'C' trees and groups with reasonable future prospects (as detailed in Appendix 4) should be retained as part of any new development. However, care should be taken to avoid misplaced tree retention; attempts to retain too many or unsuitable trees on a site can result in excessive pressure on the trees during demolition or construction work, or post-completion demands for their removal.

- 3.3.3 If required by the development proposals, occasional lower value, retention category 'C' trees and groups could be removed, and replacement planting would largely mitigate their losses.

- 3.3.4 The tree Root Protection Area (RPA) detailed on the Tree Constraints Plan at Appendix 5, should be used as a layout design tool, to inform on the area around a tree where the protection of the roots and soil structure is treated as a priority.
