**Arboricultural
Report to BS
5837:2012**

19 Peacock Street
Scunthorpe
DN17 2DX

17th November 2023

231115

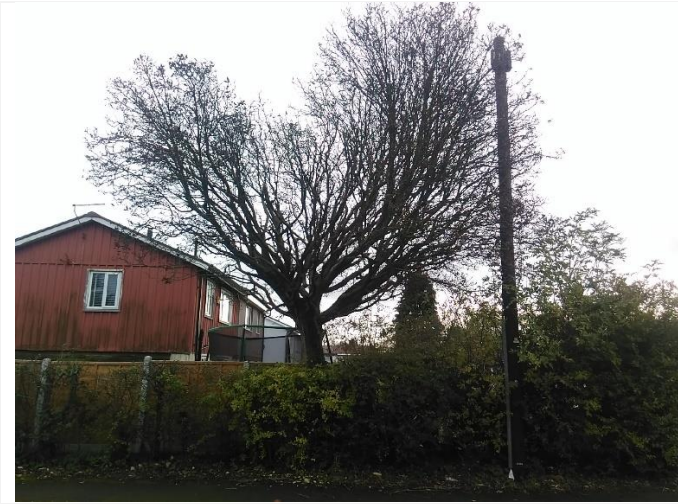
Image 1 – T1 with H1 in foreground

2.2.2. Tree T1 forms a moderate sized green feature when viewed from the immediate surrounding area (see Appendix 4, image 1). This tree forms a modest part of the local treescape, and conveys a low to moderate visual amenity value.
