PDS Design Ltd

Structural Report For Derelict Barn

- Structural survey carried out for Mr N. Choudry
- Survey date – 28th November 2023
- Site location – Rear of 33 High Street, Barton-Upon-Humber, DN18 5PD
- Report Number – 23266-SR1

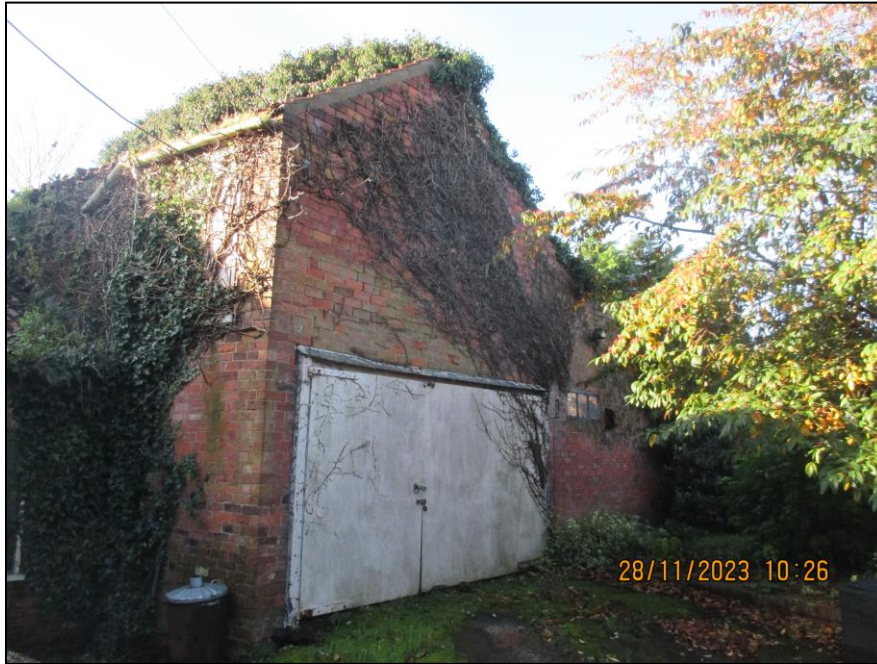
Photo 1 – Front Elevation (A)

The front gable elevation (A) has had major movement with some large/ significant cracking and open mortar joints which will need re-building/ making good throughout.

The left-hand corner has subsided & moved/bowed outwards to an extent in which would require re-building.

Front wall, right-hand side wall & part left-hand side walls to be demolished & re-built.

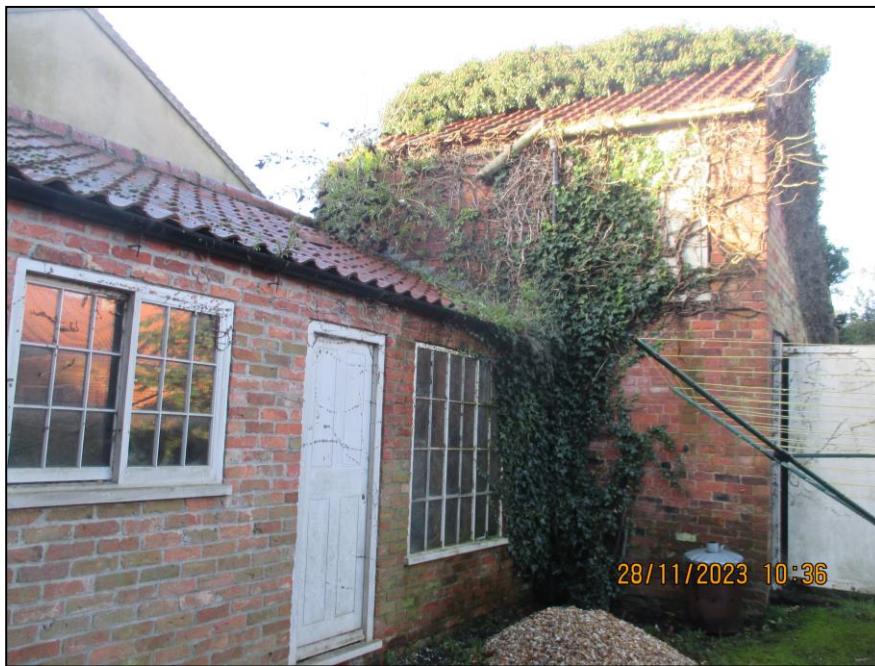
Photo 2 – Left-hand side Elevation (B)

The left-hand elevation (B) has some large/ significant cracking and open mortar joints which will need re-building/ making good throughout.

There is a section of wall which is partly external and partly a shared wall with the adjoining link building which should be able to be retained to avoid disturbance to this building.

Part of the left-hand side wall (shared with link) to be retained where possible.

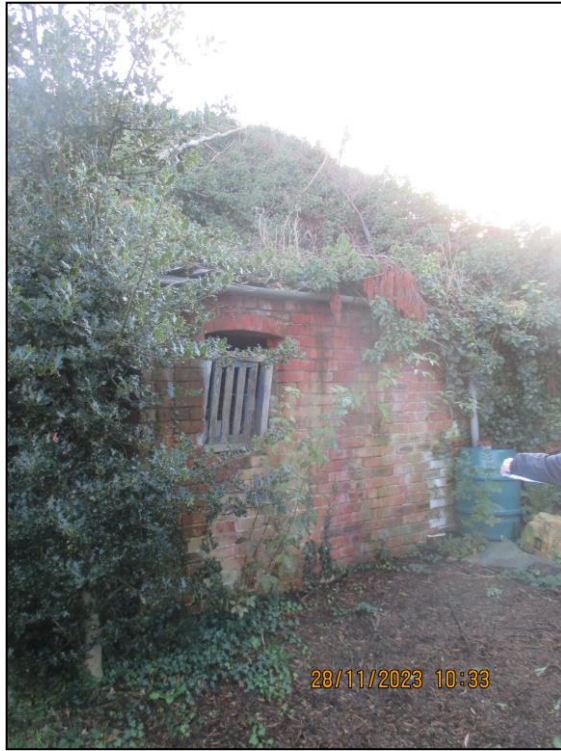
Photo 3 – Right-hand side Elevation (C)

The right-hand elevation (C) has also bowed outwards, (possibly due to the fallen tree) albeit not quite as significant as the left-hand/front side. There is some large/ significant cracking also to this elevation and areas of missing mortar joints which will all need re-building/ making good as required. The corner to rear elevation (D) could be retained for a short length to the start of the bowing.

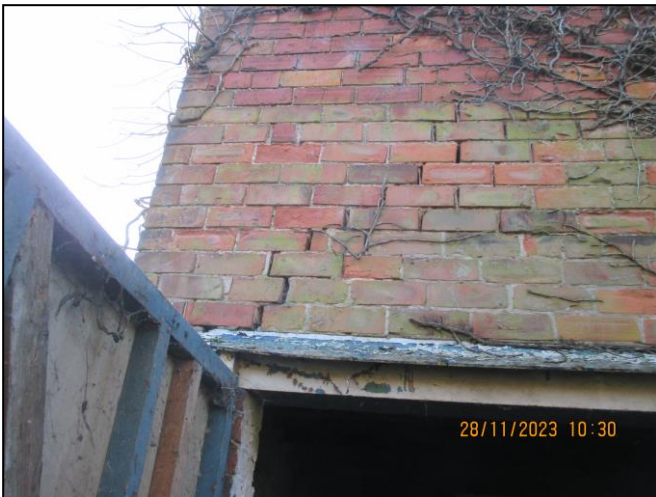
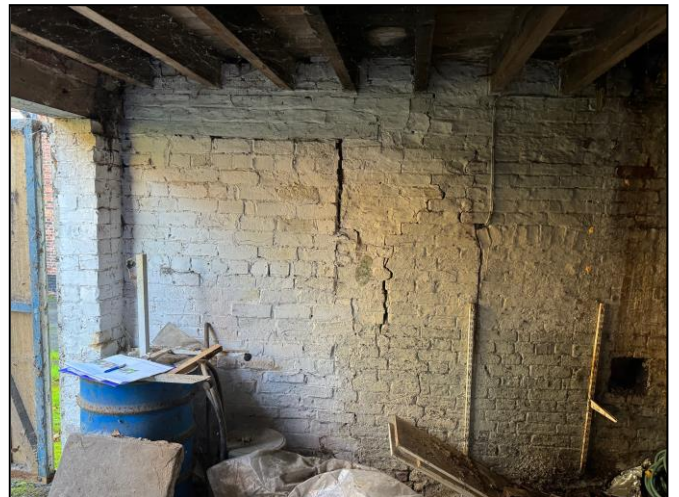
Photos 4/5 - Movement/ bulging to front left corner

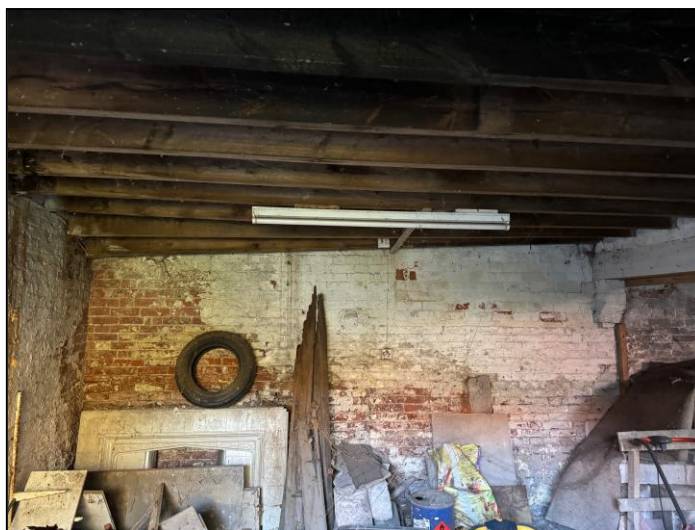
The floor timbers are in generally a very poor condition, with many of the joists sagging and being uneven, some of which have lost the end bearing onto the supporting walls. The timber ends show signs of rotting and splitting in several locations, therefore the floor joists should be replaced throughout & brought up to present day building regulation standards.

Photo 6 – Sagging 1st floor joists

The 1st floor timbers are in a very bad condition and in a state of collapse. Floor timbers are to be fully removed & replaced with new to current day standards.

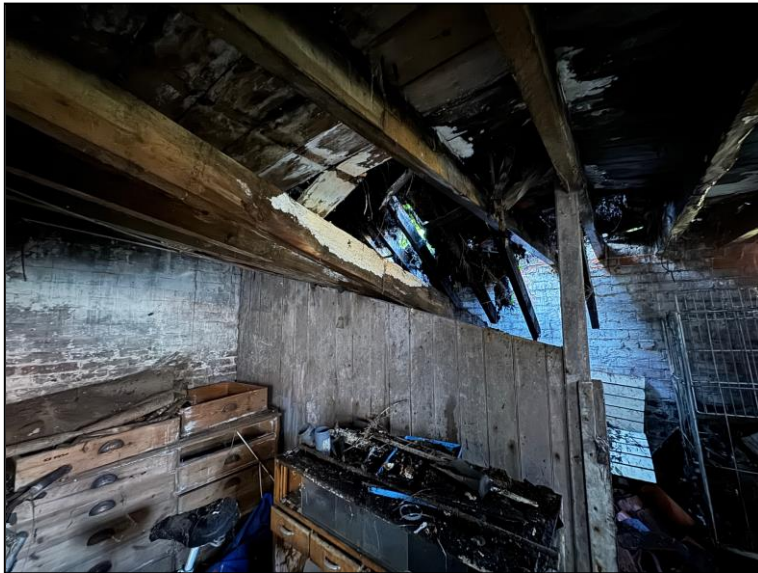
The existing roof structure is in very bad condition with areas sagging and collapsing with the timbers having signs of rotting/ splitting therefore will need replacing with new timbers throughout. A tree has also fallen onto this section of roof causing major damage to several of the roof timbers. The new roof should then be insulated/ dampproofed & brought up to present day building regulation standards.

Photo 7 – hole/damage to single storey roof

The roof is in very bad condition and in state of collapse. Roof is to be fully removed & replaced with new roof to current day standards.

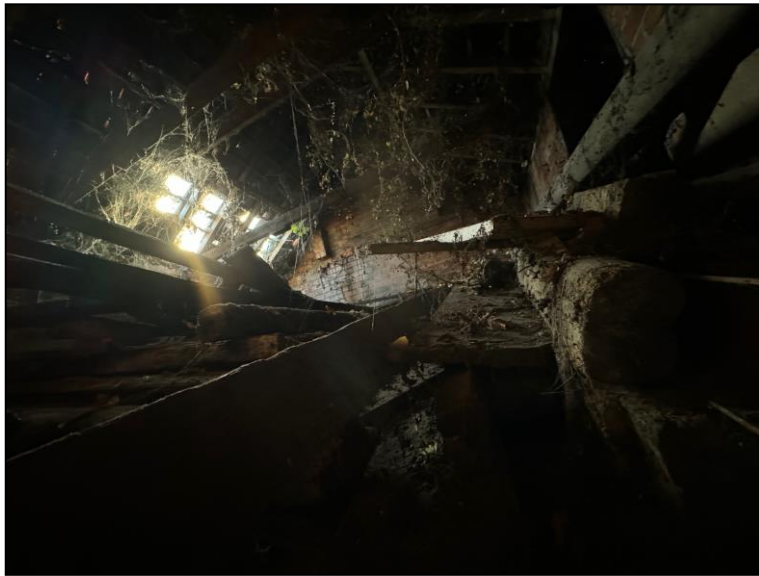
The existing main roof structure is in very bad condition with areas sagging and collapsing with the timbers having signs of rotting/ splitting therefore will need replacing with new timbers throughout. The roof can then be insulated/ dampproofed & brought up to present day building regulation standards.

Photo 8 – 2 storey roof (rotten/ sagging members)

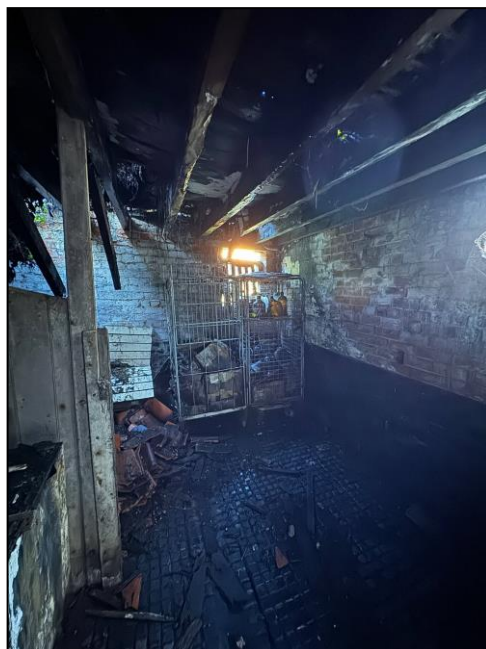
The existing ground floor floors are a combination of various cobbled floors at various levels throughout the property. These will need to be taken up and replaced with new insulated concrete floor to current standards for the conversion.

Photo 9
Cobbled ground floor

Ground floor to be dug up & replaced with new floor to current day standards.
