Structural and Condition Report

The Tithe Barn, The Hall, Owston Ferry, Doncaster, DN9 1AW.

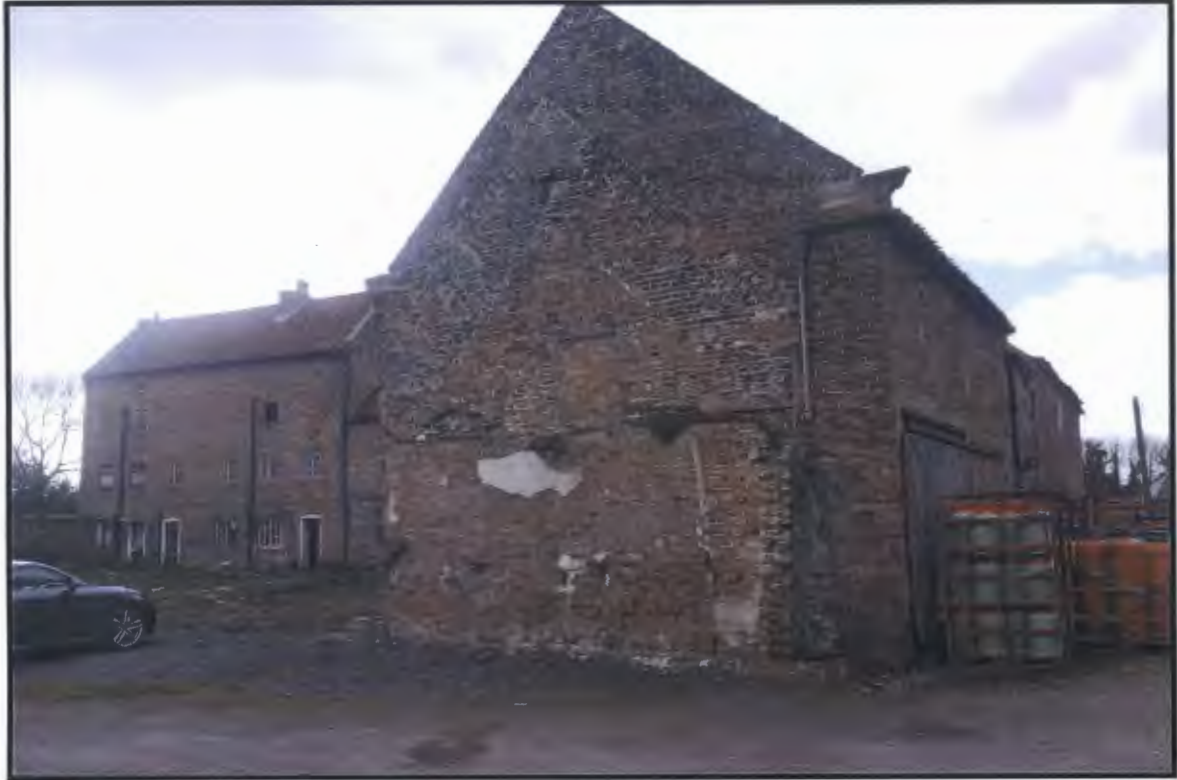
East Elevation

The east and west gable walls are constructed in 225mm solid brick and show signs of deflection from vertical or being out of plumb both in and out from vertical. They will require to be rebuilt to take out the dishing and bowing evident probable to 50% of their area.
