21 June 2024

## Structural and Condition Report (update)

The Tithe Barn, The Hall, Owston Ferry, Doncaster, DN9 1AW.

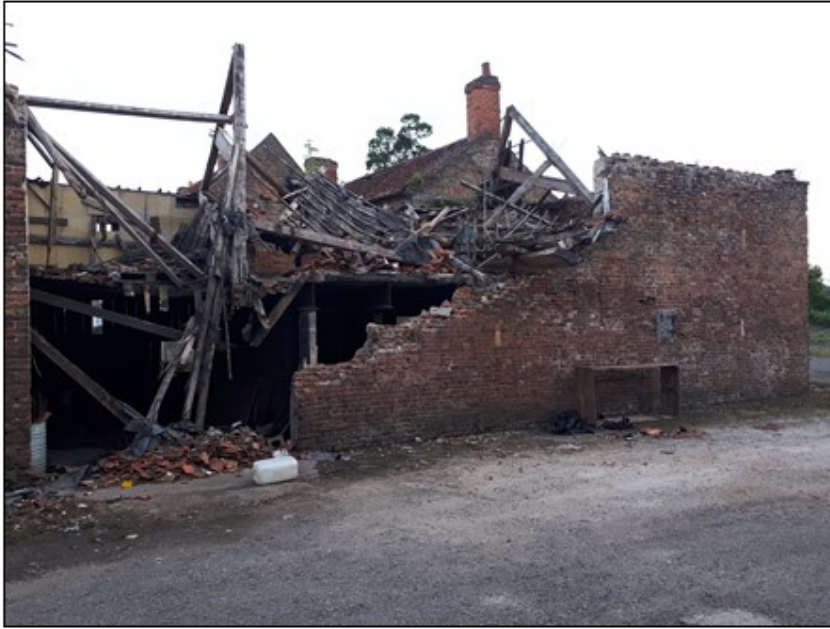
The main roof structure and covering collapsed as described in planning application PA/2022/542 please refer picture below submitted with the application.

Collapsed Roof Structure.

The obvious difference is the collapse of the roof structure, which however does lead to the conclusion that it was weaker than originally thought and that when a very close inspection (from scaffolding) was able to be had this state of affairs would have become clear. Thus its renewal would have been necessary in any event.

The proposed refurbishment of the barn will now require the complete renewal of the roof timber structure which gives the opportunity of replicating the original timber structure but with the benefit of an engineered design which will reduce the amount of additional strengthening timber or steel framework the original roof would have required.

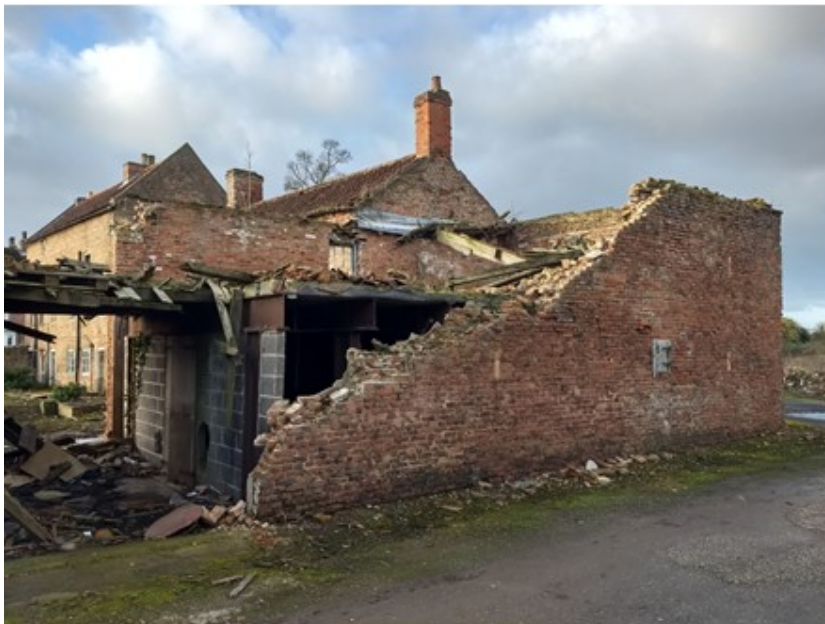
In order to save the main walls of the barn the remaining roof trusses were carefully lifted off the wall plate and moved to a storage point on site. This resulted in the main walls being made safe from further damage the collapsing roof but the barn being denuded of it's roof covering, see below.

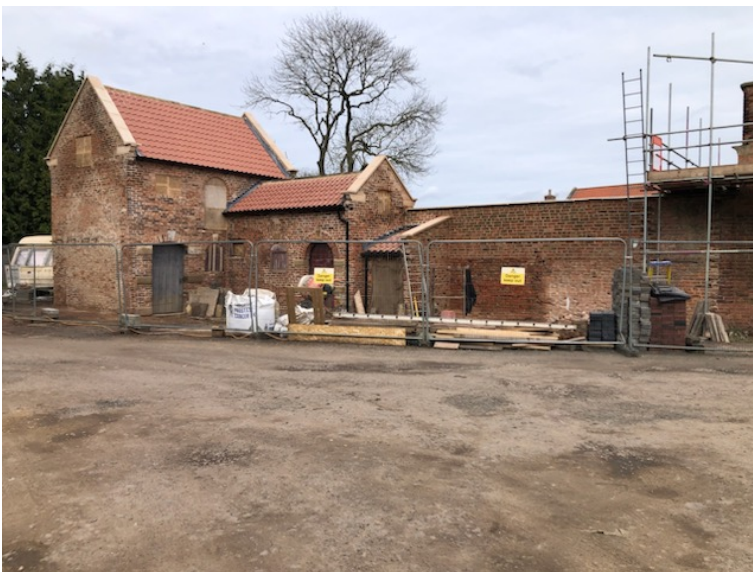
Dove Cote with new roof

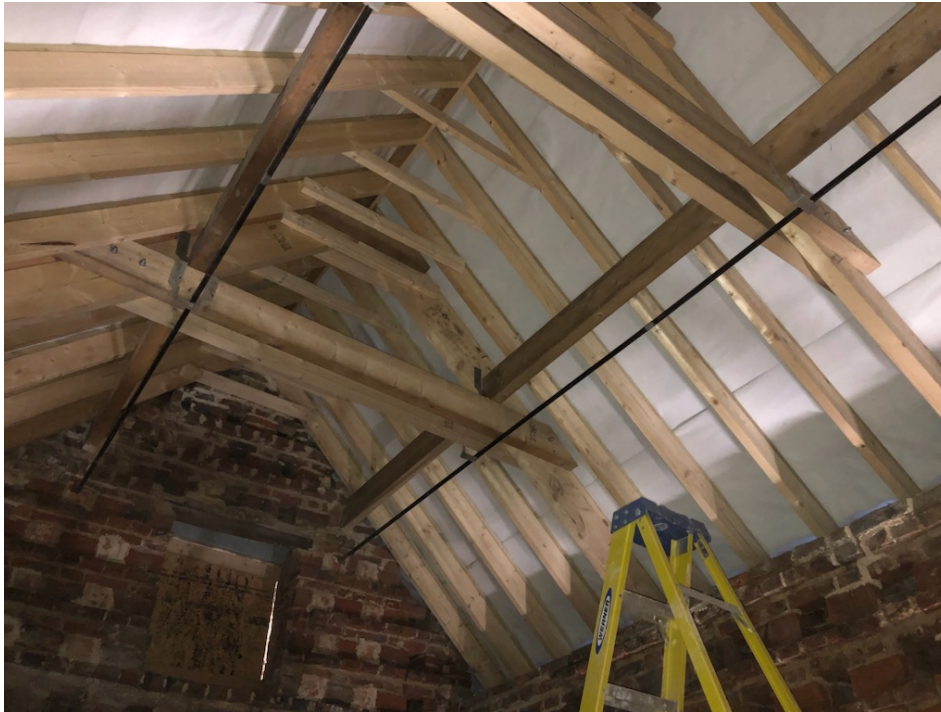
The photograph below shows the new roof timbers supporting the Dove Cote roof, these have been engineer designed in order for Building Control approval to be obtained.

New roof structure at the Dove Cote Tetley.

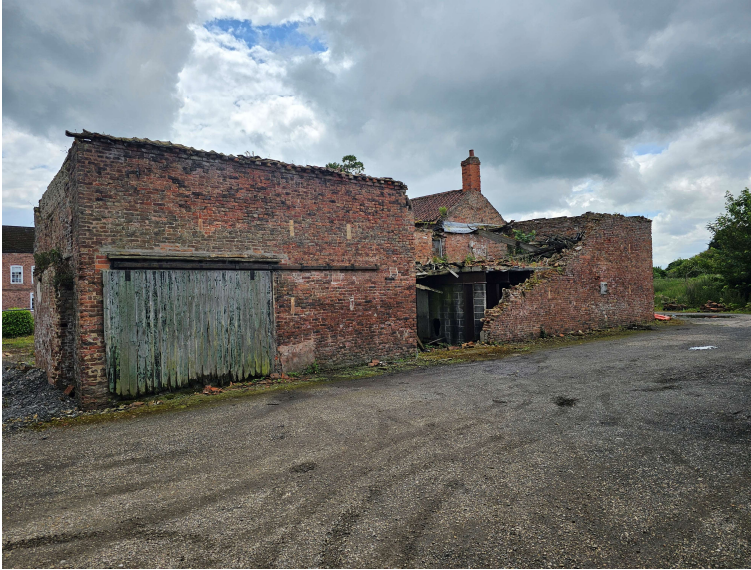
Little has changed to the main walls from that in 2016 and 2022 see below.

The main difference being the loss of the western and eastern gables, which will have to be rebuilt incorporating the “tumbled” brickwork detail previously displayed.

Therefore, comments and recommendations from the original report are still valid, thus “whilst the main walls show signs of longstanding structural movement they are considered to be in an acceptable condition to be retained and incorporated in the conversion, with the exception of part of the gable walls which do require to be rebuilt” as can be seen little has changed in the recommendations.
