Phase 2 (Supplementary) Report

Mendle Farm, Holme

<i>Title:</i>	Phase 2 (Supplementary report) Mendle Farm, Holme
<i>Client:</i>	North Cotes Butts
<i>Report number:</i>	1260/5063/P/P2

Ground investigation report

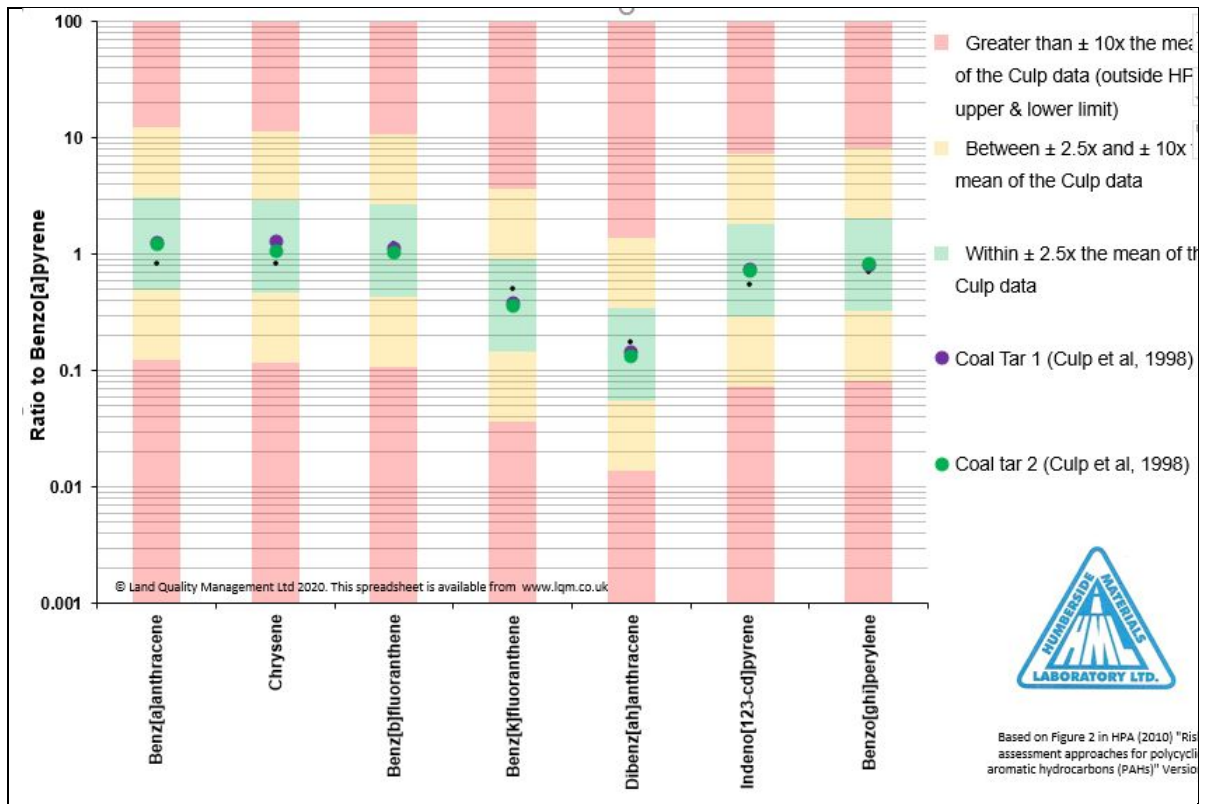
Figure 1 shows the PAH species to benzo(a)pyrene ratios of the measured data lie reasonably close (within 2.5 times the mean) to the Culp et al. (1998) data for most of the PAH species. Therefore, PAH double ratio profiling should be generally applicable to the data.

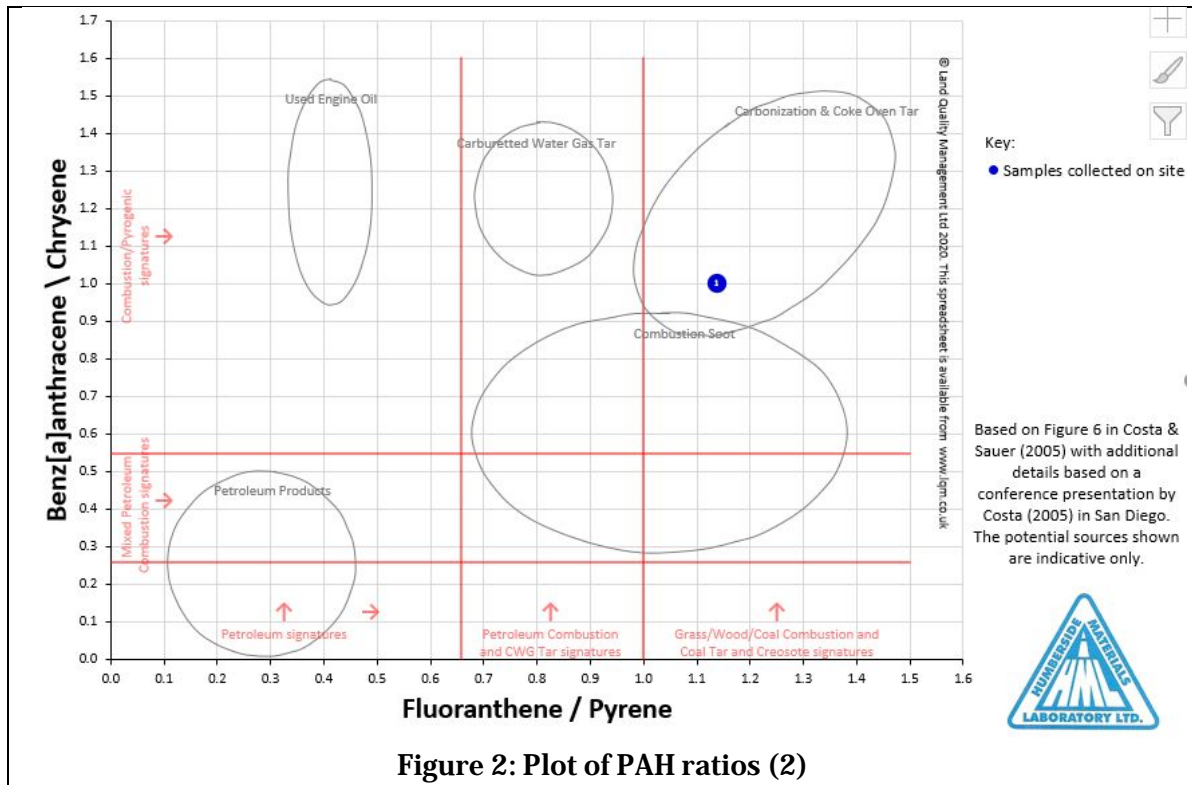
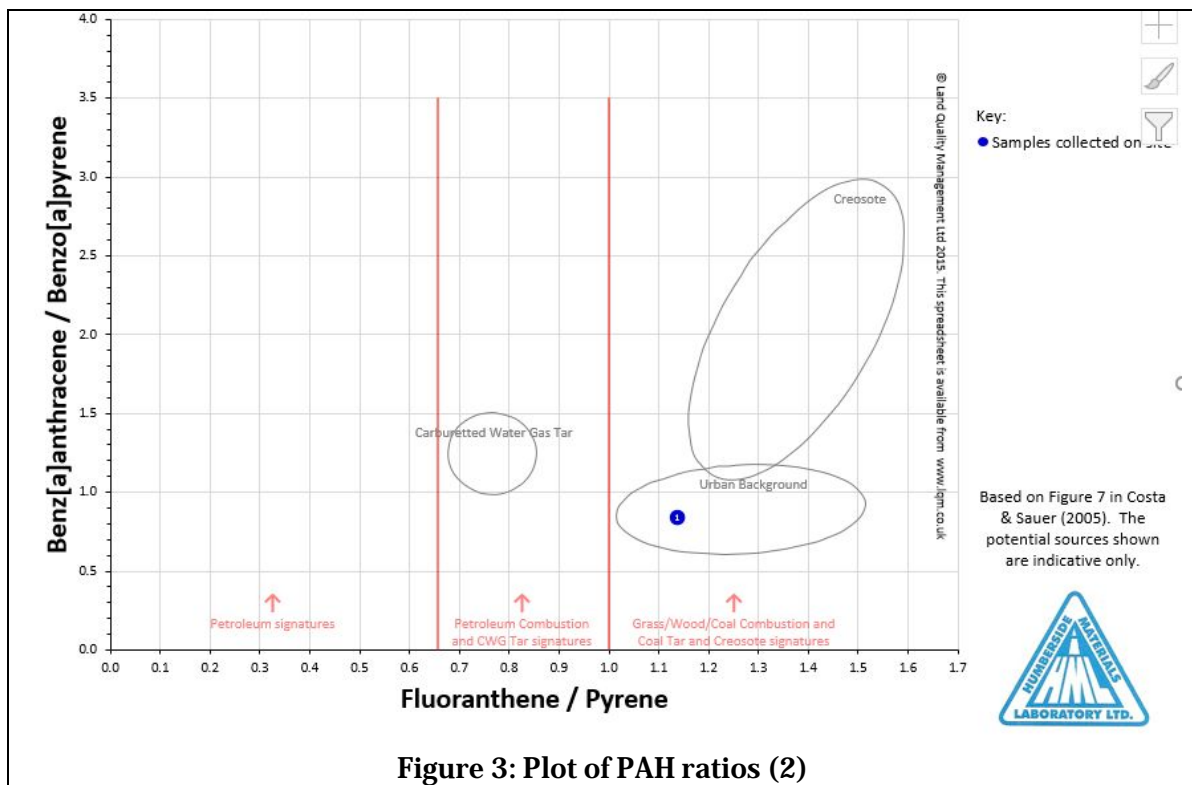
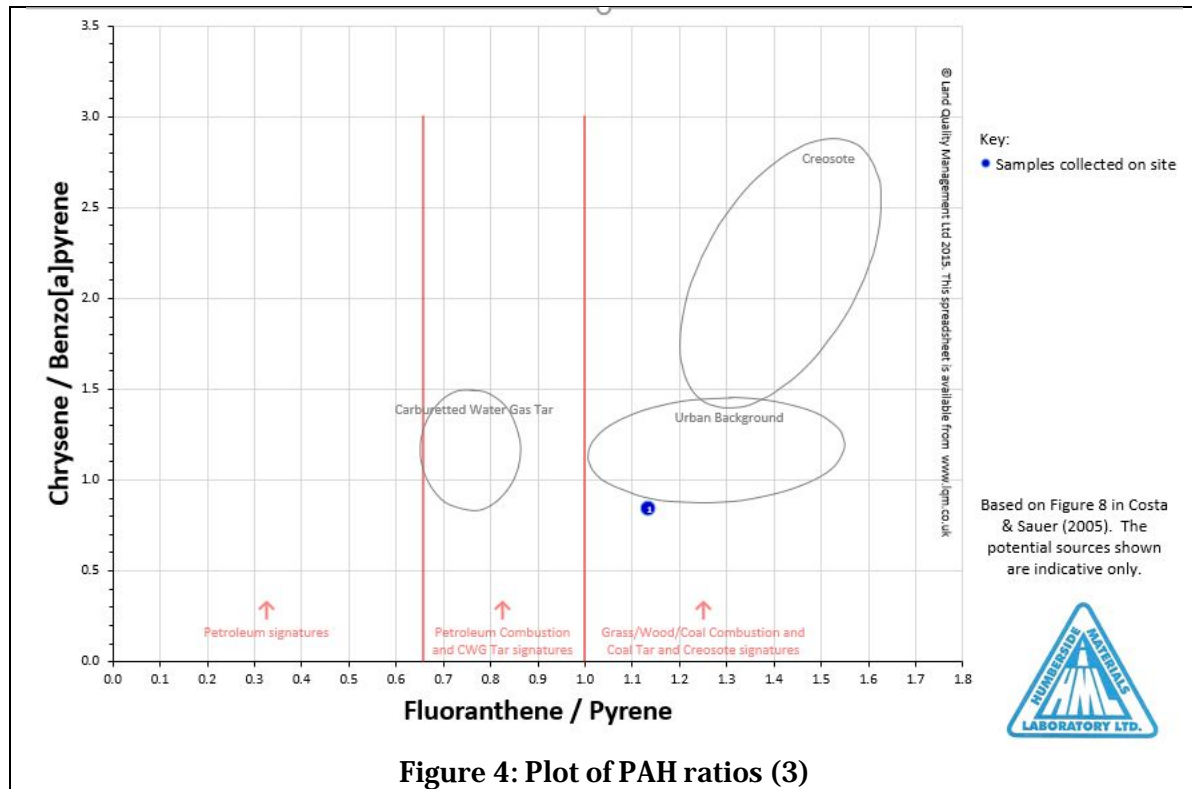
The profiling plots below (Figures 2 to 4) indicate the samples all have the signature of a *carbonization or coke oven tar* from an *urban background*. The profile clearly falls into the category of *Grass/Wood/Coal Combustion and Coal Tar*.

The results indicate the source of the low-level PAH contamination in the made ground is likely to be from either (a) coal tar or (b) ash or clinker from burnt wood or coal. The evidence does not point to PAHs from a petroleum hydrocarbon source.

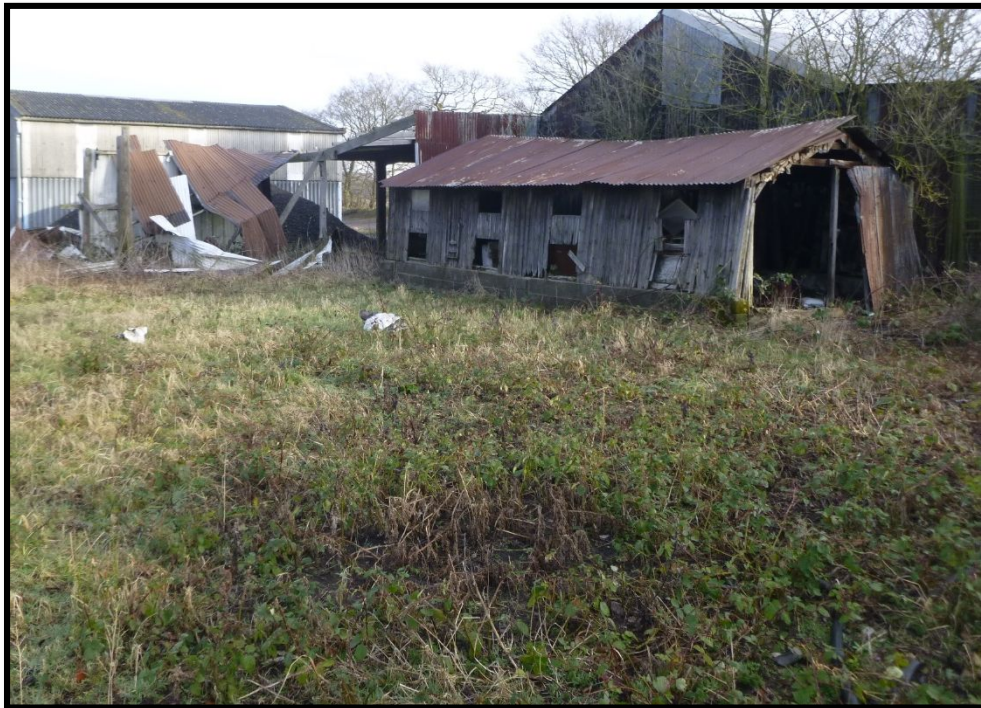
No elevated levels PAH have been recorded within the green area to the west of the existing structures. Two made ground samples from around the existing structure did not reveal any elevated levels of PAH identified within the initial ground investigation. One sample of the two made ground samples from below the existing structure

Green area to the west of existing structure
