Arboricultural Report - 250709

Survey Schedule - 250709 26BarrickCIDN197DU

Site Images - 250709 26BarrickCIDN197DU

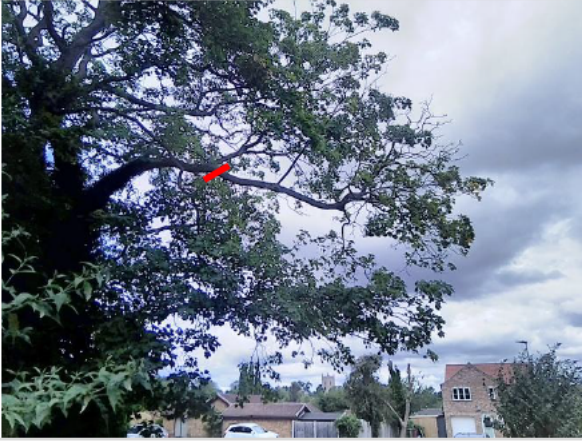
The mature sycamore T1 was found to be in a fair/good structural condition, and a poor/fair physiological condition. Structurally the issues are related to a notable volume of deadwood in the crown, and an elevated chance of live limb failure where dieback is present. An adequate structural assessment of the entire tree was not possible due to ivy cladding. The greatest risk posed by the tree is related to a major lateral limb, with significant dieback, which extends from 6m to the northeast over a shared private driveway (see image 1).

Image 1 - Limb at 6m to NE with dieback.
Reduction cut marked in red.

I recommend the large limb at 6m to the northeast be reduced in length to prevent failure onto the shared private driveway (see Survey Schedule, and image 1 for full details). I also recommend the limb at 4.5m beneath be reduced to prevent encroachment over the

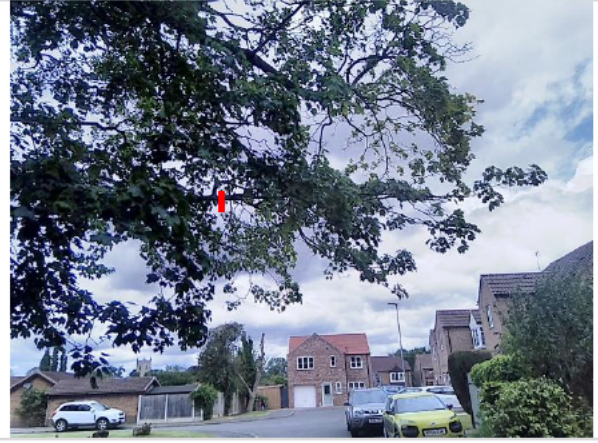
Image 2 - Limb at 4.5m to NE.
Reduction cut marked in red.

driveway, and to give the tree better form following the reduction of the limb above (see Survey Schedule, and image 2 for full details). Finally, the tree may need other minor reshaping of the NE crown following the works detailed above, this pruning must not result in any cuts greater than 50mm diameter.
