Photograph Schedule

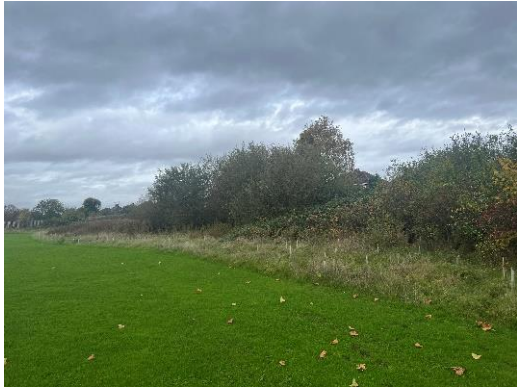
Figure: 1
General view of site boundary

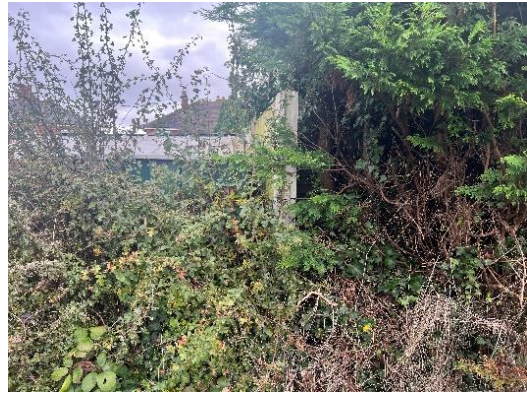
Figure: 2
Large hole in site boundary – H&S risk

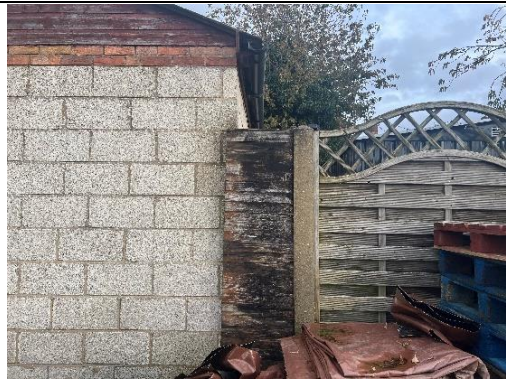
Figure: 3
Previous patch repair to site boundary

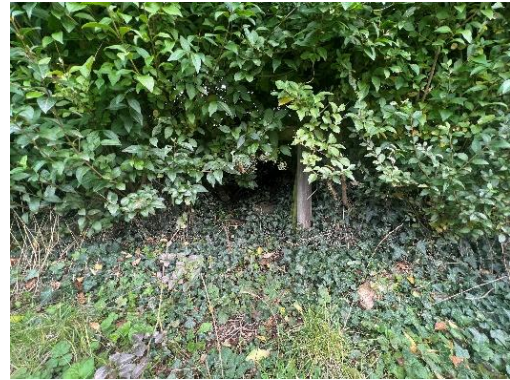
Figure: 4
Further evidence of large holes in site boundary – H&S risk

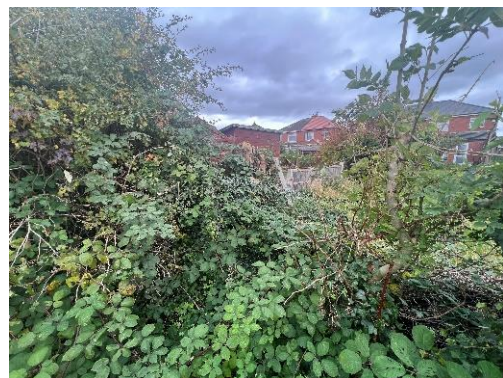
Figure: 5
Low level chain link fencing providing no security – H&S risk

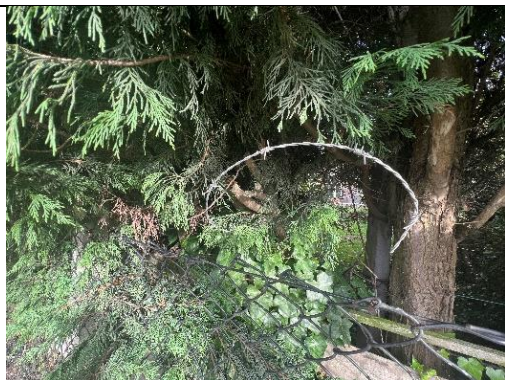
Figure: 6
Sharp barbed wire used as a temporary patch repair by site neighbours – H&S risk

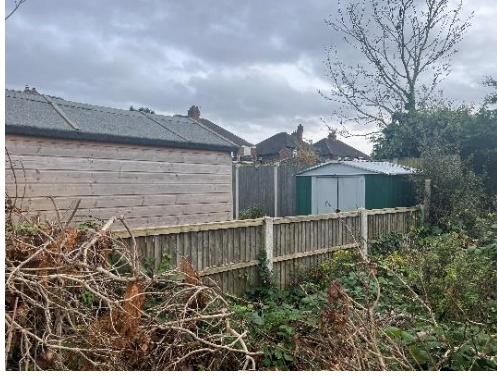
Figure: 7
Low level fencing providing limited security from intruders – H&S risk

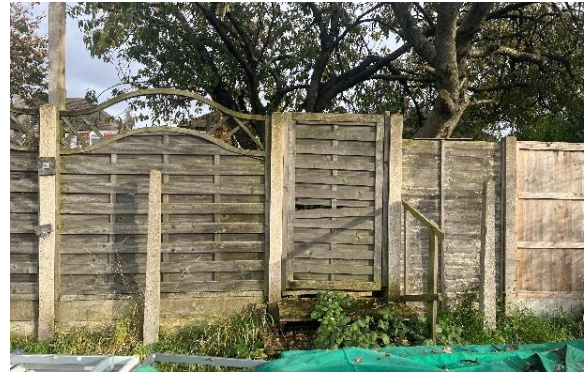
Figure: 8
Gated access from neighbouring residential property directly into school ground – major H&S risk

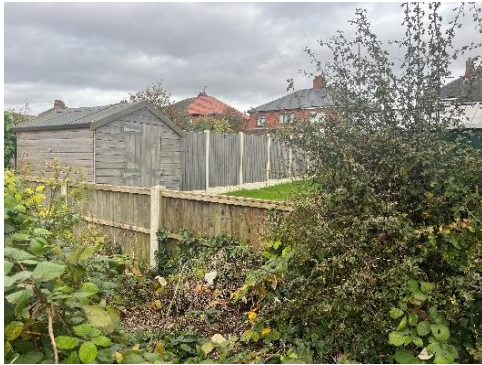
Figure: 9
Evidence of insecure site boundary line – H&S risk

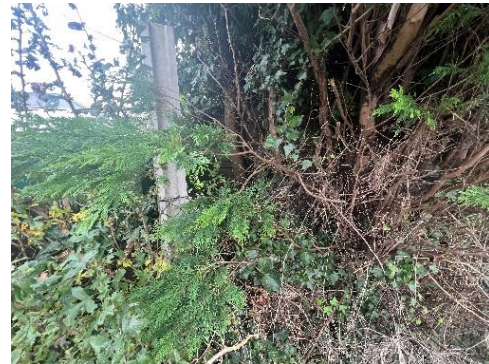
Figure: 10
Further evidence of insecure site boundary line– H&S risk

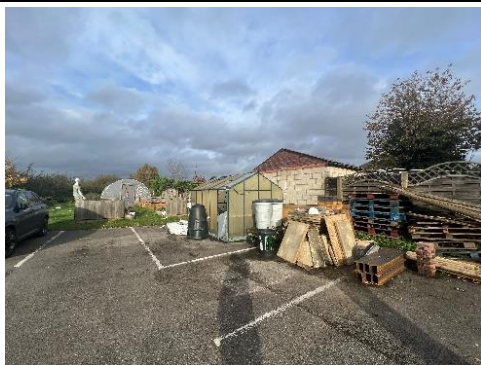
Figure: 11
General view of unsecured east boundary – H&S risk

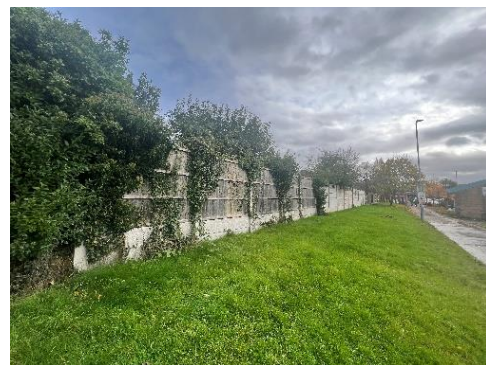
Figure: 12
General view of unsecured east boundary – H&S risk

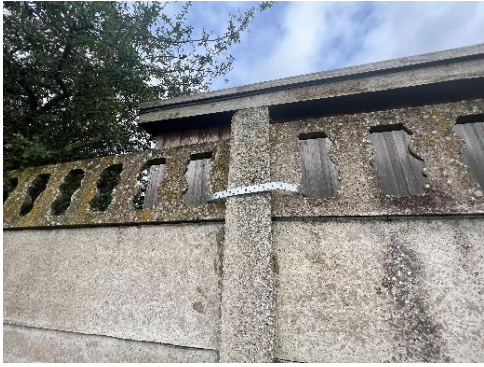
Figure: 13
Unsecure and unstable concrete panel fencing – H&S risk

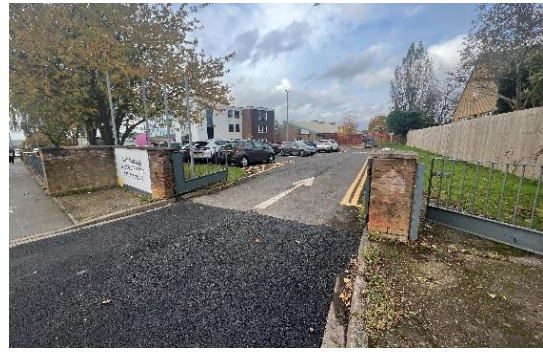
Figure: 14
Insufficient security fencing to main entrance leaves school at risk of intruders entering the site unknowingly – H&S risk

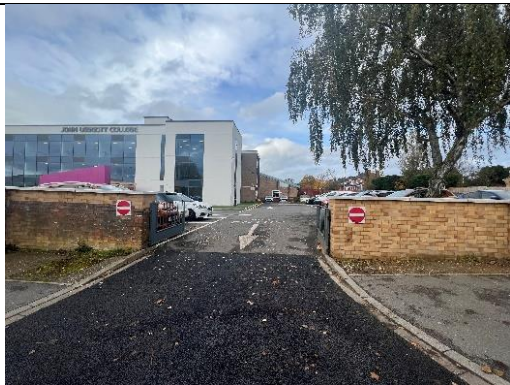
Figure: 15
Entrance gate provides inadequate security to school – H&S risk

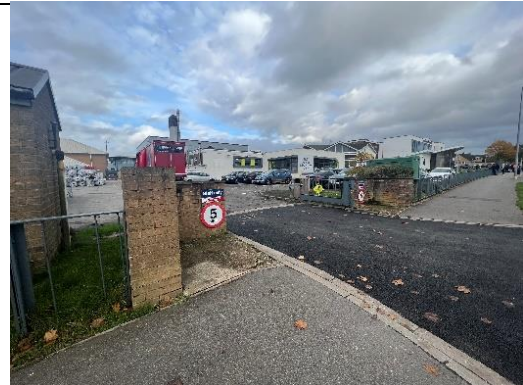
Figure: 16
Entrance gate and boundary wall/fence provides inadequate security to school - H&S risk

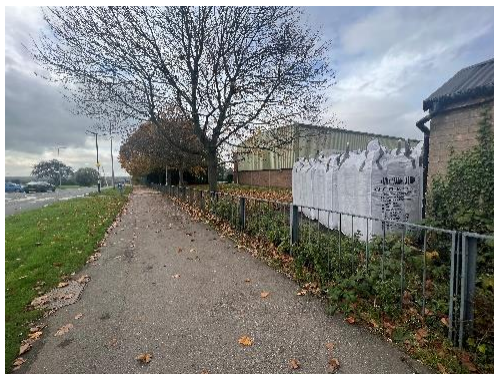
Figure: 17
Inadequate security fencing to site boundary leaves school at risk of intruders entering the site unknowingly – H&S risk

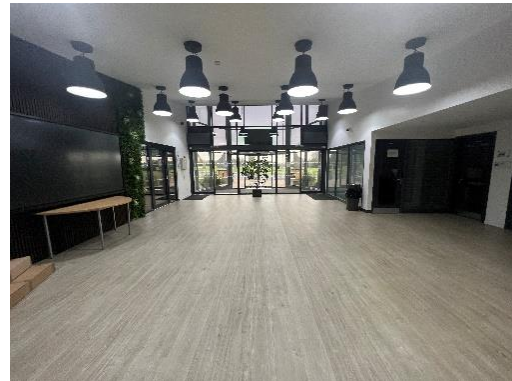
Figure: 18
Reception airlock with no segregation between reception / office staff and members of the public / intruders – H&S risk
