Safeguarding & Security Report

John Leggott Sixth Form College

**John Leggott Sixth
Form College
West Common Lane
Scunthorpe
DN17 1DS**

Date: October 2024

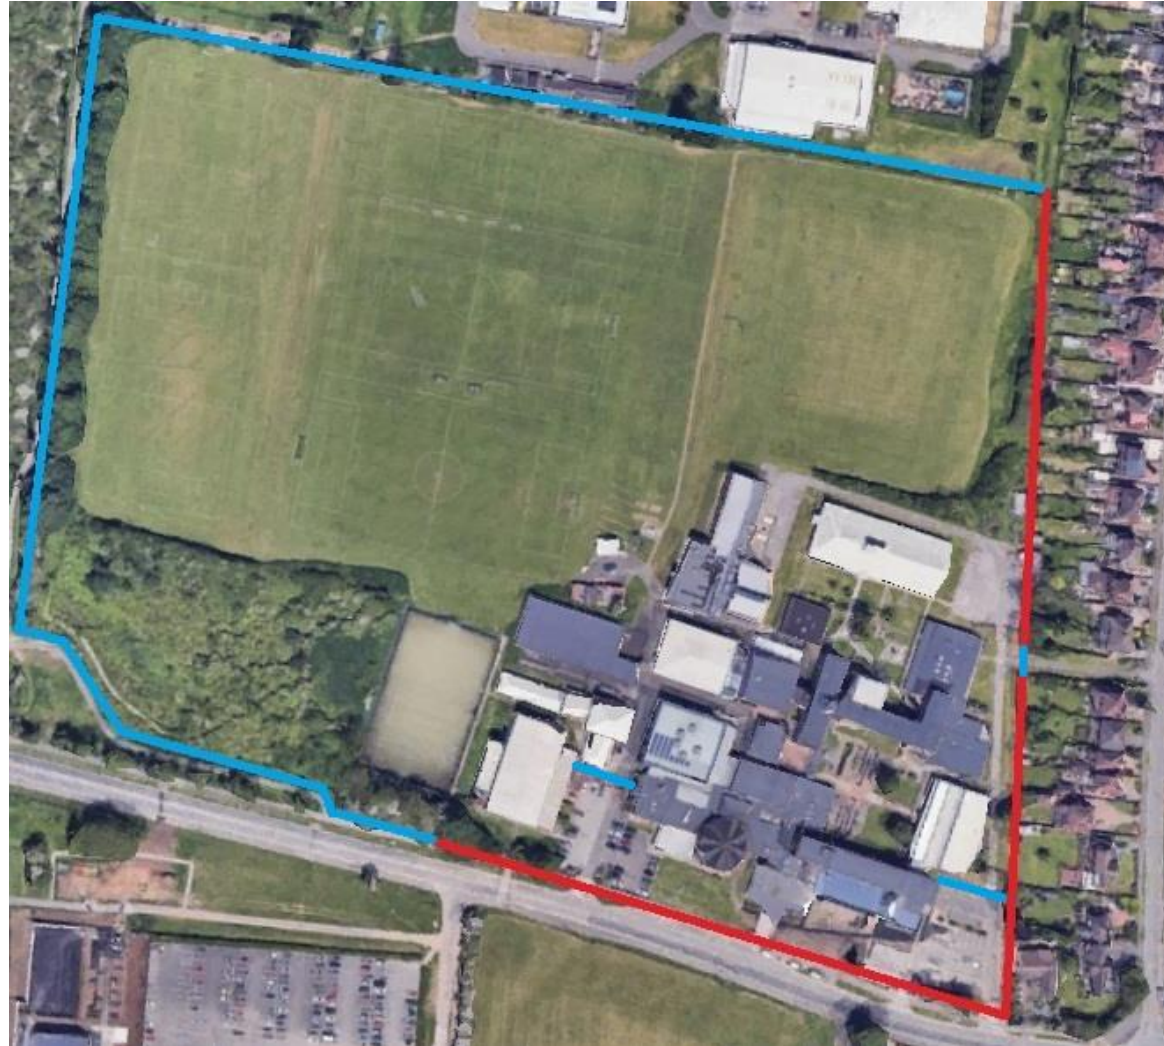
5. Site Plan

During our inspection, we noted that approx. 40% of the site boundary is not enclosed by suitable fencing.

To the east of the site, the boundary is defined by a mixture of bushes, chain link fencing, timber panel fencing and concrete panel fencing in which there are large holes and openings that **intruders could easily enter the site undetected.**

The north boundary of the site which encompasses the main pedestrian and vehicle entrance to the site is defined by low level metal railings and brick walls, which provides **limited protection from intruders entering the site and making their way into the school's main reception area or grounds.**

We would recommend that the site boundary is secured with new, 2.4m high paladin fencing, and automated vehicle gates with inclusion of CCTV monitoring, designated fobbed access and intercom system that comply with the Further Education Output Specification Technical Annex 2B: External Spaces and Grounds May 2023.
