Tree report

42 Holme Lane,
Bottesford,
North Lincolnshire.

Prepared by: Tree Generation on the 25th of August 2025
Date of Inspection: 21st of August 2025

A report on a single Horse chestnut growing within the grounds of the above property

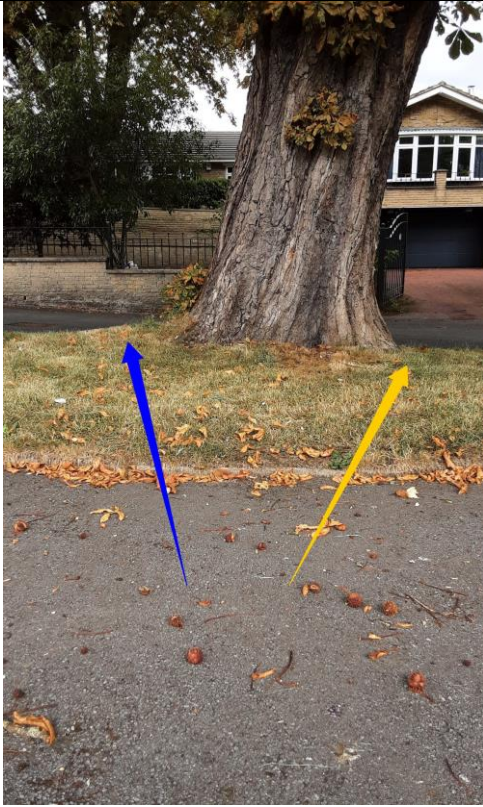
Root heave shown by the blue arrow west, and sunken ground yellow arrow east.

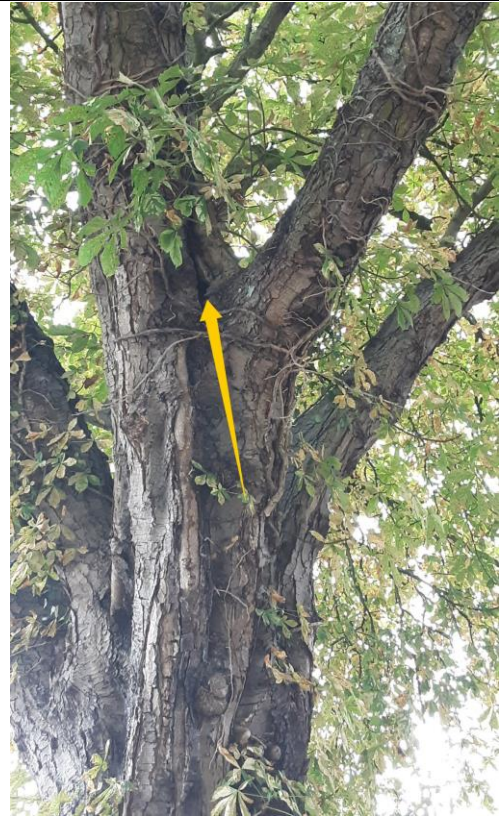
Cavity visible above the long lateral to the southeast and weak union.

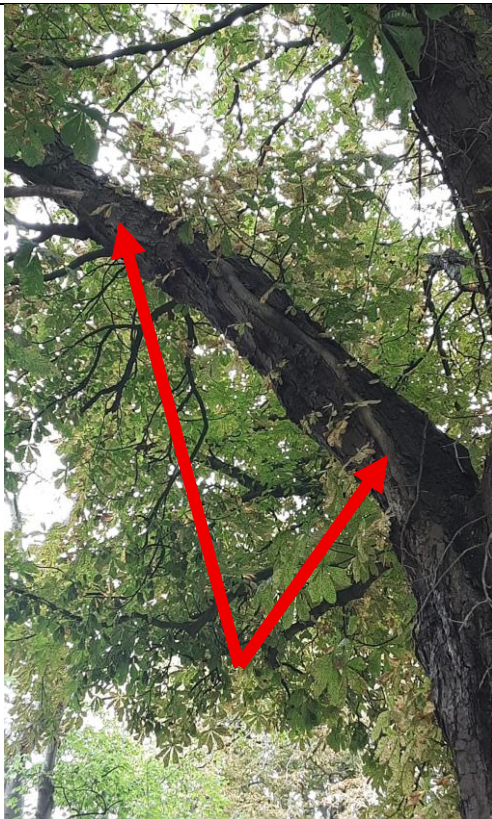
Rib and helical grain on the large lateral to the north over the road.

Reduce the lateral spread to the east and northeast by 3m to leave a finished length of 8.6m - measured from the main stem.

Reduce the lateral spread to the north by 2m to leave a finished length of 6.2m - measured from the main stem.

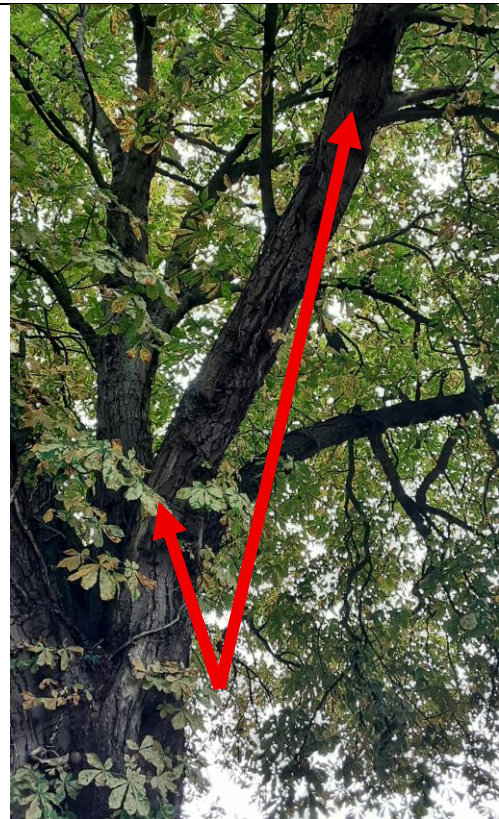
Rib on the north limb
