## **STRUCTURAL APPRAISAL**

**'Manor Farm',  
Church Lane,  
Cadney, Near Brigg,  
North Lincolnshire  
DN20 9HR**

# **SIMPKINS KENNY LTD**

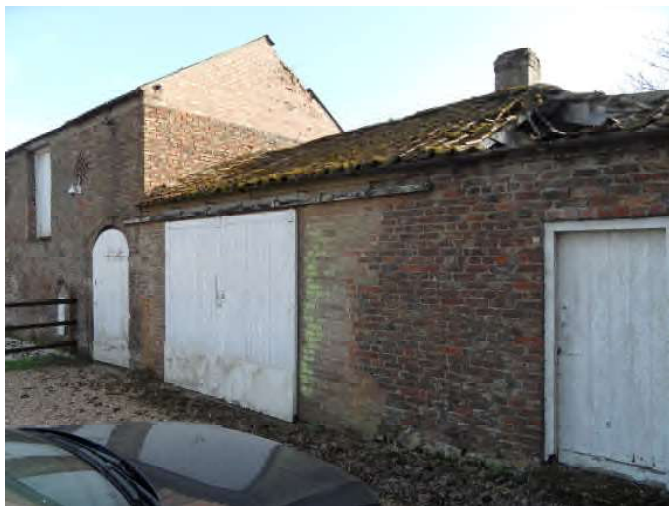
3.1.1 On the front (northern) elevation of the building (Plates 1 - 5) the roof had a corrugated asbestos cement sheet covering on the central two storey section and heavy moss growth was noted. The ridge line was slightly uneven and localised damage was noted adjacent to each gable. The cast iron rainwater goods were damaged and sections were missing. On the right hand single storey part of the building, the roof comprised clay pantiles that were distorted, broken and uneven. At the extreme right hand side of the building (hip roof section), the roof had partially collapsed (Plate 3). The clay pantile roof over the left hand single storey section was in poor visual condition. Tiling was also uneven and damaged in places and substantial vegetation growth was noted in the hip valley guttering (Plate 4). The brickwork was weathered and mortar loss was evident in the perpend and bed joints in several instances, especially at low level where dampness in the walls was also evident. On the right hand side of the building (single storey section), the brickwork was of varying type (and age); the garage area was seemingly a later infill. Above the left hand side of the door accessing Room 2 (refer to appendix 2 for a layout plan), there was a left to right 3-4mm wide 'stepped' diagonal crack, propagating up to eaves level (and the area of collapsed roof over); this appeared to have longstanding origins. Over the Garage door the steel runner (visible in Plate 1) was noted to be corroded. On the central two storey barn section (Plate 3) the wooden door at first floor level was noted to have flaking paint finishes and the timber sill was rot affected. The paint finishes on both the large and small door at ground floor level were also flaking. Localised damage was noted within the diamond brickwork feature above the low level small door position and to the left of the central window position. Some historical mortar re-pointing was noted; this had not significantly re-cracked. The remaining area of wall on the central part of the building were in seemingly good visual condition, there was no obvious signs of distortion around the pattress plate positions and no evidence of any further structurally significant cracking or distortion. The timber door to the Stable area had been repaired over the years but remained in a visibly poor condition and the timber lintel was rotten at the right hand bearing position. Below the sill of the window to the left of the Stable door, there was a 4-5mm wide 'stepped' diagonal crack that returned on itself, before diminishing in width to 1mm at low level. Above the same window opening, there was a further 'stepped' crack (through the mortar perpend and bed joints). This was assessed as being 8mm wide at the window head, reducing to 3mm as it propagated up to the roof slope over. The timber shutter on the window to the left

Plate 1 Northern elevation of the barn complex (western side).

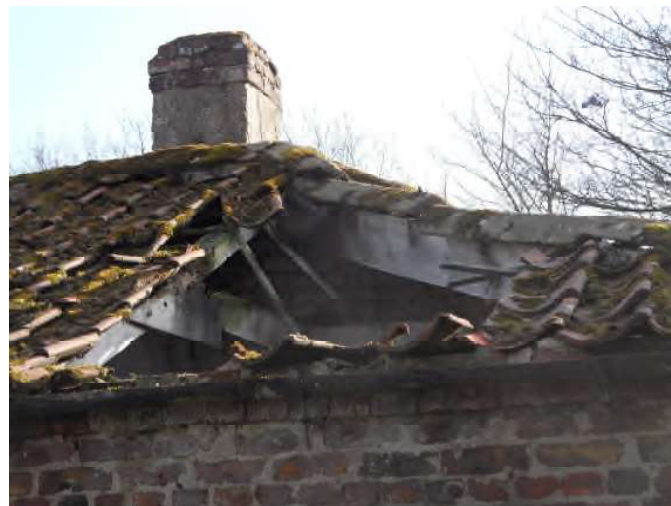
- 3.2.2 Inspection of Room 2 on the front western side of the building (Plates 17 and 18) revealed a collapsed area of roof beyond the hip over the northern section and the extent of tiling seemingly precariously supported on a partial damaged and rotten roof structure. The rendered wall finishes were perished, particularly at low level, where the ingress of damp had occurred over the years, with heavy mildew growth noted also. Where repairs had been made to the rendering at low level and around the door position, this too had deteriorated and re-cracked over time. The concrete floor slab, where visible, contained historical cracking. On the north wall (visible in Plate 18), there was a 2mm wide historical crack adjacent to the right hand top corner of the door opening and there was a second 1-2mm wide crack below this. On the east wall, there was a 2-3mm wide diagonal crack (possibly relating to historical racking effects) to the left of the door position (accessing the Garage). There was crazed cracking in the finishes above the door head. On the south wall there was a 2-3mm wide diagonal longstanding crack that propagate from the right hand top corner (shared with the west wall). On the west wall there was a 2mm wide mainly horizontal crack over the window position and a pair of 3-4mm wide diagonal cracks travelling from the bottom right hand corner of the window reveal (visible in Plate 17). Areas of missing/partially repaired plaster finishes were noted at low level.

Plate 2 Collapsed roof over Room 2.

- 4.6 The roof to the barn will have to be re-constructed (possibly re-utilising the existing roof timbers – see item 4.6 below) due to a lack of weather tightness and indeed extensive observed damage to the existing roof tiling and in the case of the central barn, the replacement of the corrugated sheeting. Structural capacity checks would need to be undertaken, if there were to be a significant increase in the weight of the roof. The new roof should incorporate sarking felt and insulation materials compatible with the latest building regulations recommendations. The internal division walls will need to be locally rebuilt at high level and robustly strapped to the external walls to inhibit possible future cracking at these interfaces. All walls, as a matter of course, should be securely tied to the roof rafters and new first floor members via 30 x 5 x 1200 (min) galvanised straps at approximately 1500mm centres. This in turn would render the external patters plates as being effectively decorative in nature only (if retained).

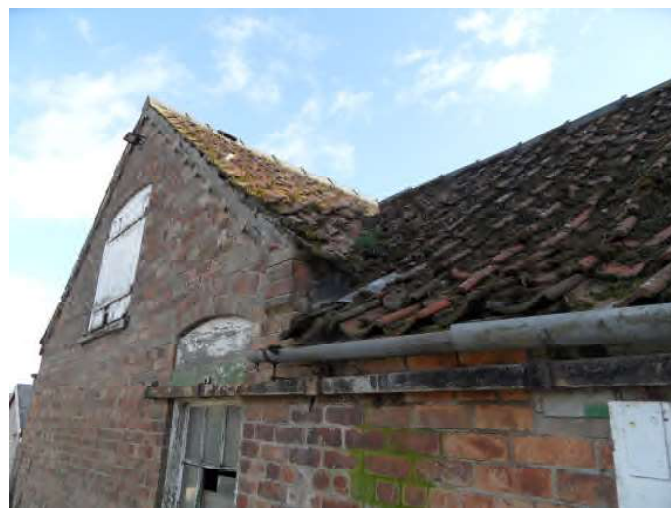
Plate 4 Uneven roof tiling around valley between the Stable and Room 3.

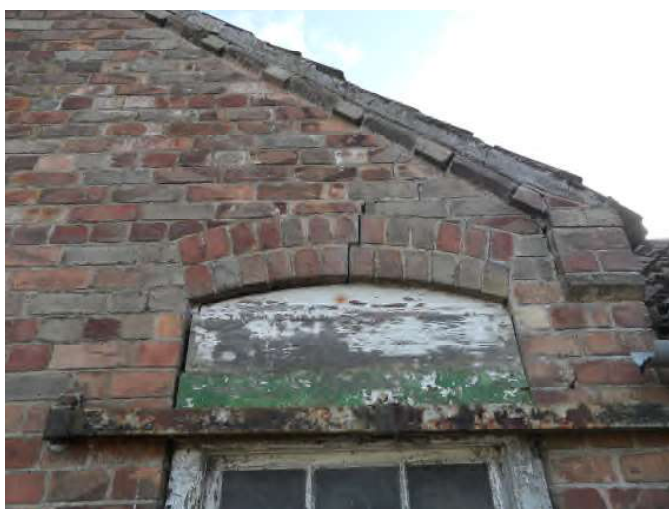
Plate 5 Cracking above the right hand window (Room 3).

- 4.5 For those cracks identified as being in excess of 2-3mm in width, we recommend that these should be stitched using proprietary resin injected repair ties (e.g. 'helibars'), prior to any decoration work. The observed cracking elsewhere within the building is in our opinion of lesser importance and is also essentially of an historical nature and would only be classified in the BRE Digest 251 (Assessment of damage in low-rise buildings) as category 1 or 2 (very slight to slight) and therefore aesthetic in nature. Consideration should therefore be given to cosmetic repair only, for such items (and lintel replacement with localised rebuilding as necessary in the worst cases). Timber wall inclusions and timber lintels (with the possible exception of the large 'feature' beams) over the door and window openings were noted. Independent of the need for replacement of the latter under perceived strength shortfalls or rot/insect attack, they should be removed as part of the refurbishment of the property where possible. If they were to be retained internally and simply plastered over, then introduction of heating into the new dwelling could lead to thermal volumetric change, which would in turn damage the new decorations.

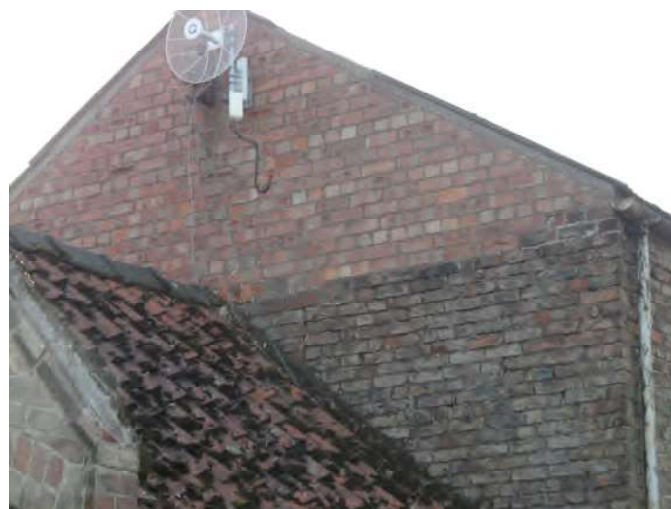
- 3.1.2 On the eastern elevation of the two storey part of the building (Plates 6 and 9), the original brickwork at lower level was weathered with some erosion noted in the mortar joints, but there were no obvious signs of structurally significant defect. In the upper section, newer brickwork had been used to form the gable wall. Again there was surface weathering, but there were no obvious signs of structurally significant cracking or distortion. On the end elevation of the single storey part of the building (Plate 7), there was a 2-3mm wide central crack that diminished to hairline in width as it propagated further down the wall. Outward distortion and localised damage in the brickwork was also noted at high level, which appeared to be symptomatic of historical roof spread effects. Further, slight misalignment of the wall, overrunning the damp proof course (dpc) at low level, was noted. No further structurally significant cracking was noted in this wall elevation. Settlement was noted in the plane of the clay pantiles over (which correlated with the observed outward movement in the wall) and there was tile damage at the left hand edge of the roof (as viewed).

Plate 6 Eastern elevation of the Main Barn (First floor level).

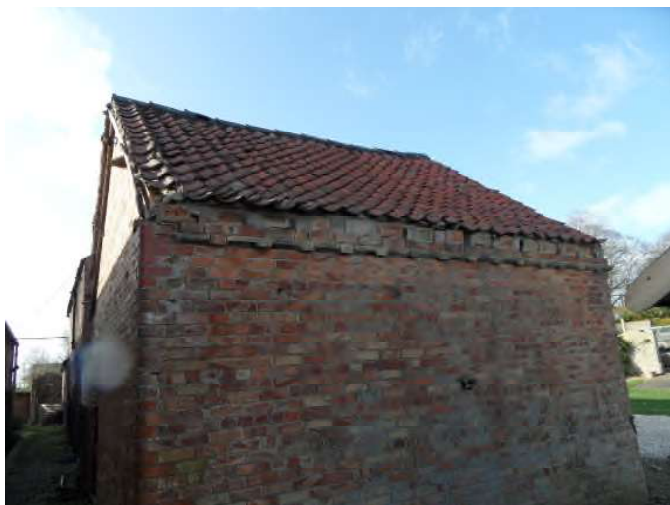
Plate 7 Eastern elevation of the building (forming Room 3).

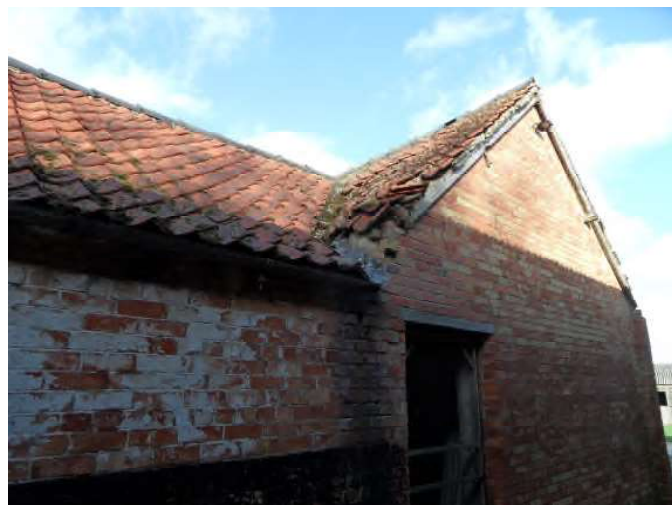
- 3.1.3 Inspection of the rear (southern) elevation of the barn (visible in Plates 8 - 11) again revealed stained and weathered brickwork that appeared to be in reasonable overall condition (particularly bearing in mind the age of the building). In Plate 10, it can be seen the block paved path had heavy moss growth (seemingly exacerbated by the shadowing effect of the adjacent building), undulated and had rotated away from the building over the years. The retaining wall behind, however, did not exhibit any obvious signs of structurally significant distress. At the eastern end of the building the timber roof fascia members all exhibited signs of rot. The leading edges of the roof tiling were again noted to be loose and damaged (as referred to above) and at the pier interface on the right hand side of the building (as viewed), there was a 1mm wide longstanding vertical separation crack. Remnants of past paint finishes and a black band to dado height (presumably a past damp prevention measure) were noted (Plates 10 and 11), but again despite being weathered, the brickwork in the central building section appeared to be in relatively good visual condition. The cast iron rainwater goods were damaged in several instances on the western single storey part of the building (Plate 11) and the clay pantile roof over, contained areas of loose tiles and localised damage; indeed a distinct slope in the roof line was noted between the chimney stack position and the interface with the two storey building. In this single storey section, the brickwork was more heavily eroded and some of the individual

Plate 8 South elevation of the building complex (eastern end).

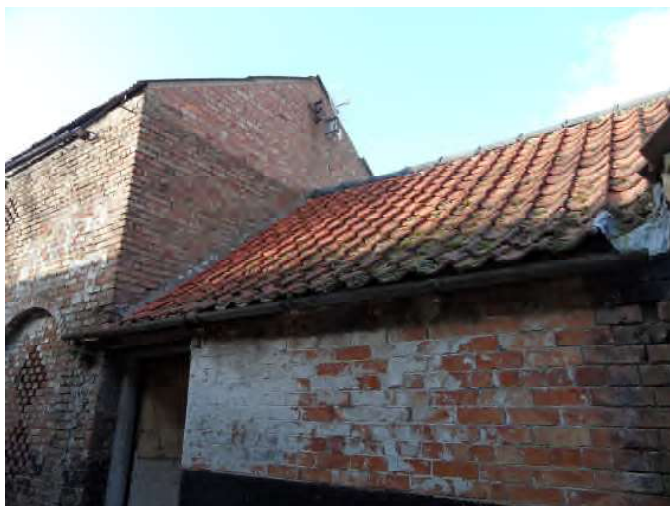
Plate 9 South eastern corner of the Main Barn.

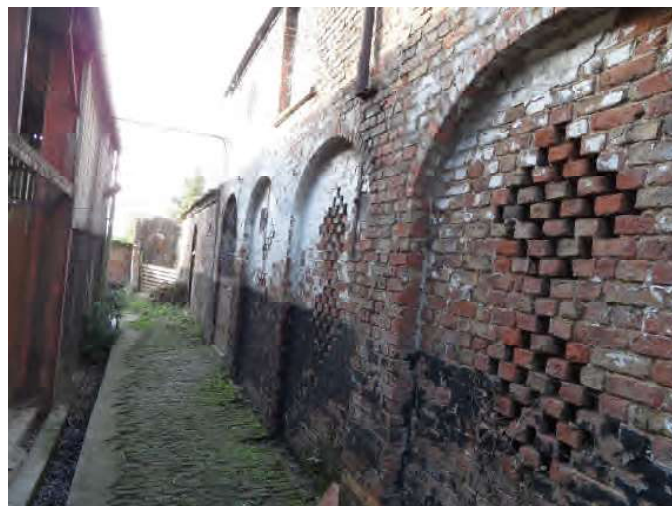
Plate 10 Feature arches on the south elevation of the Main Barn.

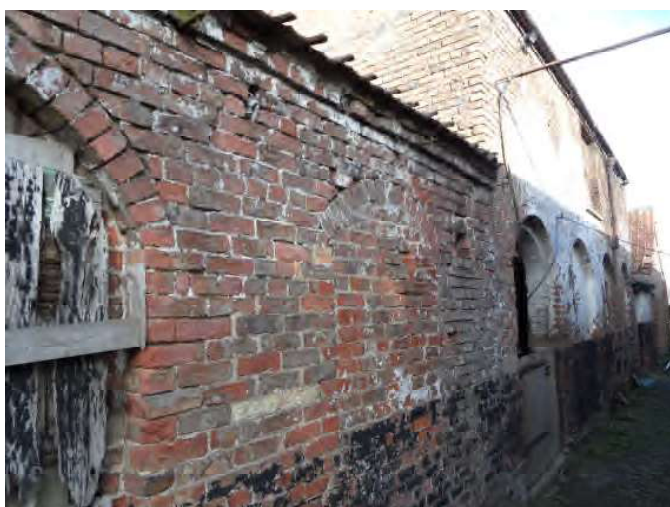
brick units appeared to be 'friable' and had succumbed to heavy erosion. Damaged brickwork was also apparent on the corner of the building. The timber 'stable-type' door paint finishes were flaking and in several instances to underlying timbers appeared to be rotten. To the right of the infilled door position, there was an outward bulge in the plane of the wall (Plate 11), but any discernible crack pattern was difficult to identify in the weathered brickwork.

Plate 11 Plate 8 South elevation of the building complex (western end).

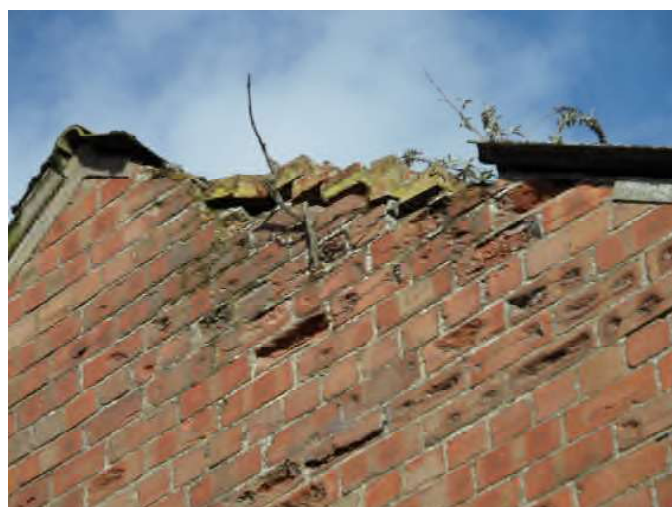
- 3.1.4 Inspection of the western side elevation of the two storey part of the building (Plate 12) also revealed brickwork, although weathered, in relatively good condition, but below the southern roof slope in the newer section of brickwork some of the individual brick unit faces were heavily eroded. The roof was damaged at this position and some individual bricks appeared to be loose and vegetation growth was apparent. On the west elevation of the single storey building (Plates 13 and 14), the partial collapse of this section of the clay pantile roof was again apparent and vegetation growth was noted at the eaves level. Above the window on the left hand side of the building the soldier coursing had slipped and there was a 2-3mm wide crack that propagated up towards the eaves (Plate 14). This cracking had propagated through past mortar re-pointing (although these repairs were themselves weathered and longstanding). An outward bulge in the wall was noted within the infilled door position, but the re-pointed brickwork showed no obvious signs of significant re-cracking, suggesting that the movement was historical and not significantly progressive in nature. Above the door arch (accessing Room 1), there was a 4-5mm wide longstanding vertical crack. The historical re-pointed mortar had, however re-cracked at this position. There was an area of heavier mortar loss to the left of the door position, but there were no further obvious signs of structurally significant distress or distortion.

Plate 12 Damaged brickwork on the south western roof slope interface on the Main Barn.

- 4.4 Extensive external re-pointing of brickwork, to ensure the future weather-tightness of the building will be naturally required as part of the refurbishment.

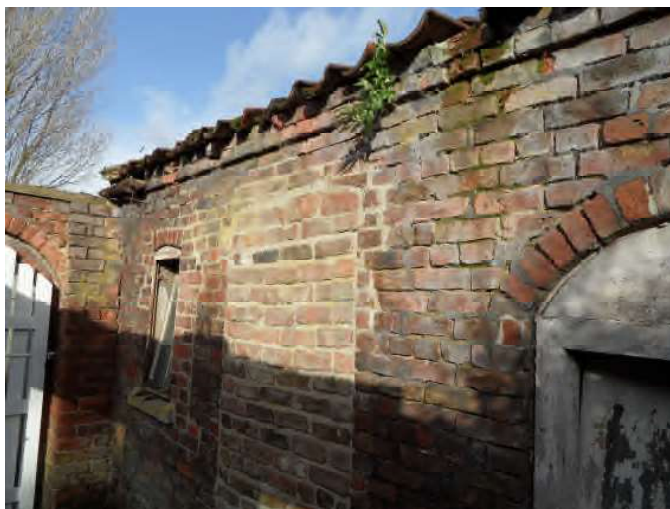
Plate 13 Western elevation of the barn complex (comprising Rooms 1 & 2).

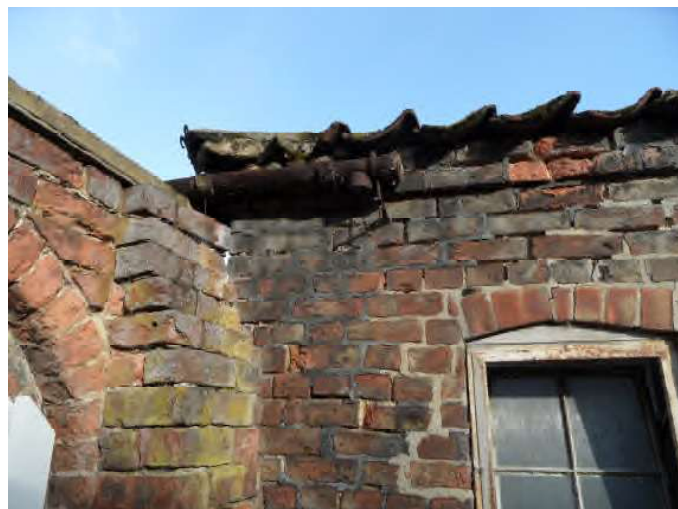
Plate 14 Cracking over west elevation window opening.

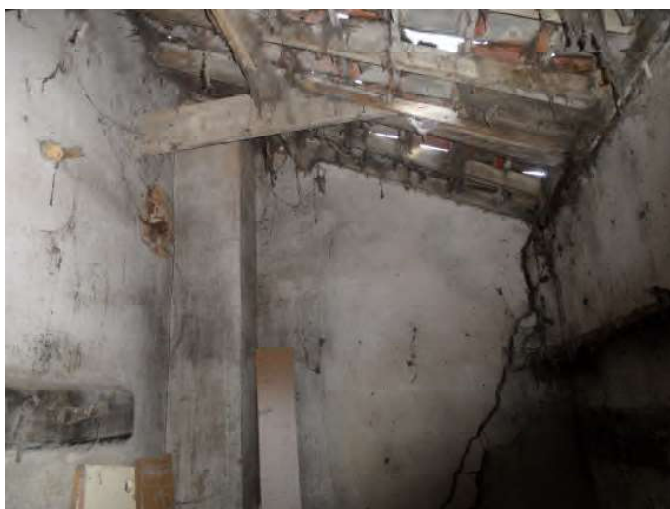
- 3.2.1 Inspection of Room 1 on the rear western side of the building (Plate 15) revealed daylight visible within the clay pantile roof. The room was in a derelict condition with the rendered wall finishes perished (particularly at low level). The traditional roof timbers were also noted to be distorted and seemingly rot affected in places. The concrete floor slab was not clearly visible due to surface material. In the eastern wall, there was a substantial crack (Plate 16) that appeared to be symptomatic of outward rotational movement in the building structure at this point. Whilst the cracking appeared to have longstanding origins, the width of the fissure was noted to be some 20mm at high level. On the western wall, there was a longstanding 10mm wide crack above the right hand side of the door reveal and a further 4mm wide diagonal crack above the left hand side. Plaster repairs had been undertaken to the right side of this crack, but these were also seemingly historical and in poor visual condition. The timber door itself was rot affected and in poor condition. On the south wall there was a 3-4mm wide diagonal crack that propagated up to the interface with the western wall, plaster was missing in patches along the line of this crack. On the north wall, there was a 5-6mm wide diagonal crack that propagated from the left hand top corner of the room down to a central position at low level.

Plate 15 Compromised roof within Room 1.

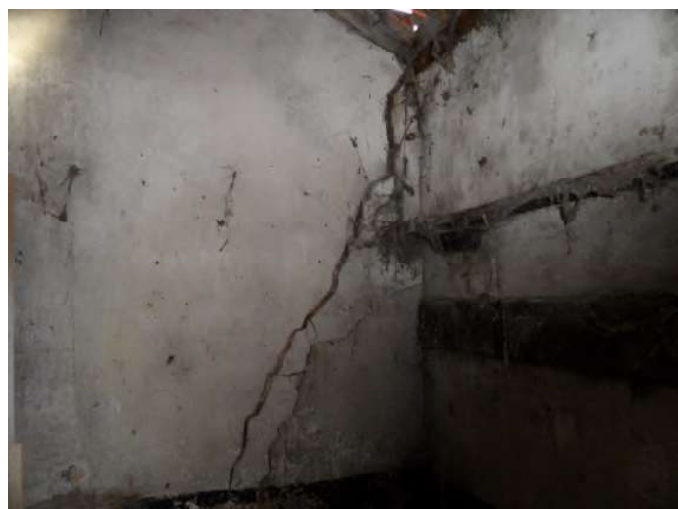
- 4.2 With reference to the points raised in section 3.0, we are of the opinion that there has been some past rotational movement in the building. This was seemingly associated with lack of adequate tie provision and evidenced by the presence of pattress plates at first floor level and the cracking at the interfaces of the internal walls with the external walls, particularly within the western single storey parts of the building, where dilapidation was at its worst. Indeed in the part of the building it was felt that the level of rotational movement had contributed to the partial collapse of the roof. Due to the extent of observed degradation in this side of the building and the fact that once the roof has been removed there will be relatively little structure remaining, consideration should be given to demolition/rebuilding in this area (re-utilising existing materials where possible). This would allow for new construction on appropriate foundations and avoid the need for underpinning and extensive repairs to already dilapidated walls. The movement generally, however, appears ostensibly to be of historical origins. For the remainder of the building (and subject to the recommendations below), the walls will need to be effectively tied to the new or retained construction, thus introducing the necessary stability and inhibit the potential for the rotational movement that has been experienced in the past.

Plate 16 Rotational cracking on the eastern wall within Room 1.

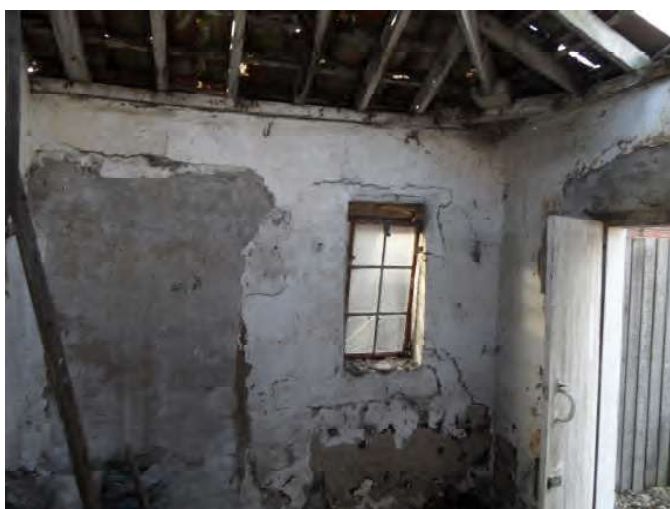
Plate 17 North eastern corner of Room 2.

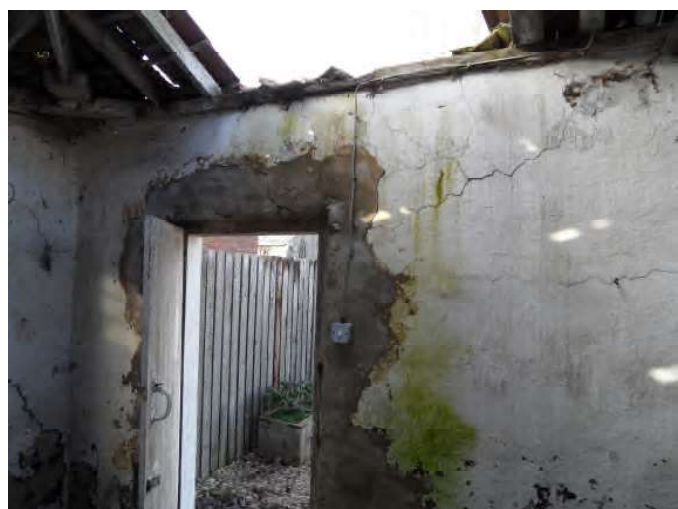
Plate 18 Missing section of roof and perished plaster walls within Room 2.

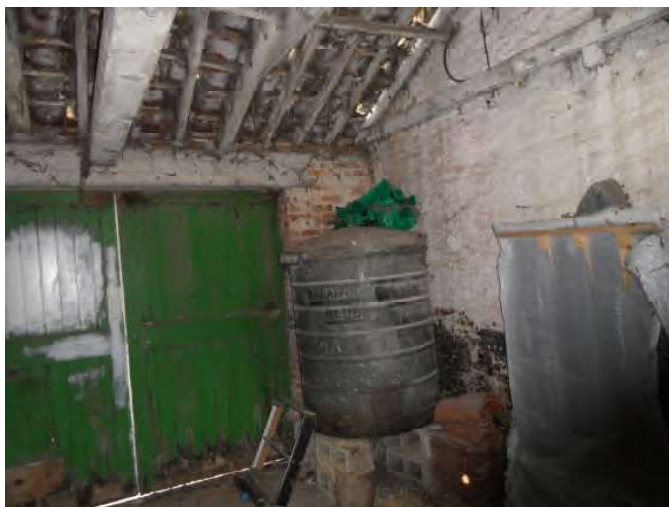
- 3.2.3 Inspection of the Garage area on the western side of the building (Plate 19) revealed painted walls and a concrete floor that was uneven in places. Daylight was again visible in the joints between the loose clay tiles. The timber roof truss construction was of varying type and there were visual signs of rot. The timber purlins were relatively lightweight and had distorted under the weight of the roof. The western wall, with a deteriorated black paint band at low level, was seemingly free from obvious structurally significant cracking or distortion. On the south wall the timber lintel over the window contained shakes and appeared to have deteriorated under the effects of rot. There was a 1.0mm wide diagonal crack in the wall above this position, but the remaining wall elevation, was free from any signs of structurally significant distress. On the eastern wall (Plate 20), there was a 20-25mm wide crack at the interface with the south wall that propagated into the building. This was indicative of historical outward rotational movement in the building. There was a light timber lintel above the central door position and a 1-2 mm wide horizontal (again longstanding) crack was noted in the brickwork over. To the right of the doorway (as viewed) there was a 3mm wide 'stepped' diagonal crack that travelled towards the north wall interface. A substantial timber beam formed the lintel over the large opening on the north wall (visible in Plate 19). This in turn supported the principal tie member. The condition of these timbers was generally seemingly reasonable although there was some surface deterioration. There were no obvious signs of structurally significant cracking or distortion in the sections of exposed brickwork wall to each side of the main door, but flaking paint and onset of rot was noted in the wooden door.

Plate 19 Dampness within the timber floor members in the smaller ground floor Garage area.

- 4.7 It is our belief that a specialist timber consultant should be appointed to examine the current condition of the roof and floor timbers, wall plates and other timber inclusions in order to ascertain the need for repairs or remedial work as necessary. The roof timbers in particular have obviously been exposed to the elements over the years and are likely to have suffered to various extents (but will need to be replaced in several instances due to obvious visible damage). The effects of rot, fungal or insect infestation will naturally have a weakening effect on the structural members. It is also highly likely that window framing (as appropriate) will have to be replaced, although specific advice on this matter is outside the scope of this particular report.

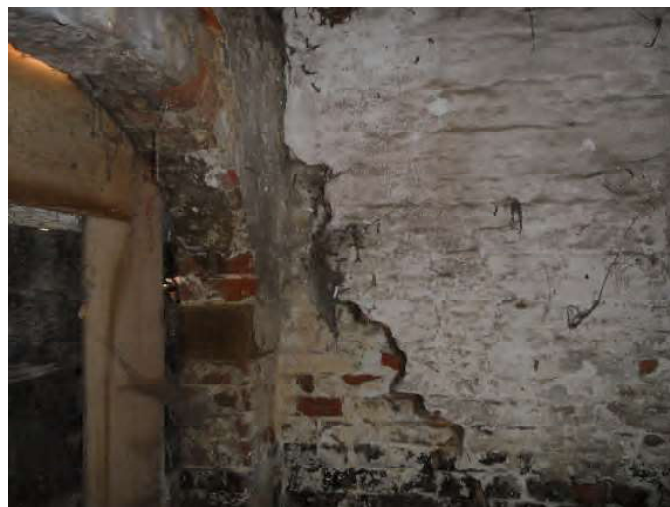
Plate 20 Eastern wall within the ground floor Garage area.

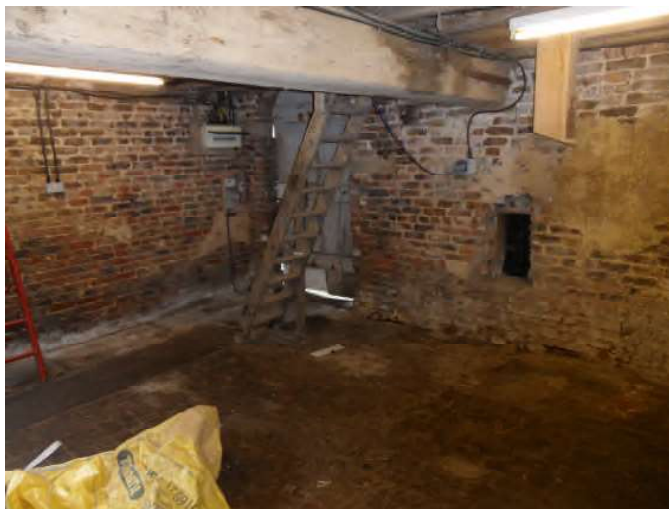
- 3.2.4 Inspection of the main central barn at ground floor (Plates 21 and 22) revealed timber flooring members over, which again had surface dampness evident, but were in reasonable visual condition. There were no obvious signs of structurally significant cracking in the brickwork (essentially exposed but with the occasional legacy of past render/plaster finishes) walls. Some mortar was missing from joints occasionally, but the overall visual condition was good. The floor was mainly of brick paver construction although a substantial area had been excavated. A significant slope in the floor (some 200mm towards the eastern end of the building) was noted, but this was believed to be by design for practical 'washing out' purposes, rather than building movement. The timber floor joists were supported by a pair of substantial cross beam members, that were effectively also acting as a building tie as they were 'strapped' at each end to external patters plates. Some surface dampness and insect borings were noted in these members.

Plate 21 North eastern corner of the Main Barn (dampness noted in principal timber adjacent to the pattach plate strap).

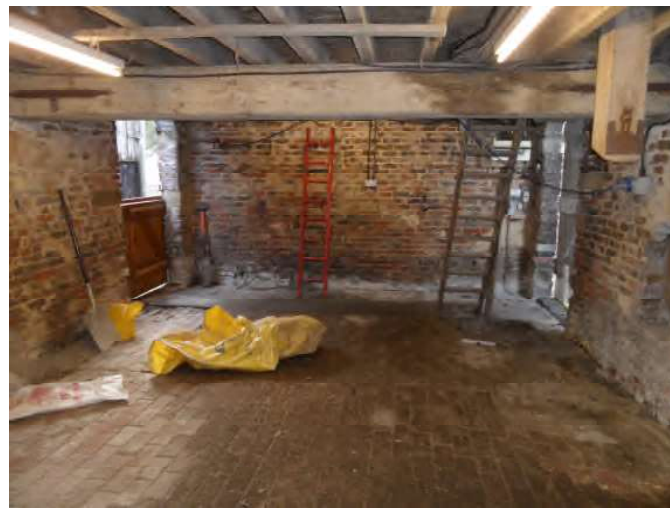
Plate 22 Main ground floor barn area (looking east).

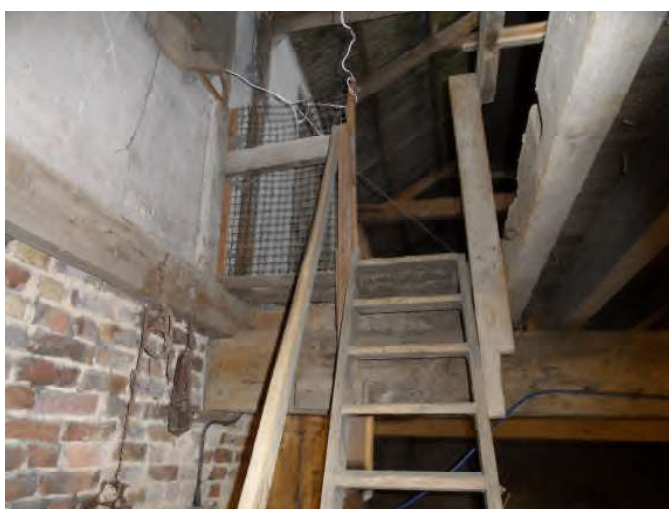
Plate 23 Ship ladder access to the first floor storage area.

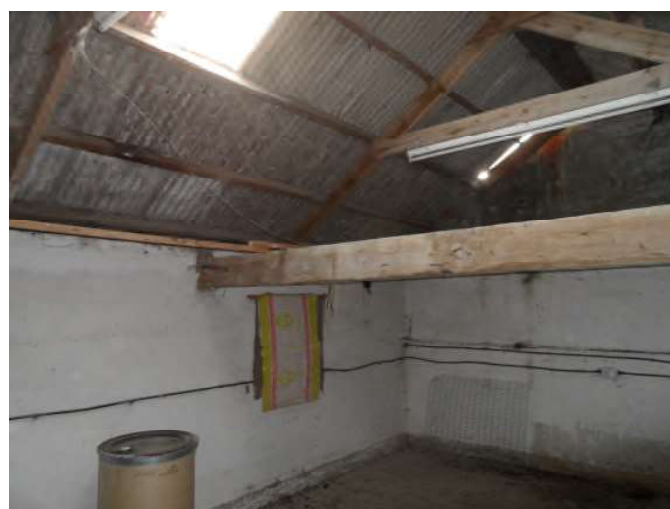
- 3.2.7 First Floor
- The main central barn building at first floor level (accessed via a ships ladder (Plate 23)) had a traditional timber roof (visible in Plate 24) comprising asbestos cement sheeting carried on purlins; all supported on a collared trusses, with principal tie members crossing the room. Between the sheeting joints, daylight was visible in some instances. Whilst the condition of the principal timber members was seemingly sound, there was dampness and rot evident (and indeed signs of past insect infestation). The plastered walls were again in reasonable condition, with no obvious signs of structurally significant cracking, although the plaster finishes were missing or perished just above the floor level on the north wall. There was a 1mm wide vertical crack below the left hand tie beam position and slight outward rotational movement in the brick walls were noted at high level. An outward bulge was also noted in the south wall, but there were no further sign of obvious structurally significant distress. The floor timbers appeared to be in reasonable condition, although there was one area of localised deterioration (seemingly from bird dropping build up) – Plate 25.

Plate 24 Roof construction over the first floor of the Main Barn.

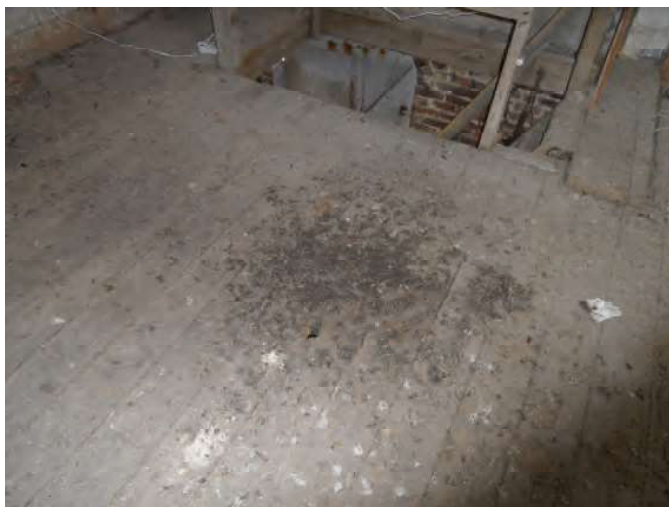
Plate 25 Damaged floor timbers (seemingly associated with bird droppings).

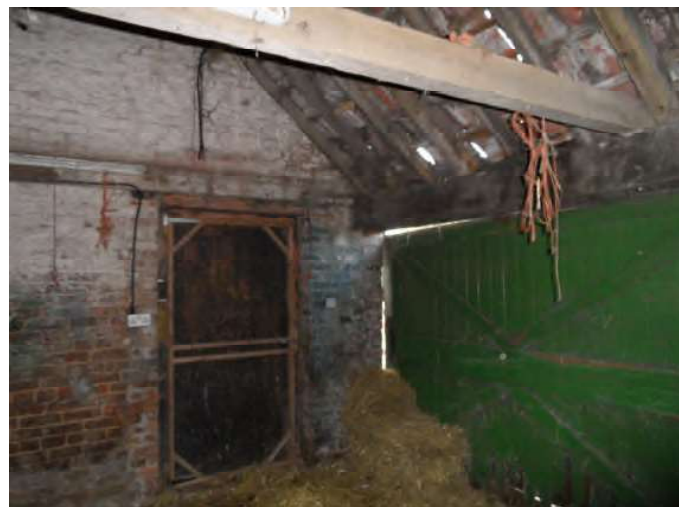
- 3.2.5 Inspection of the Stable on the eastern side of the building (Plate 26) again revealed a compromised roof construction with daylight visible between loose roof tiles. The rafters also appeared to have 'racked' in an easterly direction over the years. The traditional timber roof members appeared to be rot affected in several instances. Viewing of the concrete floor was made difficult by the presence of straw, but whilst uneven, there did not appear to be any significant undulations. The masonry paint on the exposed brickwork walls had worn away over the years. There were, however, no obvious signs of structurally significant cracking or distortion in the walls.

Plate 26 North eastern corner of the Stable.

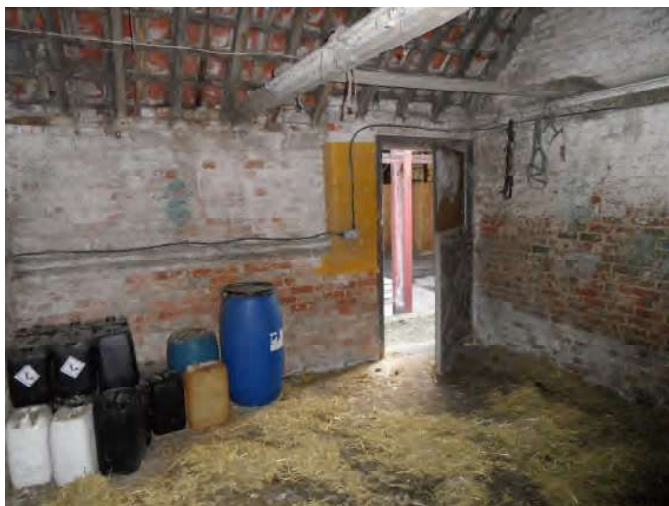
Plate 27 North western corner of the Stable.

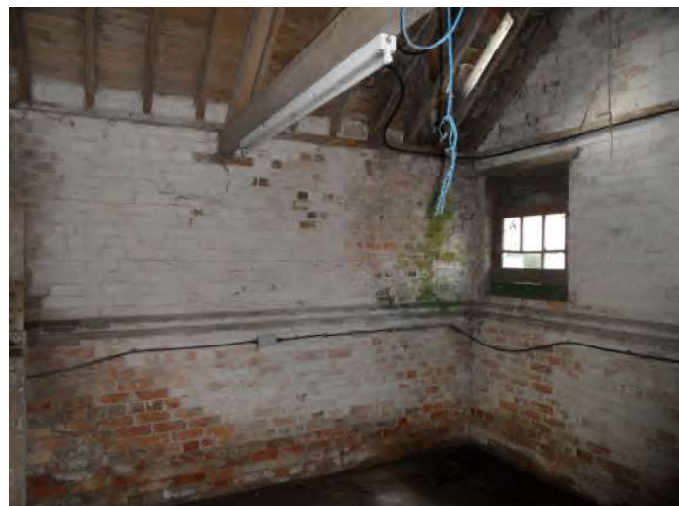
- 3.2.6 In Room 3 on the farthest eastern side of the building (Plates 28 - 30) daylight was again visible through the clay pantile roof in several instances. The battens appeared to be rotten, but the rafters and indeed the principal king post roof truss (visible in Plate 30) appeared to be in reasonable visual condition (this should of course be verified by a timber specialist where re-use is proposed). In the west wall, at the junction with the south wall, there was a 10-12mm wide longstanding diagonal crack at high level (Plate 29) and a further downwardly propagating crack (assessed as 3mm in width) extending into the building. On the eastern wall there was a 2-3mm historical horizontal crack at high level, with some outward movement in the masonry adjacent to the roof line (correlating with the external observations. The remaining walls appeared to be in reasonable visual condition from a structural perspective, with no further obvious signs of structurally significant cracking or distortion evident.

Plate 28 North eastern corner of Room 3.

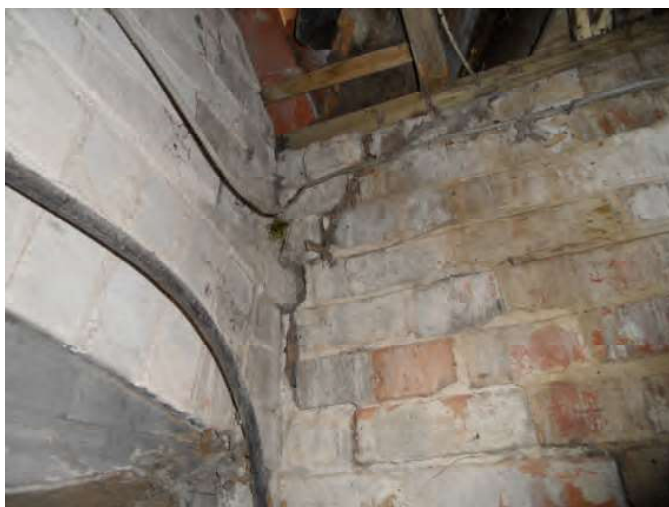
Plate 29 Cracking at high level in the south western corner of Room 3.

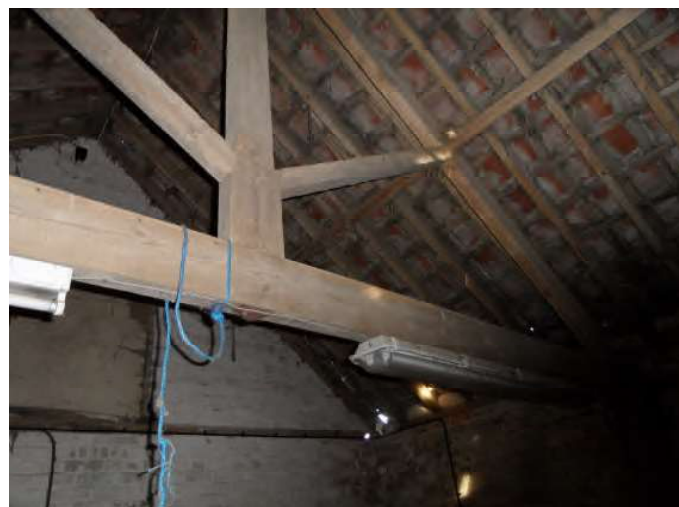
Plate 30 Principal Roof truss in Room 3. Daylight visible sporadically within roof tiling.
