**PRE-DEVELOPMENT ARBORICULTURAL
IMPACT APPRAISAL
AND REPORT**

**“APPLEGATE HOUSE”
50 HOLYDYKE
BARTON UPON HUMBER
DN18 5PP**

WIDER OPTIONS LTD

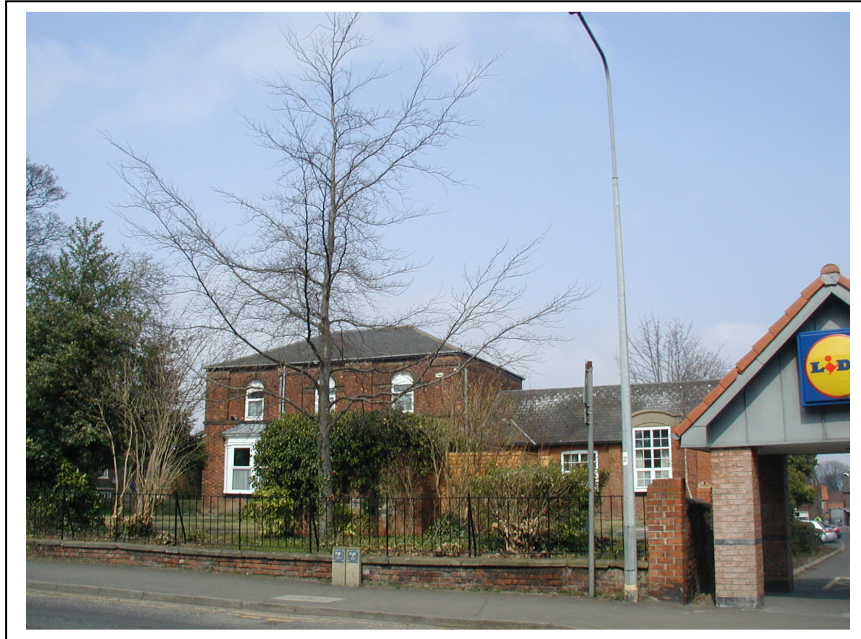
Picture 1

3.4.2 The crown habit of the beech is unusually open. Its branch formations are long and stringy with large gaps between them (see Appendix D, Picture 1). Some pruning is required to lift the crown above the access and remove the weak fork union. By reducing the lateral branch length of the lower crown by 2m and creating a conical profile, the loss of root will be mitigated and the tree's appearance improved. The pruning will also stimulate renewed vigour during the growing season.

Beech T1 stands left of centre. The position of the proposed access is located between the tree and the street lamp column.

Tree No	Species	Age Class	Condition	Height (m)	Crown Spread (m)	DBH (mm)	Root Protect Radius (m)	Remarks / Recommendations	Retn Code
T1	Beech <i>Fagus sylvatica</i>	SM/ EM	Phys Good/Fair Struct Good/Fair	10	N - 3.5 S - 5 E - 4 W - 4	231	4.0	Sound root collar with no prominent buttresses. Single, sound and erect trunk extends to leading shoot with no deviation. Cluster of epicormic shoots on E face at 0.75m and light ivy to 1.5m. Crown begins at 2.5m above garden level, with descending tips to 1.5m to E. Branches all sound with long, extended habit forming large gaps between. Narrow fork union at 6m where secondary branch grows to N. Leading shoot has died back in recent years by 1m but no other dead wood present in remaining crown. Occasional minor crossing branches. Retain tree. Lift lower crown to 3.5m above proposed entrance (4.0m above street level) and balance all round. Reduce remaining lateral branches by 2m in lower half of crown and reshape to a conical profile in to leading shoot. Remove dead tip. Remove narrow fork structure at 6m on northern quarter of crown and clean out any remaining crossing branches.	B1

- 4 Appoint competent, trained arboricultural contractors to carry out pruning works to beech T1 as per schedule in Appendix A and remove arisings offsite.

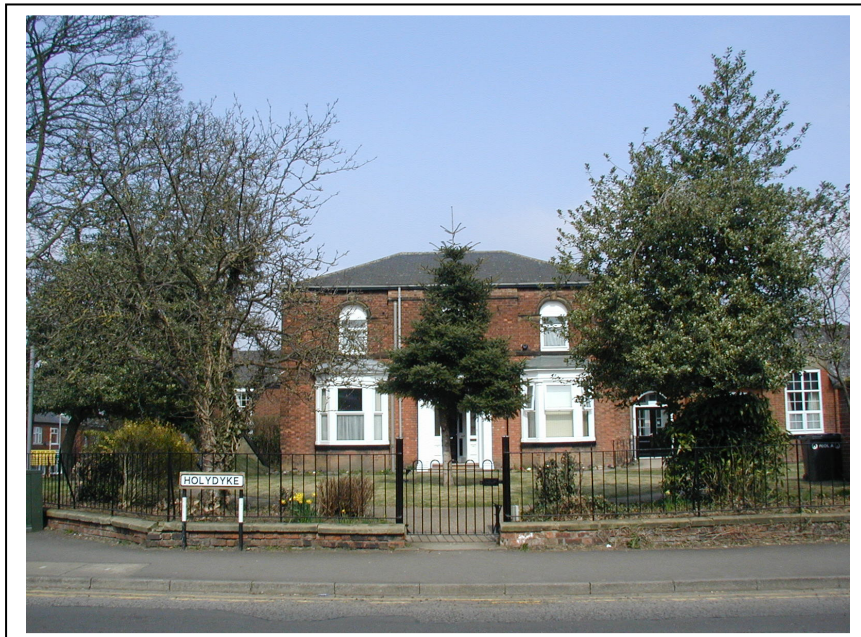
Picture 2

A general view of the frontage with Greek fir T5 in the centre.

T5	Greek fir <i>Abies cephalonica</i>	SM/ EM	Phys Good Struct Good/Fair	7	N - 2 S - 2 E - 2 W - 2	200	2.4	Sound root collar with no prominent buttresses in circular bed. Sound, single, tapered trunk with sub-standard pruning stubs at 2m. Crown begins at 2.2m and descends to 1.6m to E. Trunk kinks at 3m then regains vertical habit right to leading shoot tip. Vigorous extension growth in leader to 400mm and well furnished crown all round making incremental growth to 150mm. Very healthy, rich green foliage all round crown. Very attractive tree despite minor imperfections in terms of shape. Retain tree. Clean out old pruning stubs on trunk at 2m. Lower crown to the eastern quarter may be lightly lifted to balance it with the remaining crown if desired.	B1

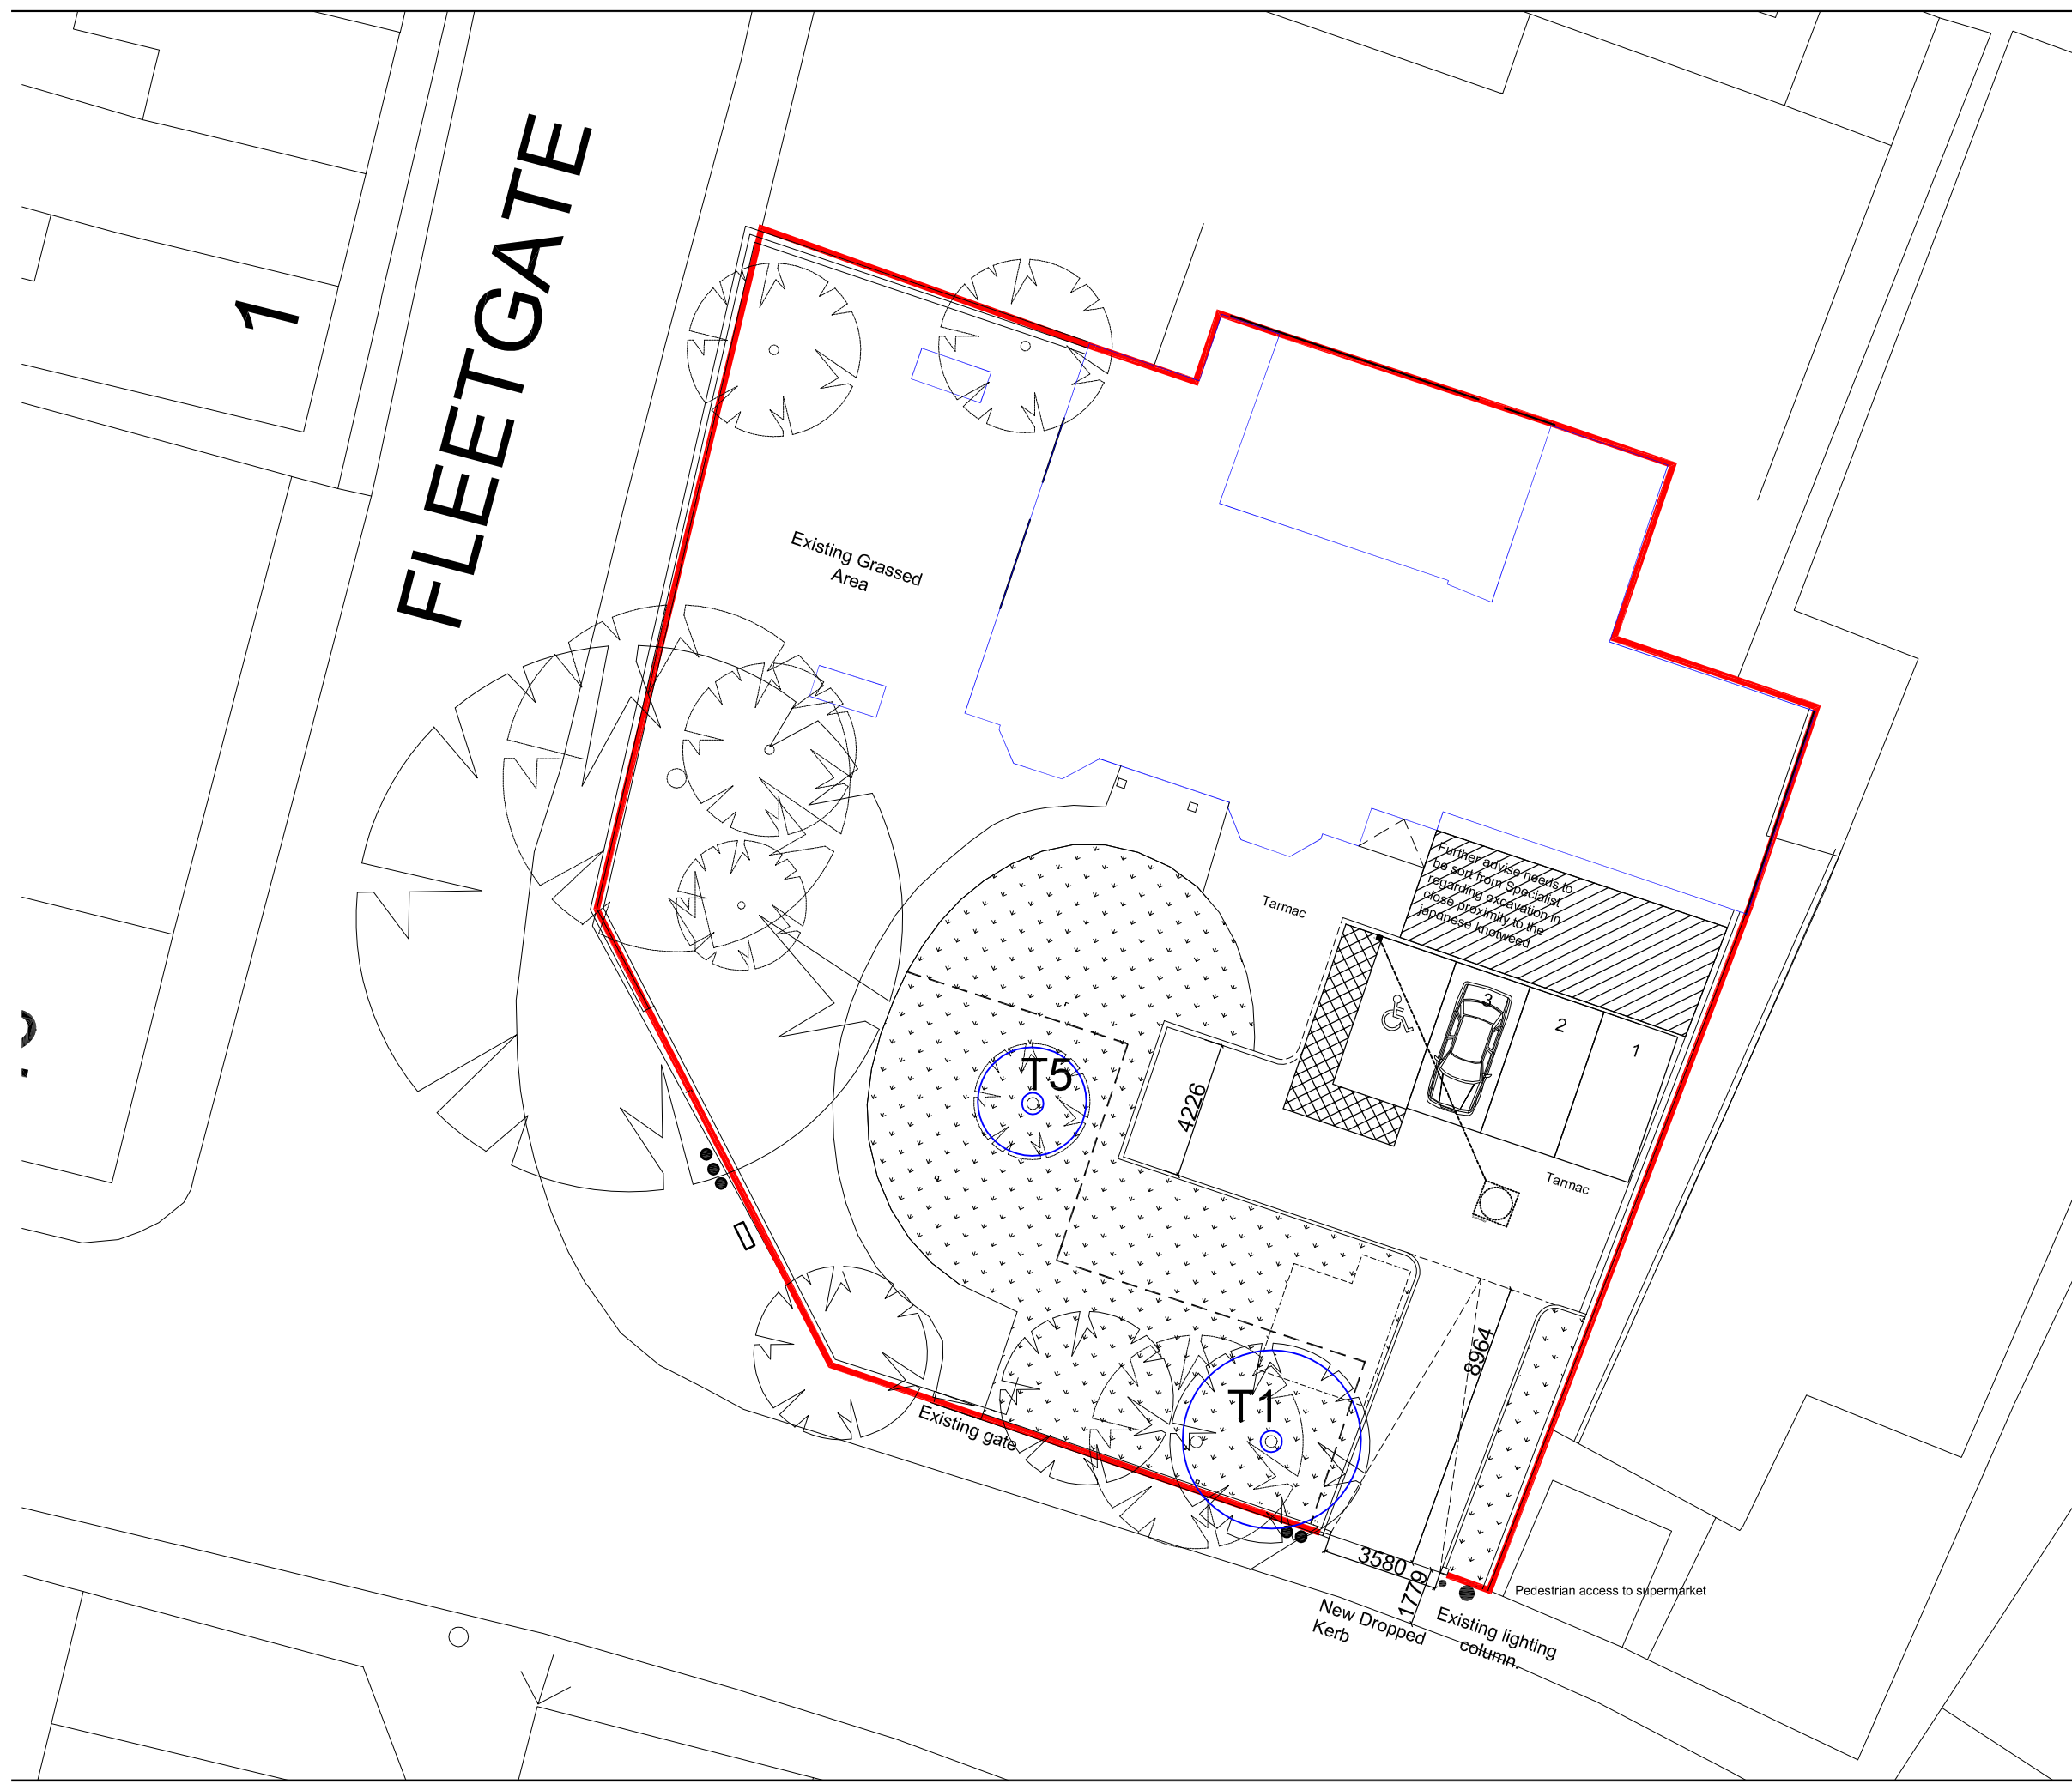
TITLE:
Proposed Site Plan

A Amendments to actual crown spread and position of root protection fencing as detailed by Lindsey Tree Services Ltd EB 12.04.2013

British Standard 5837:2012 'Trees in relation to design, demolition and construction - Recommendations', lays out specific guidelines for excluding access to the RPAs. It illustrates an acceptable type of protective fencing, the position of which is marked on the tree protection plan. The fencing can be formed from "Heras" type panels but must be fixed into the ground on stakes to prevent it from being casually re-positioned. Signs bearing the words "No Entry – Tree Root Protection Area" must be fixed to the fencing at 10m intervals. The RPAs are necessary to prevent soil compaction by machinery as well as safeguard against the spillage of toxic fuels or chemicals which, if they occurred within the root zone of retained trees, would cause irreparable long-term damage. The RPA fencing must only be removed once the construction phase has been completed. The position of the fencing is shown on the proposed layout drawing (W) 101.
