**RE: PROPOSED DEVELOPMENT AT WINDSOR CRESCENT, CROWLE,
NORTH LINCOLNSHIRE (NGR 476800, 412700).**

**Windsor Crescent, Crowle,
North Lincolnshire**

Contamination Risk Assessment

Solmek Report Number S70637/RA

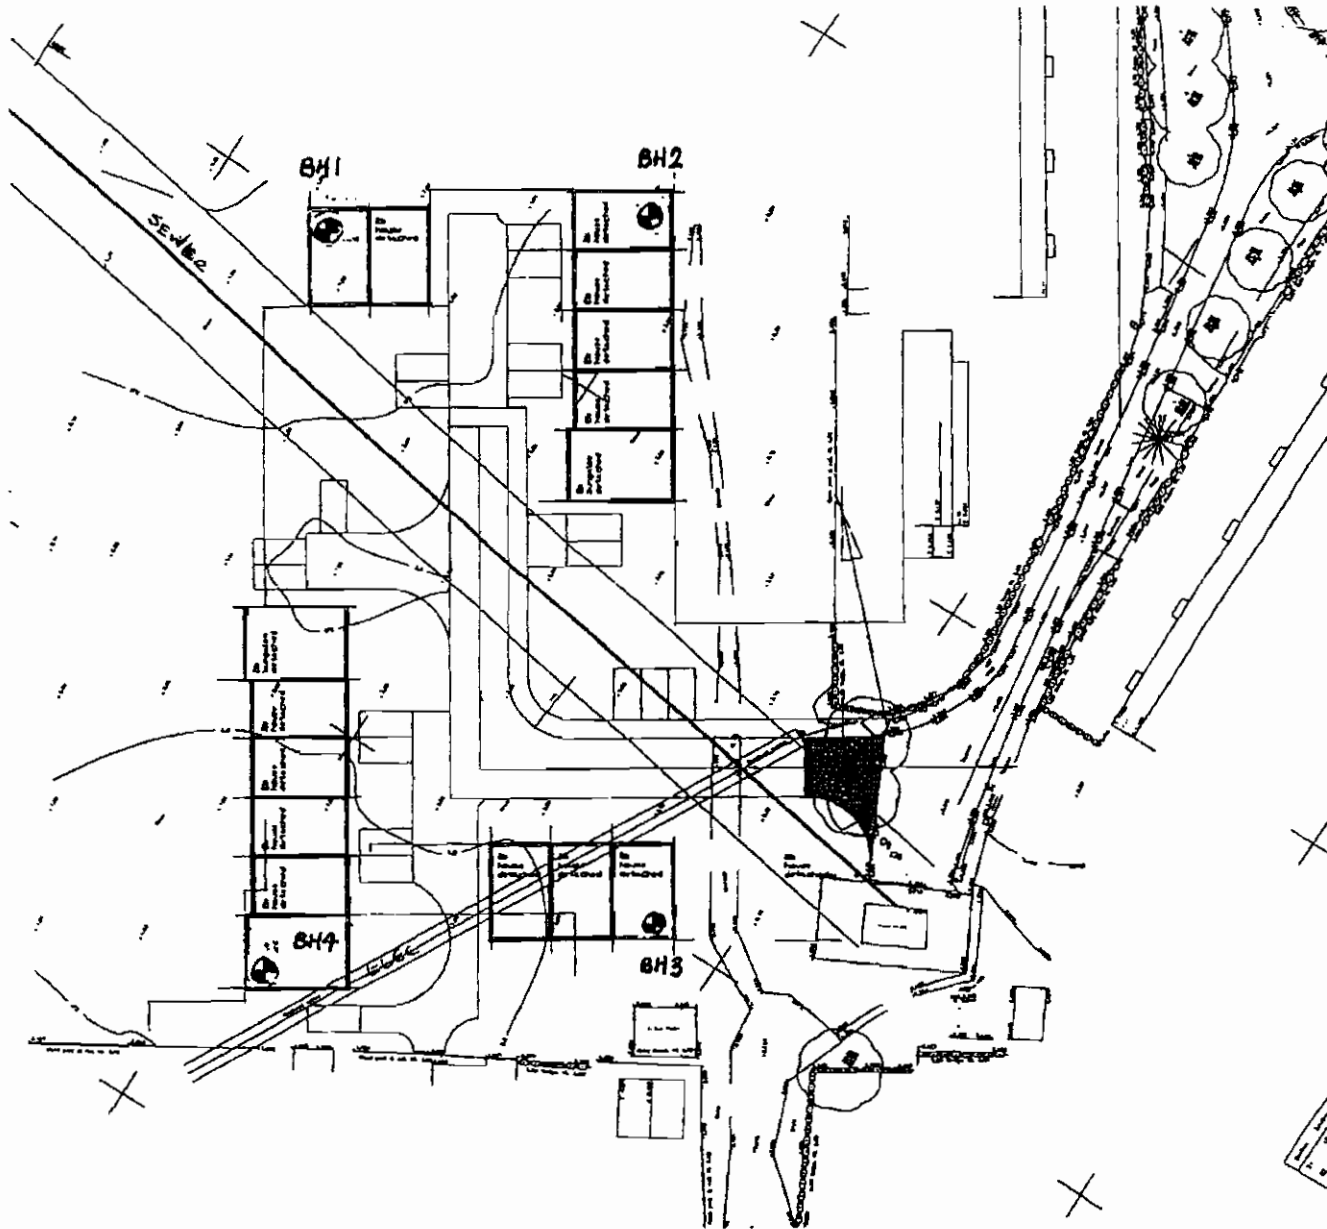
Title	Borehole Location Plan
Project	Windsor Crescent, Crowle
Client	South Yorkshire Housing Ltd
Date	May 2008
DRG No	Figure 1
Scale	NTS

- 5.2 A gas and water monitoring standpipe was installed in BH1 and BH3, and two monitoring visits were made during July and August 2007. The position of the boreholes is shown on a site plan included in Appendix A, Figure 1. The borehole logs are presented in Appendix 4.
