Protected Species Survey at Tetley Cottage, Wharf Road, Crowle, North Lincolnshire

May 2016

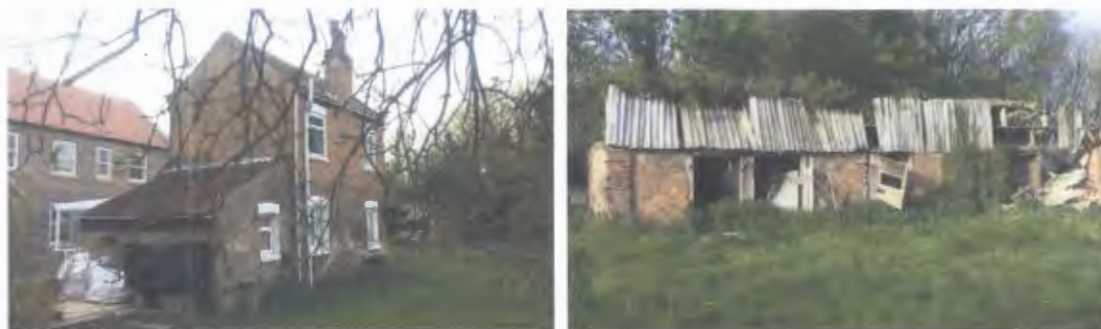
Photograph 1: Representative views of Tetley Cottage (left) and the associated outbuilding (right).

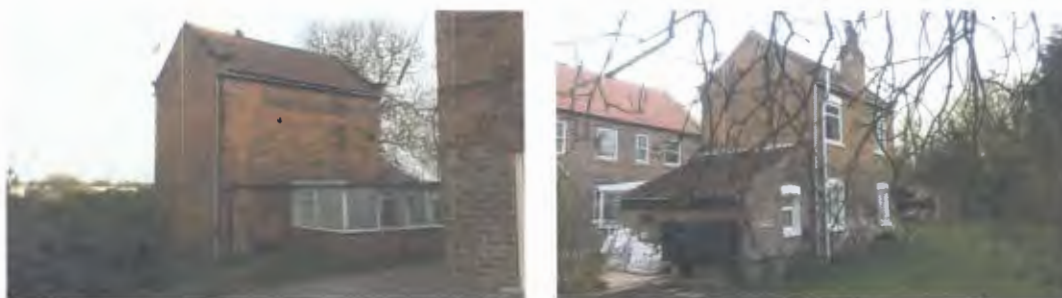
Tetley is a two storey detached property constructed of solid bricks, supporting an equal pitched, gable ended timber framed roof covered with pantiles. Internal ceilings are present throughout and there is a single small roof void which contains under felt. The roof structure is generally in a very good condition with no missing or slipped tiles. The building has no cladding, soffits, hanging tiles, barge boards, fascias or eaves. All mortar joints appear intact. Missing mortar was recorded only on the very ridge point of the southern gable end. No damaged brickwork or absent bricks were noted. No settlement cracks were recorded. All doors and windows were present and contained no gaps or other obvious defects.

Photograph 2: Representative images showing the exterior of Tetley Cottage

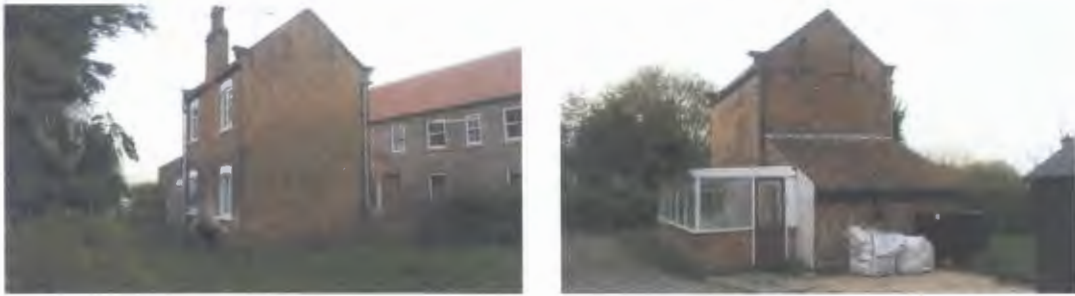
**Photograph 3: Further representative images showing the exterior of Tetley Cottage**

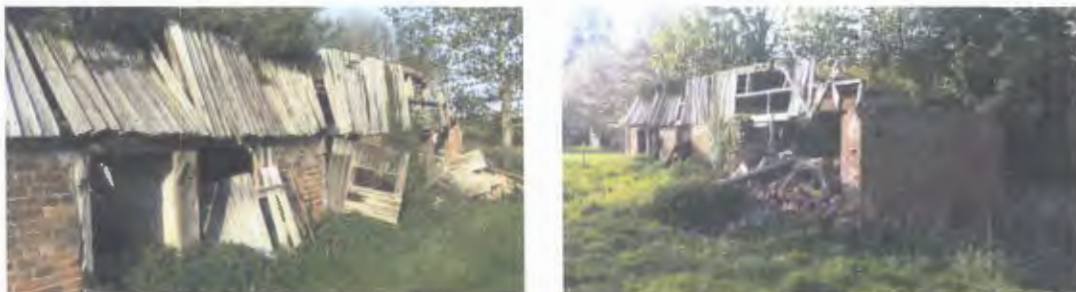
Associated with Tetley Cottage and located a short distance to the north is a former single storey, south facing agricultural building constructed of solid bricks. The building comprises some four former stables and an open fronted wagon bay separated by internal solid brick dividing walls. The building is in an extremely poor state of repair. The timber framed pent roof which was formerly covered with pantiles is largely collapsed. Some brickwork is also beginning to collapse. A dense ivy *Hedera helix* covering of almost the entire roof and large areas of brickwork help retain any remaining integrity. There is no roof void and numerous broken joists are present. The building has the remnants of elevated timber cladding, but no soffits, hanging tiles, barge boards, fascias or eaves are present. Many mortar joints appear eroded. Damaged brickwork, settlement cracks and absent bricks were noted throughout. Any doors and windows were largely absent and contained many gaps and other defects including gaps around lintels.

Detritus levels were high throughout. Ambient lights and draught levels were considered very high.

**Photograph 4: Representative images showing the external views of the outbuilding**

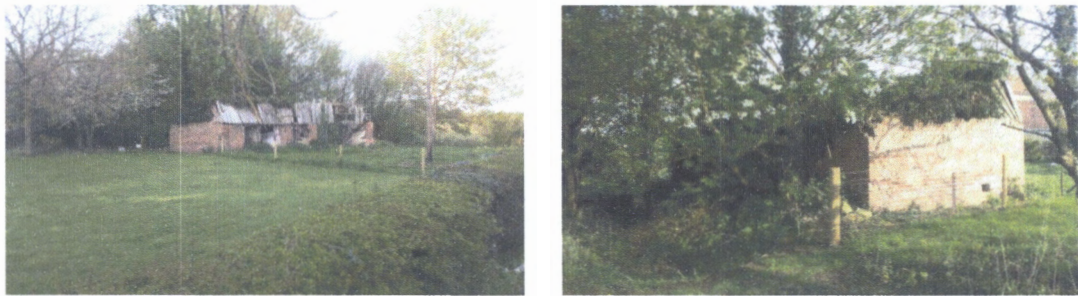
Photograph 5: Further representative images showing the external views of the outbuilding

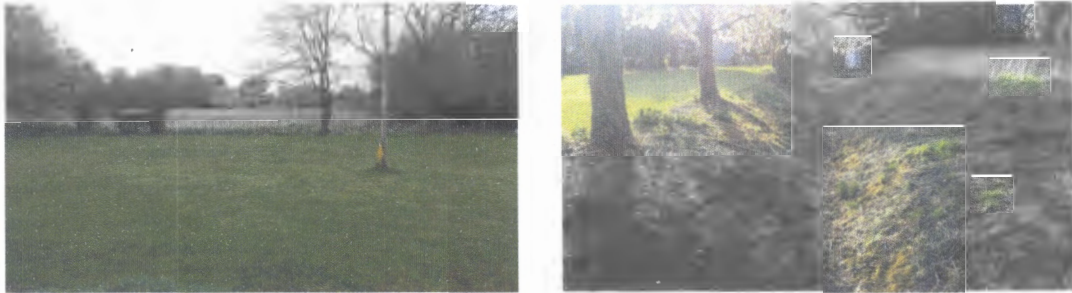
Photograph 6: Representative images showing the land to the west/north west of site (left) and dry ditch system to west (right)

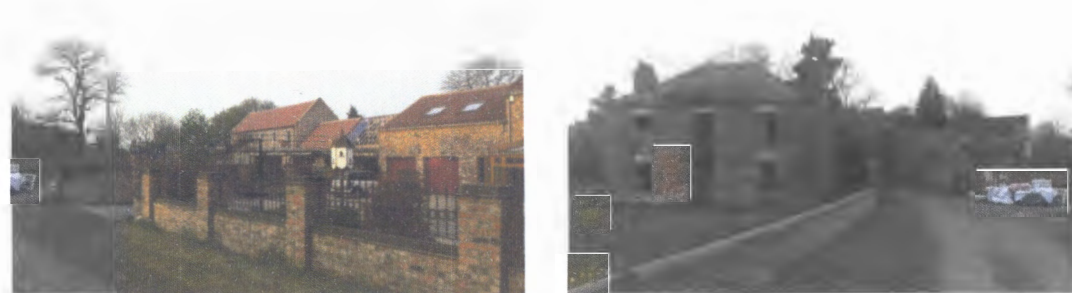
Photograph 7: Representative views of the developments immediately south west / south of site (left) and neighbouring buildings associated with the grounds of Tetley Hall (right).

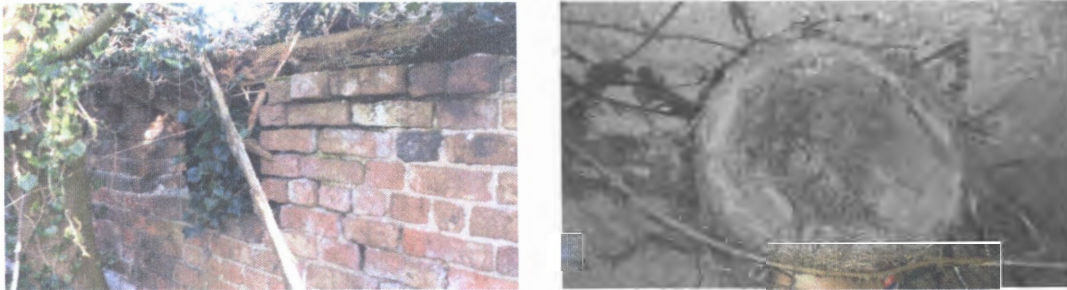
Photograph 8: Ivy and settlement cracks (left) and disused thrush nest (right)

A large number of niches suitable for use by a small number of bats were identified on both the external and internal fabric of the outbuilding, in particular niches created by failed mortar joint between bricks, between wooden lintel and the brickwork, niches where the roof timbers tied into the brickwork and settlement cracks.

Some features were considered to offer potential for use by bats and these included gaps created by failed mortar joint between bricks. These features were considered particularly favourable for roosting by pipistrelle bats.

Disused blackbird, thrush and wren and house sparrow *nests* were recorded in the outbuilding.

Any demolition of the existing outbuilding/barn is undertaken **manually** and under the supervision of a suitably licensed and experienced ecologist

A dawn pre entry bat survey should be undertaken immediately prior to demolition.
