Arboricultural Assessment Report (Ver 2)

Rowland Road
Scunthorpe
North Lincolnshire

June 2018

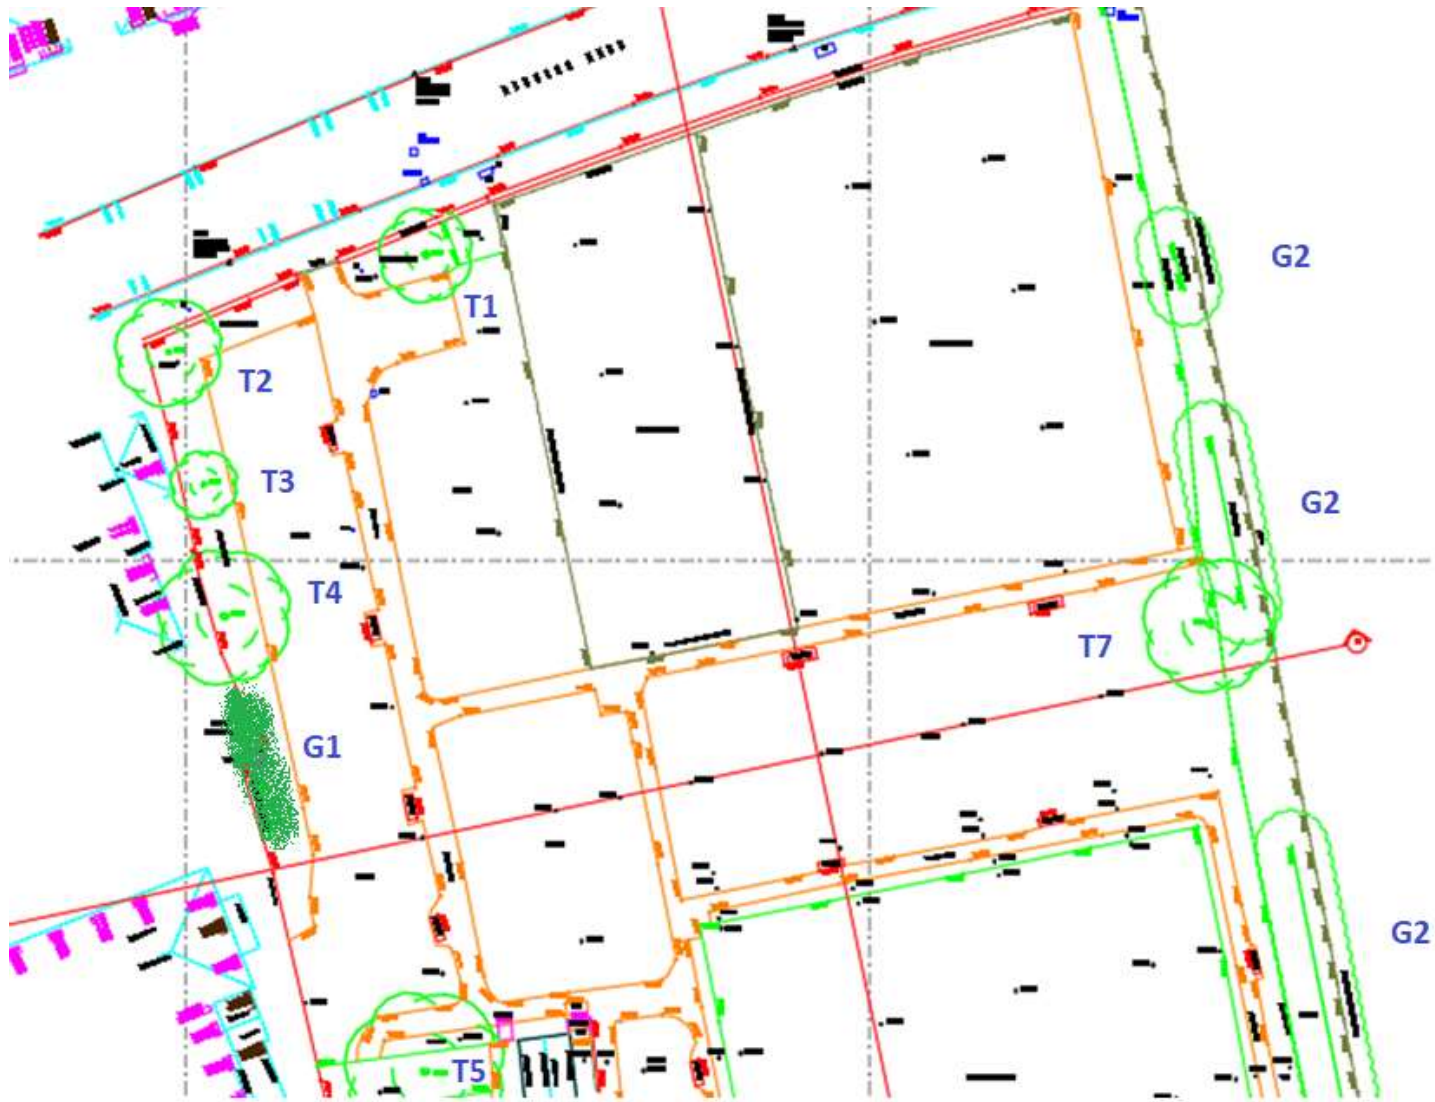
2.2 Plan 1a

Tree No	Species	Height M	Stem Dia (RPA)	Branch Spread (m)	Height of crown clearance	Age Class	Physiological condition	Structural Condition	Preliminary Management Recommendations	Useful life expectancy	Category grading
T1	Whitebeam	12m	390 4.7m	N 4 S 4 E 4 W 4	3m	M	Good	Good	Remove for development	30+	B2
T2	Whitebeam	13m	410 4.9m	N 4 S 4 E 4 W 4	3m	M	Good	Good	No action	30+	B2
T3	Whitebeam	8m	240 2.9m	N 3 S 3 E 5 W 2	3m	M	Fair	Fair	Remove for development	30+	C2
T4	Norway Maple	17m	560 6.7m	N 8 S 8 E 8 W 8	2m	M	Good	Fair	Remove for development	30+	C2
T5	Hornbeam	20m	540 6.5m	N 5 S 5 E 5 W 5	3m	M	Good	Good	Remove for development	30+	B2
T6	Whitebeam	15m	430 5.2m	N 6 S 6 E 3 W 6	2m	M	Good	Good	Remove for development	30+	C2
T7	Cherry	14m	580 6.9m	N 6 S 6 E 6 W 6	2m	M	Good	Poor	Remove for development	30+	C2

Group No	Species	Height M	Stem Dia (RPA)	Branch Spread (m)	Height of crown clearance	Age Class	Physiological condition	Structural Condition	Preliminary Management Recommendations	Useful life expectancy	Category grading
G1	Leyland Cypress 9 stems	6m to 20m	300e 3.6m	2m	2m	M	Fair	Poor	Remove- Being removed at time of inspection	30+	C2
G2	Lombardy Poplar	25m	300 To 900 10.8m	3m	3m	FM	Good	Fair	Remove for development	30+	C2

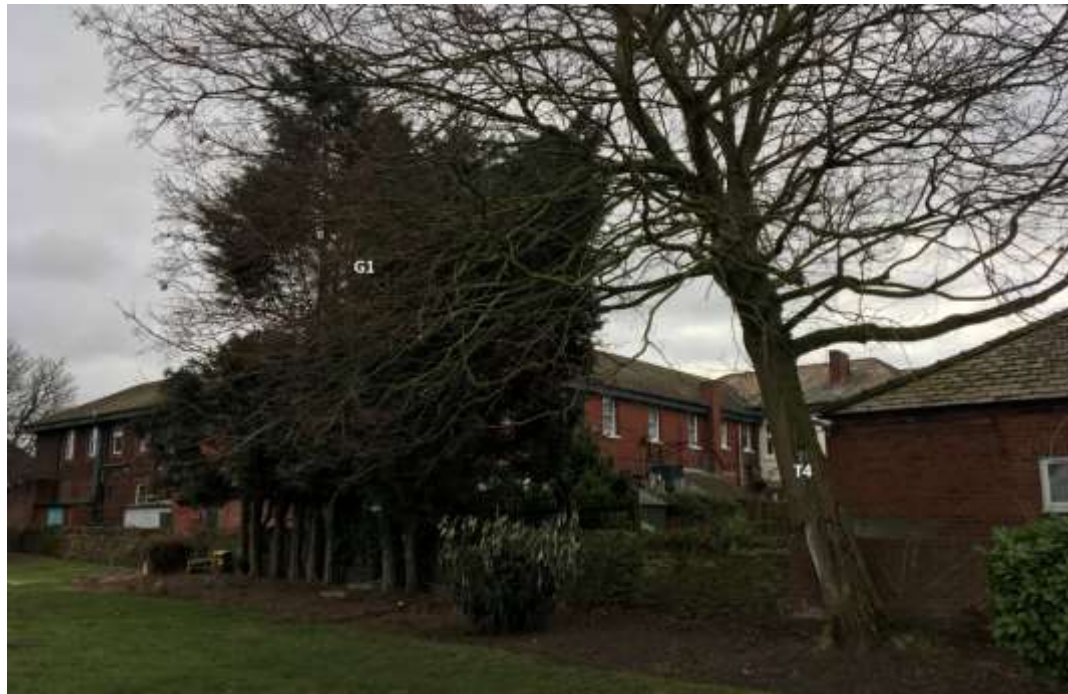
Photograph 1 - Norway Maple T4

The group of Leyland cypress (G1) appeared to be being removed at the time of inspection, perhaps due to their condition and close proximity to the adjacent property. The Norway Maple tree (T4) is a large mature tree but sadly has extensive bark damage up to 2m on the stem on the field side of the tree. This could well have been caused by a fire. In the long term this might be an area where decay enters the tree. The tree is also very close to the adjacent property as illustrated in the photograph above and it is therefore recommended for removal.

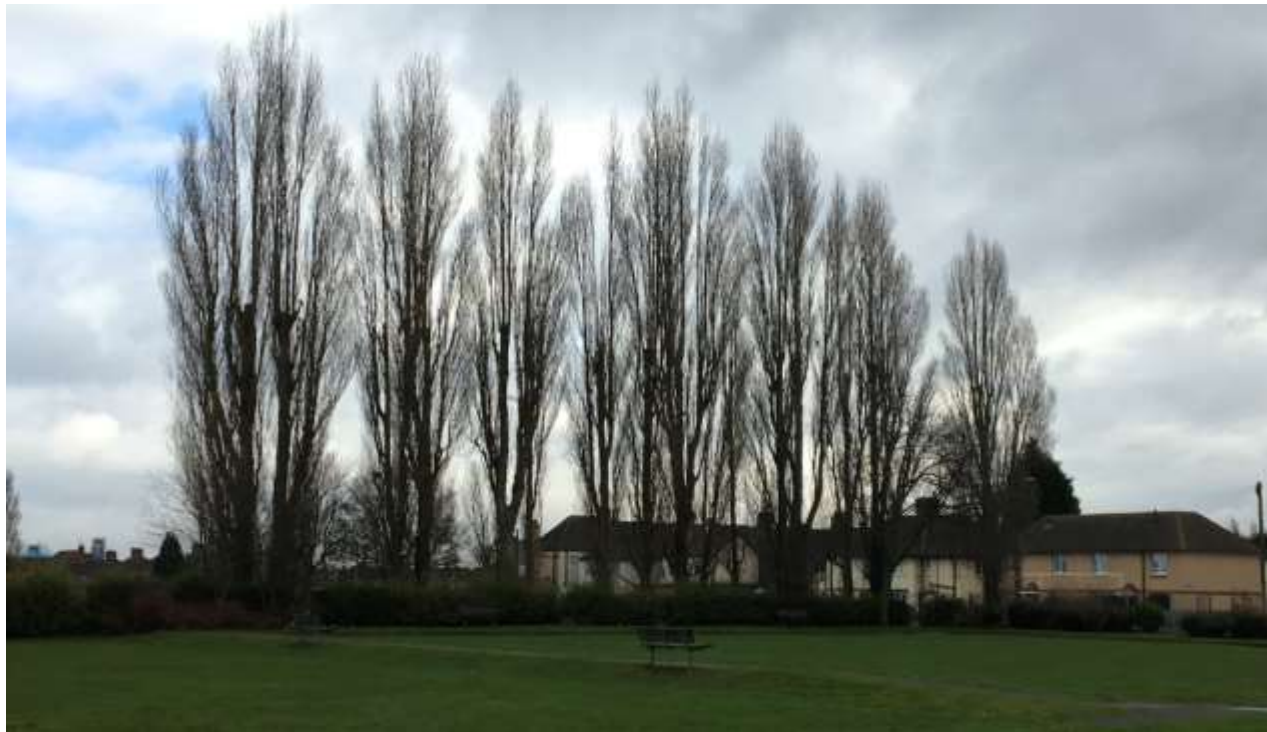
The poplar trees (G2) as illustrated on the photograph below form a substantial feature on the eastern boundary of the site. However, they have been topped in the past at approximately 14m and regrowth over the last few years has increased their height to around 24m. Poplar tend to decay fairly rapidly and once pollarding has been undertaken it is generally recommended to repeat the process. The Lombardy form of poplar produces a very upright tree and whilst it is subjective they can appear slightly out of place. In this instance they would shade the adjacent public amenity area and would be out of scale for residential development. The height of the trees and shading often results in anxiety to people living close by. Taking into consideration the condition of the trees, impact on the adjacent amenity land and landscape form it is recommended to fell and replace the trees. A new tree belt along the boundary with a mixture of native trees and hedging would provided in the long term a more attractive tree belt, more in keeping with the local landscape and of greater wildlife benefit. IF the poplars are removed then the Whitebeam tree T6 and Cherry T7 might also be removed as neither tree has good form.
