Arboricultural Impact Assessment (AIA)

Site Details		Local Planning Authority Details	
Land at Sweeting Thorns Holme Scunthorpe Lincolnshire		North Lincolnshire Council Civic Centre Ashby Road Scunthorpe North Lincolnshire DN16 1AB	
Our ref:	CT_5038.18	Revision:	3
Client:	Aarkvark EM Limited	Survey Date:	13 th August 2018
Project Arboriculturist:	Mr Simon Putt Senior Arboriculturist	Tel Number:	01392 811338
Checked by:	Millie Gilbert-Mowat Administration		
Date of issue:	16 th July 2018

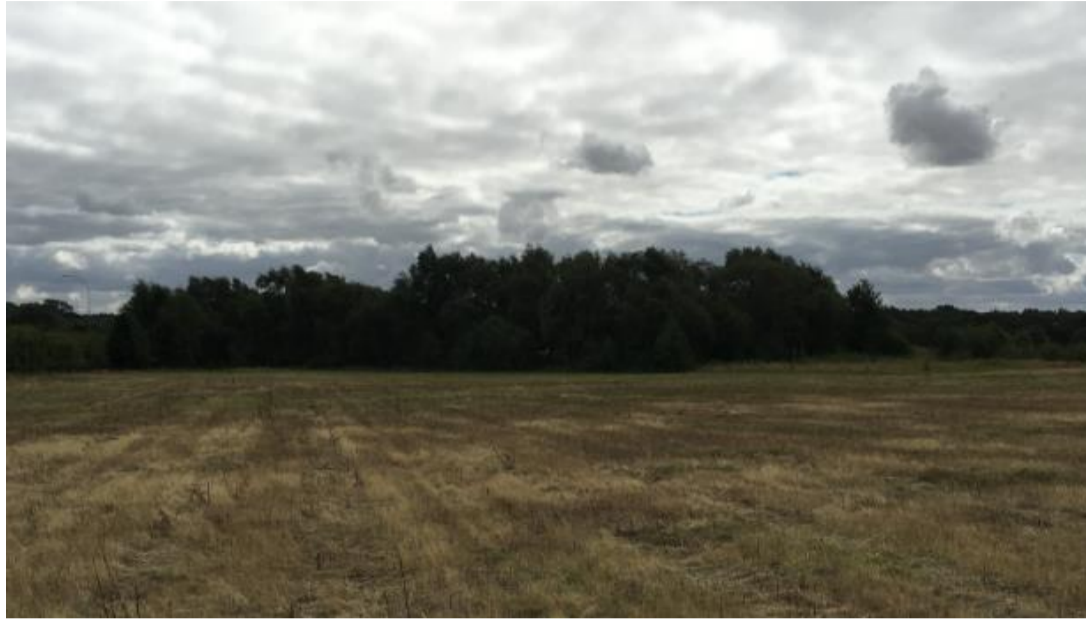
- 6.7 This is shown on the tree protection plan CT_5038.18_TPP_V3.
- 6.8 Only the low value group G1 directly conflicts with the proposed layout and will need to be removed to facilitate development.

Figure 2 Picture shows the group G1 which directly conflicts with ten proposal and needs removing.

- 6.9 The impact (*reduced visual amenity and reduced benefits associated with trees*) of removing these trees will be negligible within the immediate and wider landscape.

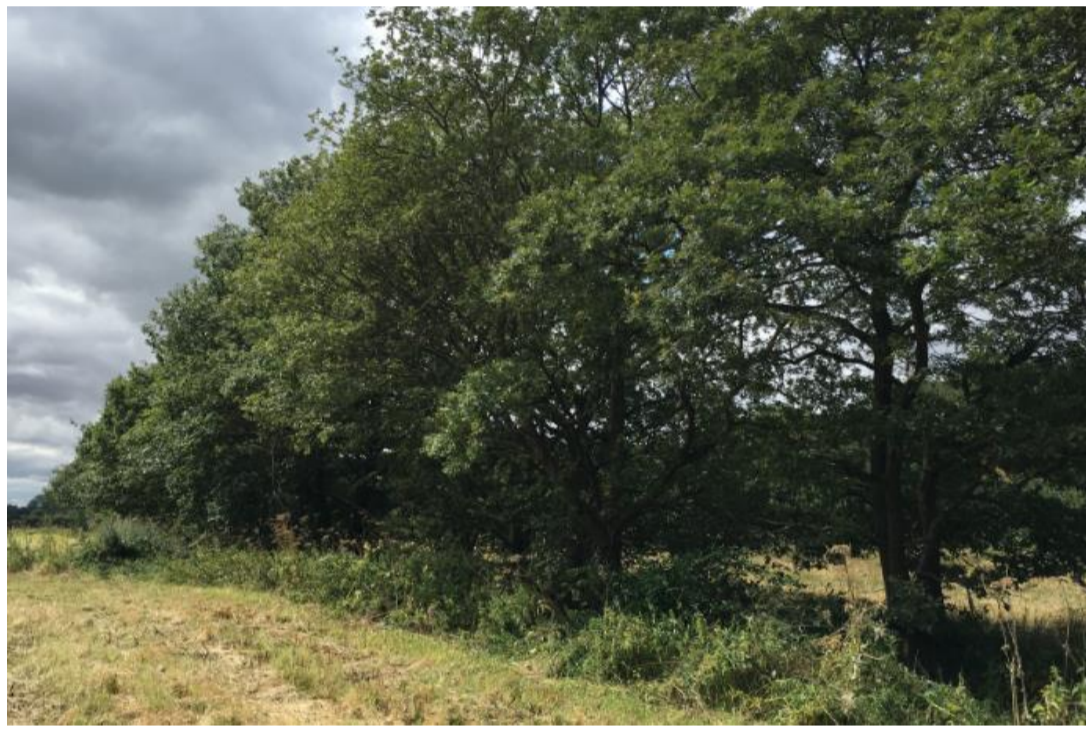
G2	Oak	450	8-15	3	3	3	3	0	2	MA	P : Fair S : Good Comments : Ditch on one side. Hawthorn understory.	None	20+	5.4	B 2 3
T3	Oak	450	8	5	5	4	6	2 N	2	MA	P : Fair S : Good Comments : Major deadwood	None	20+	5.4	B 1 3
T4	Oak	400	6	3	5	3	5	2 W	2	EM	P : Fair S : Fair Comments : Major pruning work over site.	None	10+	4.8	C 1

Figure 3 Shows the group G2 which screens the site from the footpath to the west.

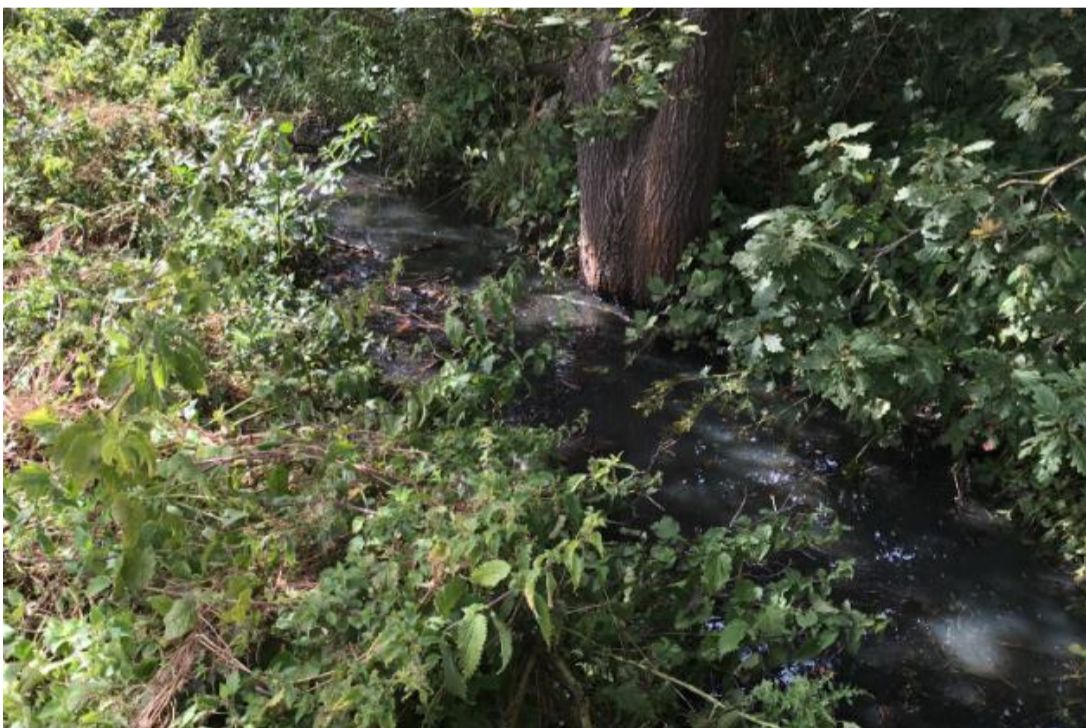
- 2.11 The presence of deep ditches filled with water act as a natural constraint to root development which has been reflected on the Constraints Plan CT_5038_TCP_V1.

Figure 4 The deep, water filled ditch which is a significant constraint to root development on site.

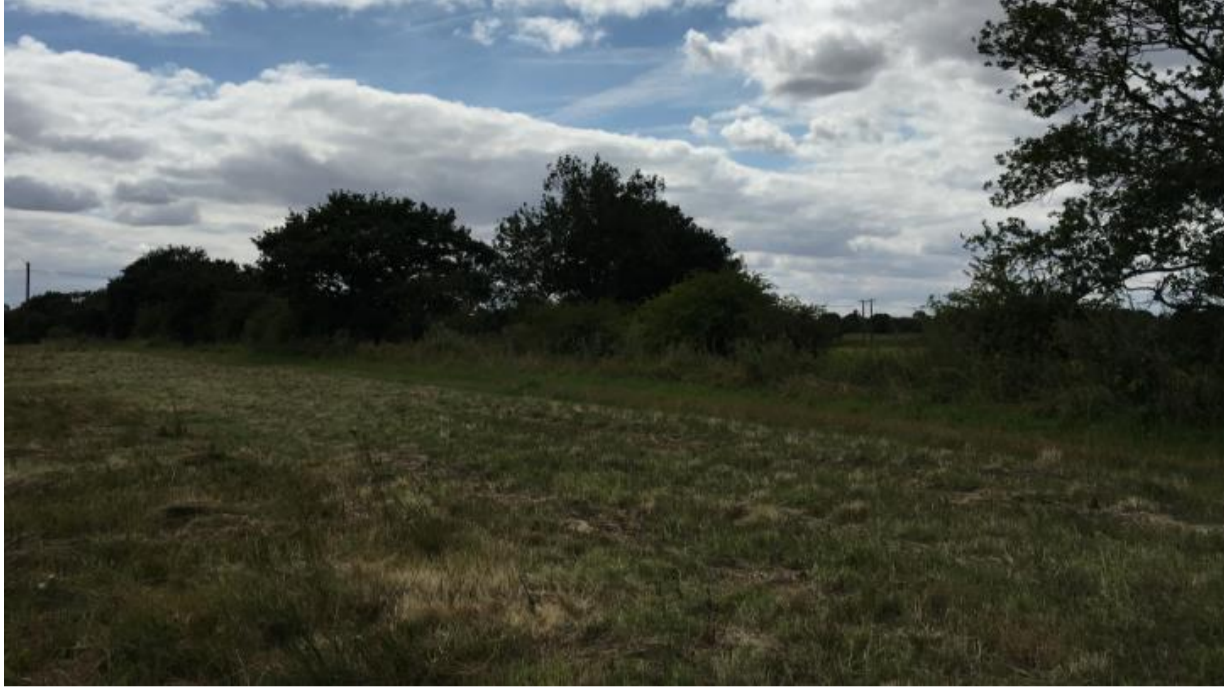
- 2.8 The trees and hedges on the western boundary are off site however, in places, the canopies of the trees extend into site.
- 2.9 For this survey the trees have been identified as

Figure 5 Shows the trees on the western boundary which overhang into the site.

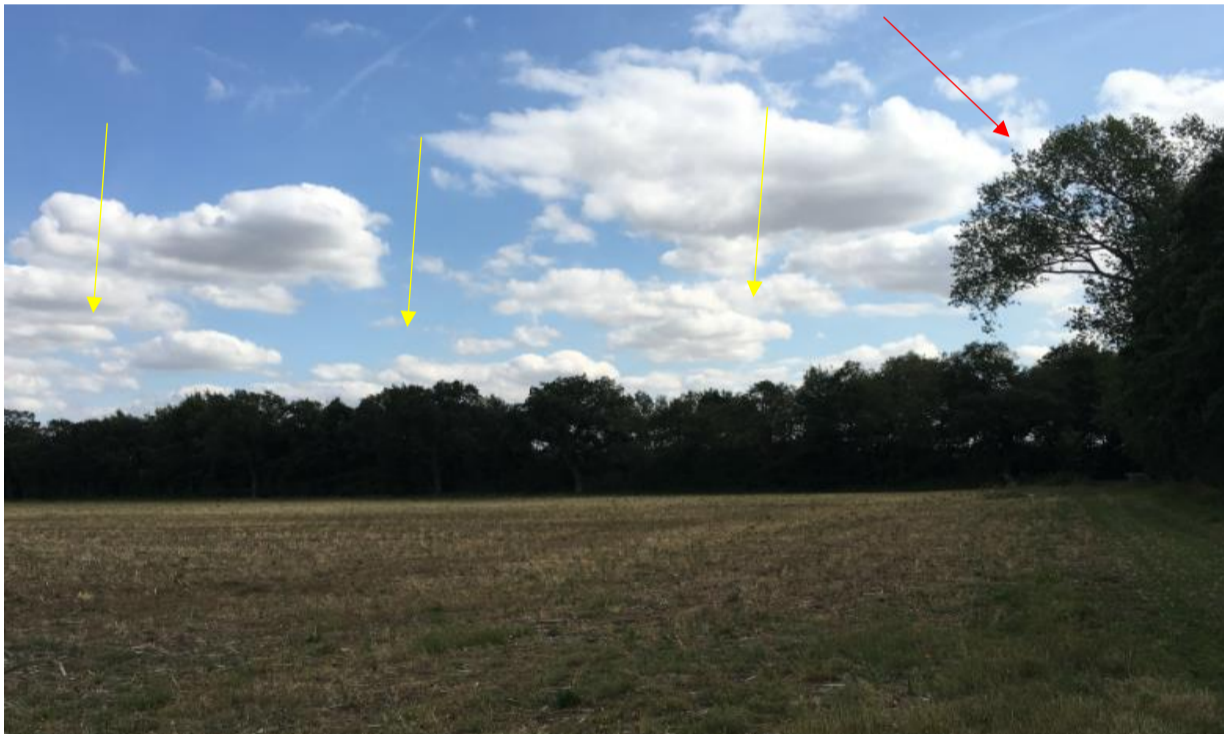
Figure 6 The picture shows the poplar T17 (red arrow) which has been graded as a 'U' and the protected oaks within G11 (yellow arrows).

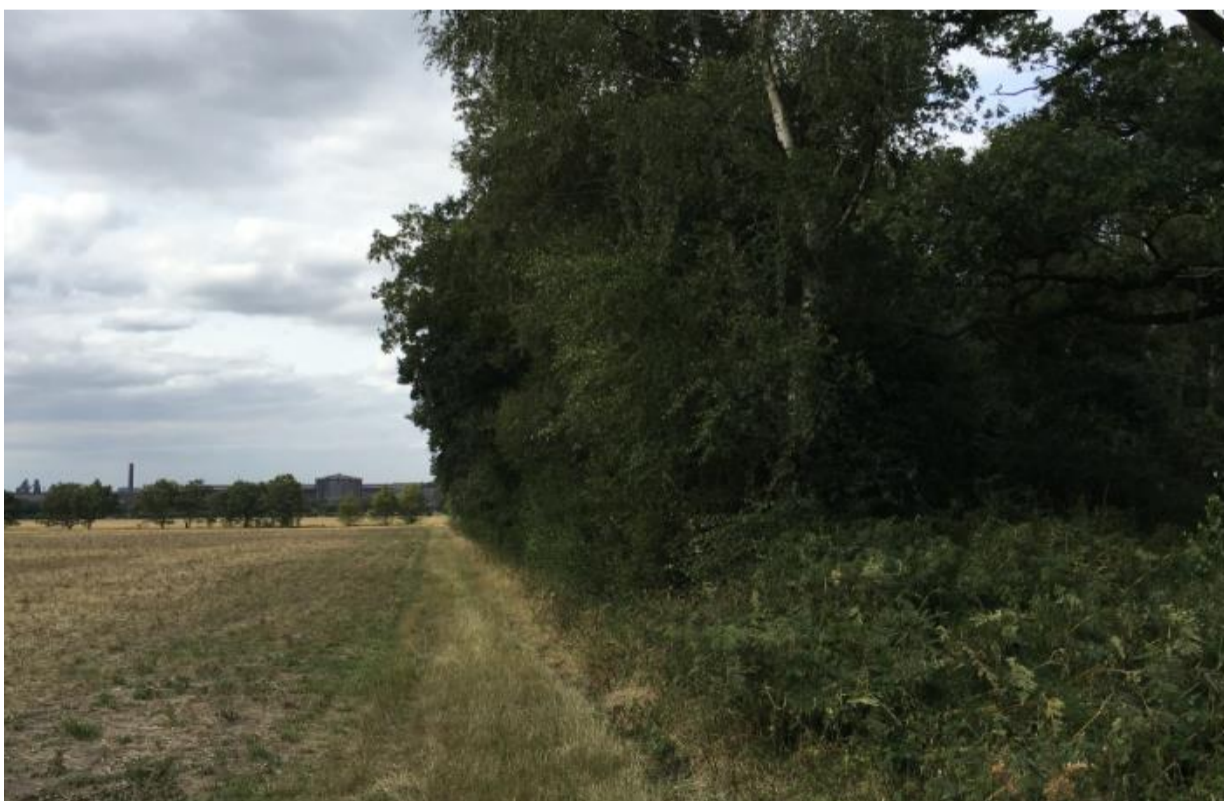
W1	Oak	600	15	-	-	-	6	4.5 W	3	MA	P : Fair S : Good Comments : x 1 dead birch within the woodland edge.	None	40+	7.2	A 2 3
G12	Oak Hawthorn	350	10	6	5	5	5	2.5N	3	SM	P : Good S : Fair Comments : History of branch failure in the oak.	None	10+	4.5	C 1
G13	Oak x 3 Hawthorn x 1	350	9	5	4	4	4	3N	3.5	SM	P : Good S : Fair	Selective removal of trees to retain specimens.	10+	4.2	C 1

Figure 7 This picture shows the woodland edge from W1 which runs along the eastern boundary.
The presence of a ditch limits root development into site.
