# Arboricultural Report

Principle Formal Arboricultural Report/Survey  
(in accordance with BS5837: 2012 Trees in Relation to Construction)

**Location:** land r/o Birch Cottage, High Street, Barrow Upon Humber

**Date:** 16<sup>th</sup> August 2018

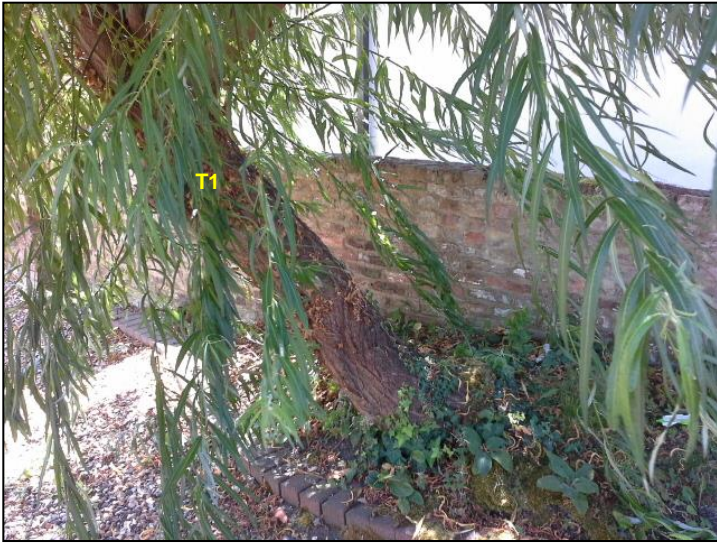
**T1 sits close to the boundary along the existing drive. There is an obvious and ongoing conflict with the drive and the neighbouring property**

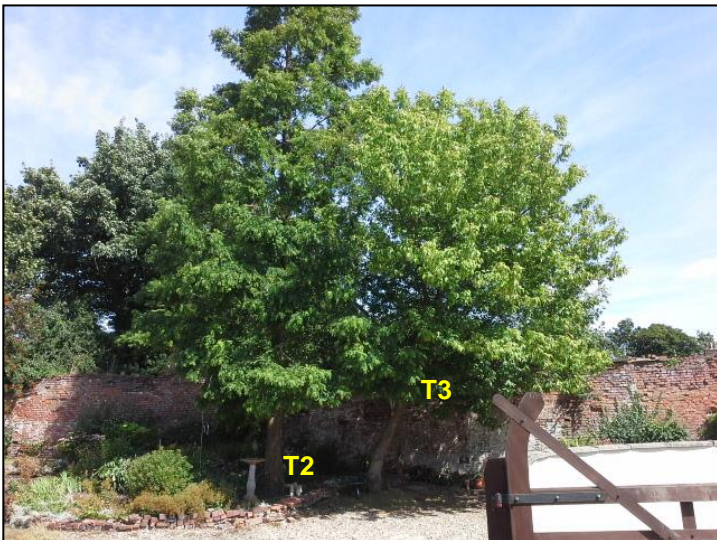
**Trees T2 and T3 are off site, within the boundary of Birch Cottage. These trees are not expected to have any influence in terms of how this site is developed**

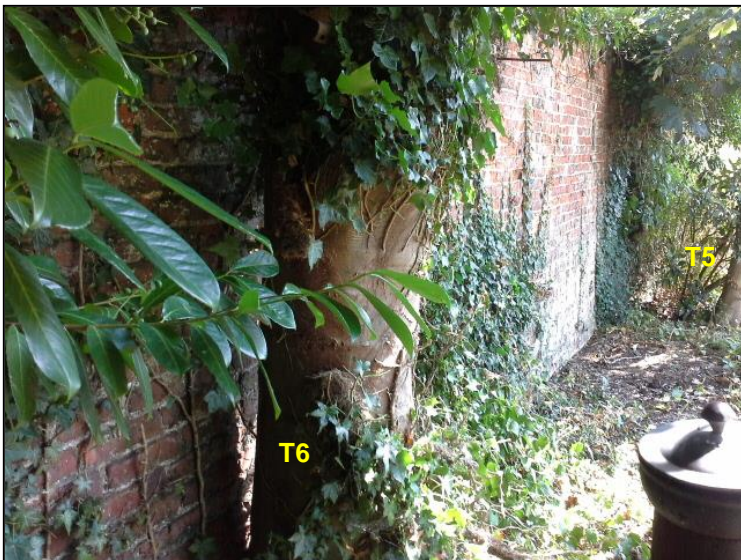
There is an obvious existing and future conflict with the boundary wall from some trees and shrubs

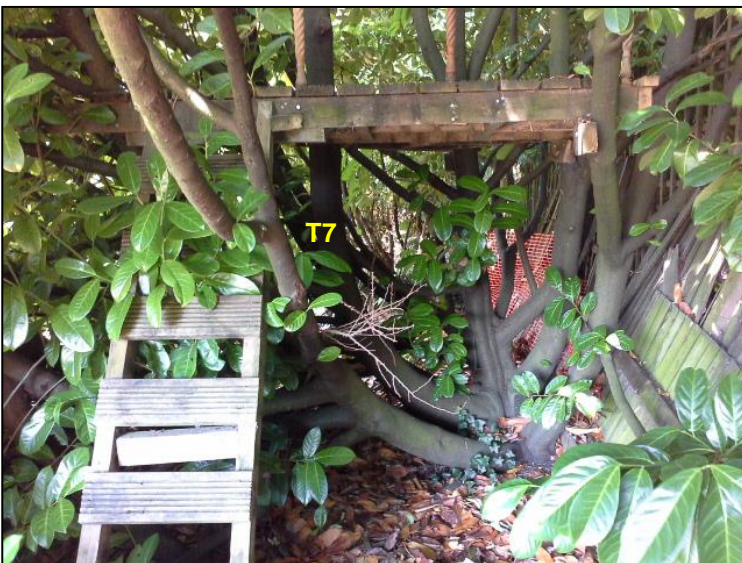
Tree T7 with a small tree house constructed within

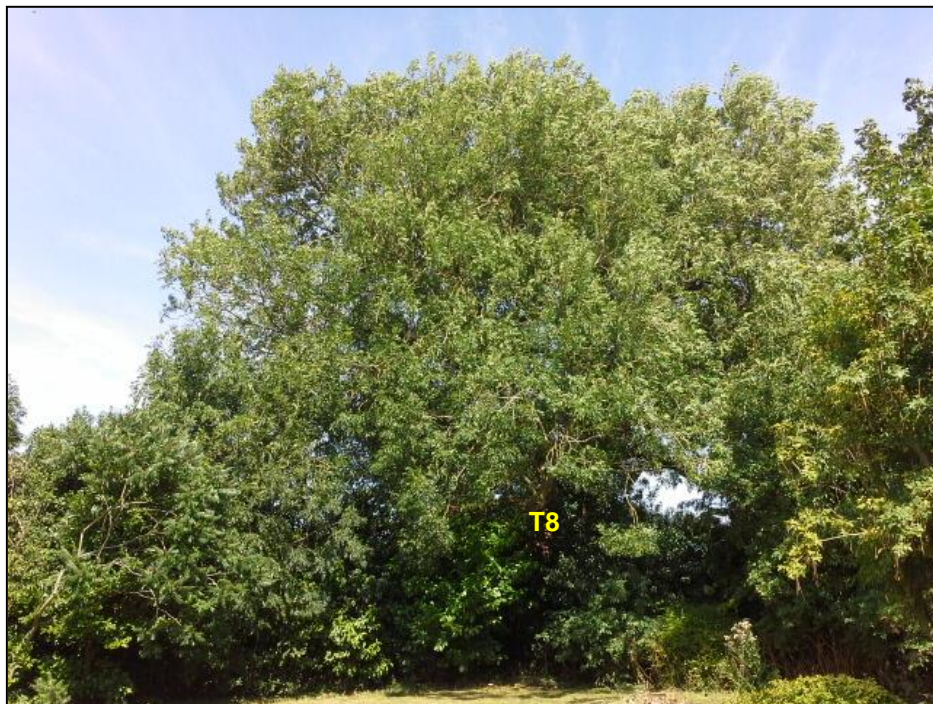
T8 – Off site, although is a dominant feature with extensive overhang into the site

**8.3** Although off-site, special consideration should be given to tree T8. Having assessed the tree stock on and immediately adjacent, this tree is considered to have moderate quality and value. Categorised “B1”, the tree is a relatively good example of the species. A detailed visual inspection of this tree is restricted due to being off-site. Although an inspection was made from a distance, within the site boundaries, it is obvious that a various amount of remedial works has previously taken place. This includes a reduction of parts of the crown, a reduction of the lower laterally spreading limbs and the installation of, what appears to be, a cable bracing system. I would assume that the works carried out, including the bracing of a main fork, is an attempt to secure any structural defect, most likely the fork union. The current structural condition of this fork is not known, due to access restrictions. The previous works carried out was possibly within the last 10yrs. It could be that the bracing has stabilised the fork union, allowing incremental growth to develop. However, this can only be confirmed by a close inspection of the fork union, an opportunity not available at the time of this survey. Due to the size and position of tree T8 there may be some conflict with the proposed development site.

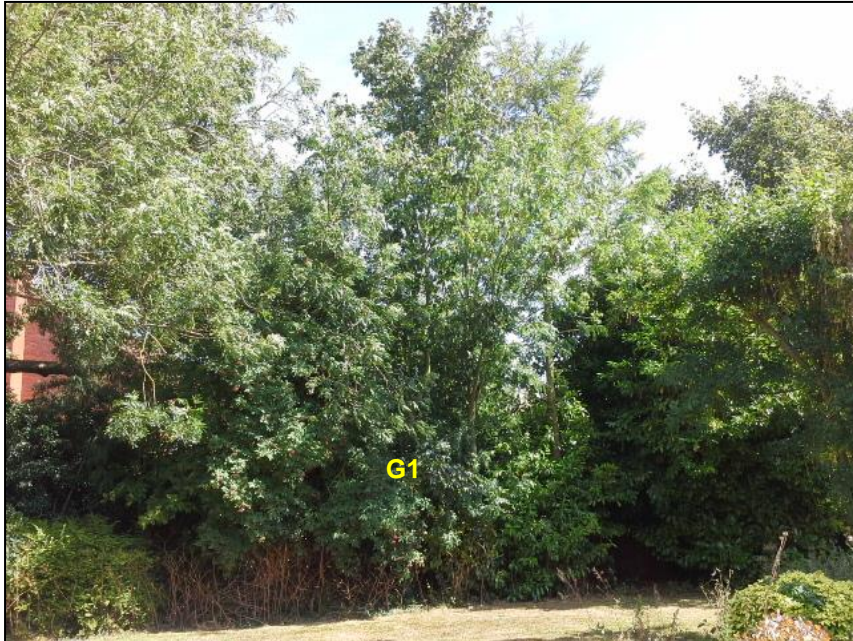
**Group G1, trees with very limited quality and value. Screening is likely the principle benefit**

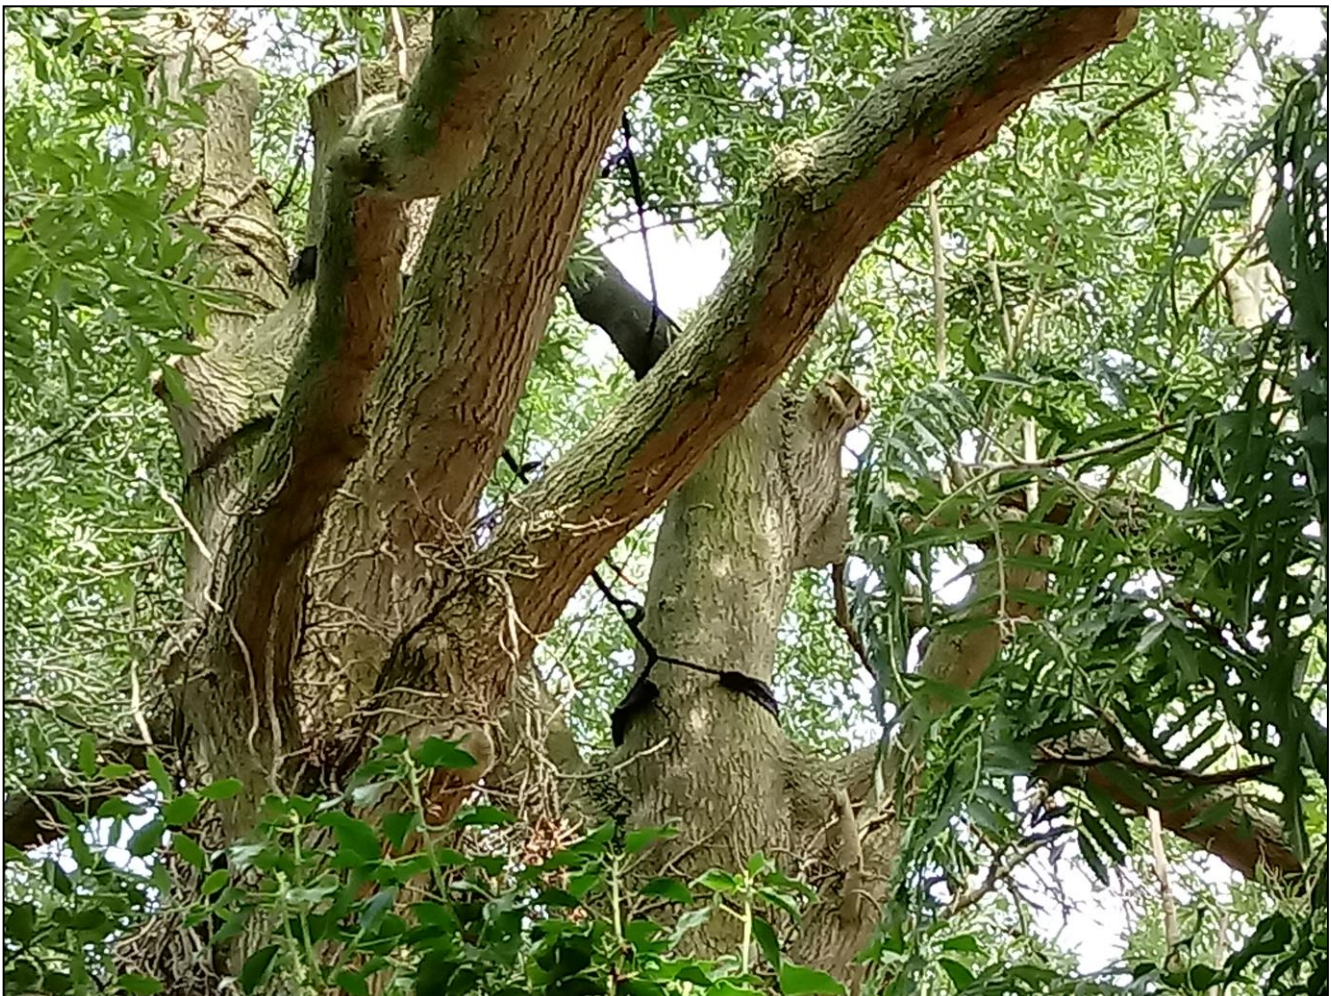
**A major fork on T8 has been braced in an attempt to secure a union defect**
