**PRE-DEVELOPMENT IMPACT
ASSESSMENT AND REPORT ON TREES**

**LAND R/O 35 SOUTH CLIFF ROAD
KIRTON IN LINDSEY
GAINSBOROUGH
DN21 4NR**

CLIENT - MR M ALLISON

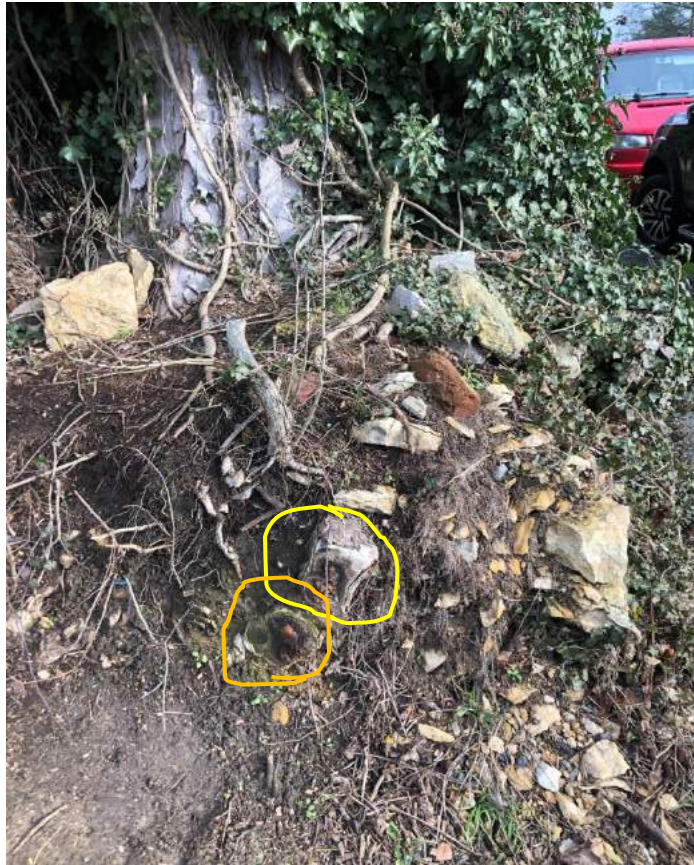
The largest tree on the site is a sycamore standing beside an unfinished access from Dunstan Hill which was formed through the limestone boundary wall. The tree grows on the top of the wall and major support roots measuring up to 200mm in diameter have been severed at this point. The elevated site and the precarious location in which the sycamore is rooted are cause for concern regarding its future stability. Other trees on the site are low-grade specimens, particularly the suckering holly T2 which has self-set in the gap where an elm once stood. A better quality holly, T4, grows within 10cm of the existing north elevation of the garage but its upper trunk is currently 5cm from the wall. Its crown has been badly pruned in the past but it remains healthy. The tree will begin to exert pressure on the structure as it continues to add annual growth rings. Two short unkempt sections of Leyland cypress hedge exist to either side of the access.

Picture 1 – showing the exposed rootplate of sycamore T1 beside the existing access. Severed major roots are circled.

The trees closest to the garage are low grade individuals which are either damaged, are causing and furthering existing structural damage or are generally poor specimens growing in inappropriate locations beside the building. The sycamore T1 should not realistically be retained. It has suffered significant root severance and stands on a wall in a position at the top of The Cliff where it is exposed to potential windthrow in storm conditions. The holly T2 is an indifferent example which is to be removed. This is to facilitate "squaring off" the indentation in building to continue a straight elevation beside Dunstan Hill. The vigorous sycamore T3 is uplifting the boundary wall of 35 South Cliff Road. If left unchecked, it will further destabilise the wall, leading to it collapsing towards the verge and footpath outside the property. The holly T4 is now 5cm from the upper courses of the brickwork and its retention in this position is unsustainable.

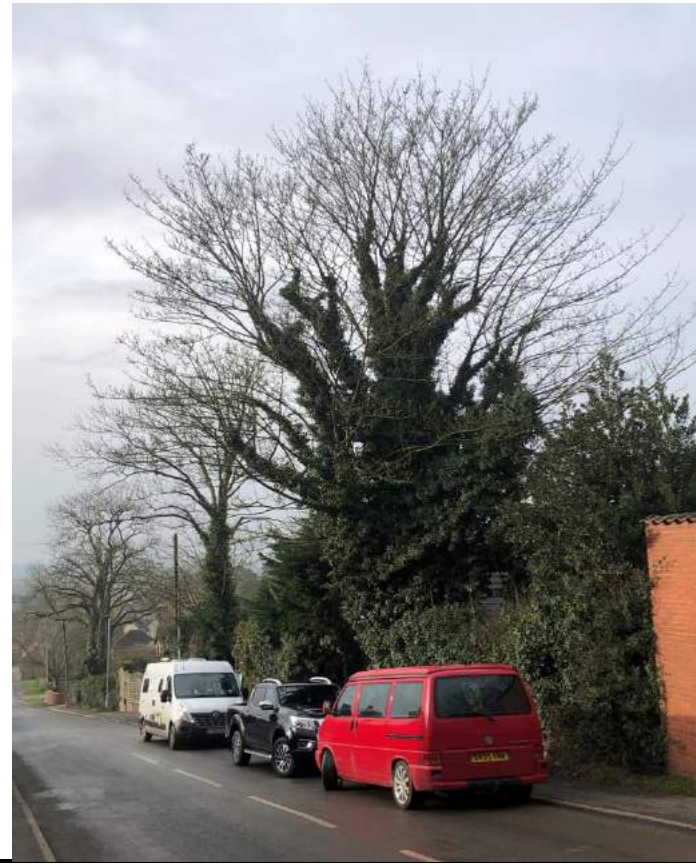
Picture 2 – showing sycamore T1 at the top of Dunstan Hill. The south east elevation of the garage is partly obscured by the holly T2.

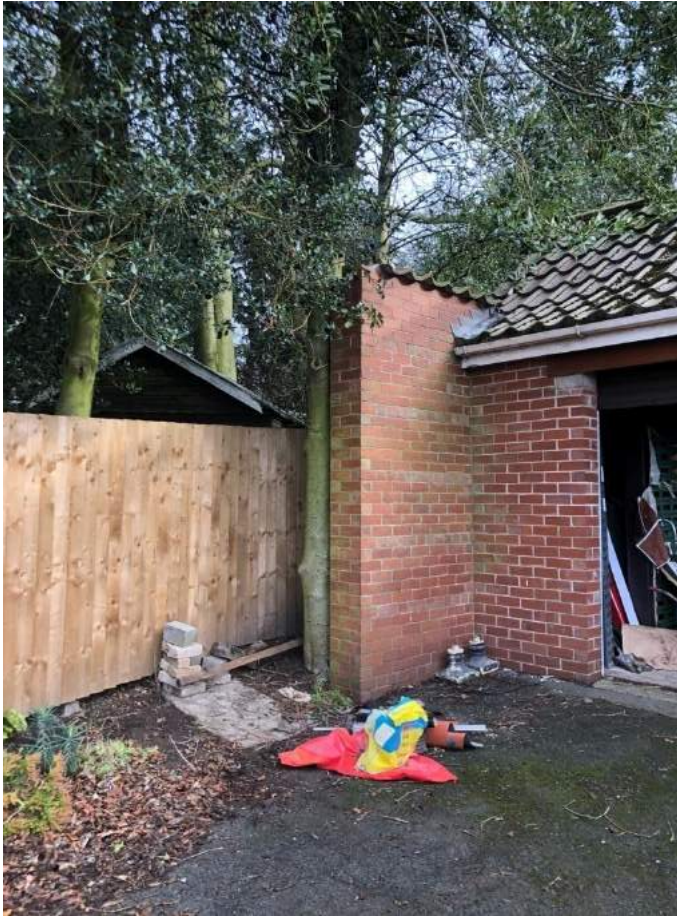
Tree No	Species	Age Class	Condition	Height (m)	Crown Spread (m)	DBH (mm)	Root Protect Radius (m)	Remarks / Recommendations	Retn Code
T4	Holly	M	Phys Fair Struct Good	13	N - 1 S - 5 E - 2.5 W - 2.5	310	N/A	Self-set tree located 10cm from garage wall projection at root collar and 5cm beside top of wall. Sound root collar and vertical trunk to 4m where it has been topped. Healthy crown biased to S, poorly pruned with old stubs present at lower levels. Growing in unsustainable location. Remove tree.	C2
T5	Beech <i>Fagus sylvatica</i>	FM	Phys Good Struct Good	22	S - 10 E - 11 W - 7	± 850	10.2	Third party tree. Root collar and trunk appear sound when viewed from site. Light ivy to 12m. Major and secondary limbs removed from S face at 5m where initial decay now establishing. Lower branches badly lifted above adjacent shed leaving pruning stubs. Evenly-distributed crown supported by upright, sound limbs and overhangs site to SW. Dead wood exists to 75mm dia. Canopy making active growth all round. Retain tree.	A2

Picture 3 - showing the proximity of holly T4 adjacent to the projection wall of the garage.

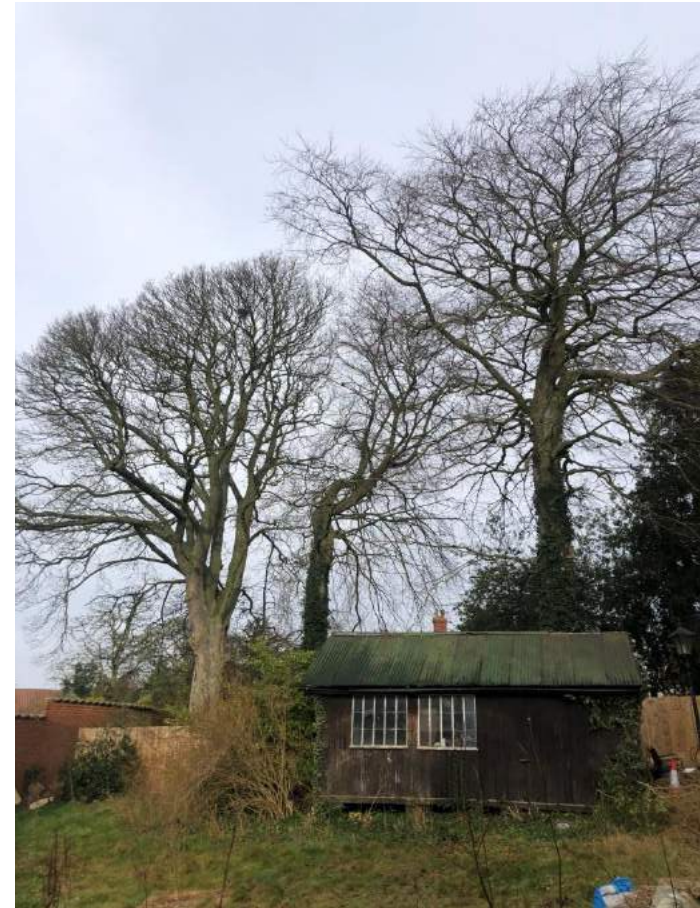
T6	Beech	FM	Phys Good Struct Fair/Poor	21	S/W - 9	± 750	9.0	Third party tree. Appears sound from sound when viewed from site. Vertical trunk with light ivy to 9m. Crown deviates from 11m with majority of growth to NE. Single light lateral branch extends above site to SW. Canopy making active growth all round. Retain tree.	C2
T7	Sycamore	FM	Phys Good Struct Good	22	S/W - 11.5	±1100	13.2	Third party tree. Large, bulky tree appears largely sound when viewed from site. Stout trunk with fully occluded scars and compartmentalised cavities. Sound multiple forks exist at 6m. Spreading crown limited to E by T6/T7 with 2 abrading branch in W quarter and dead wood to 50mm. Domed canopy to S, W and N, still making slow but active growth. Overhangs site to SW. Retain tree.	A2

Picture 4 - showing (right to left) beech T5, beech T6 and sycamore T7.

Beech as a species is very prone to suffering lasting and irreparable damage on development sites. The two fully mature beech and the large sycamore should be safeguarded by the use of the protective fencing fixed in place for the duration of the project. The yews and hollies beyond the boundary will be unaffected by any work to reduce the garage floor level or the careful resurfacing of the tarmac forecourt. Their root zones will be interlocking and those of identical species are likely to be grafted in places helping to support and sustain their peers. No disturbance is proposed within the neighbouring garden where the bulk of their roots stand.
