Grange Farm, Roxby
HERITAGE ASSESSMENT
with Design and Access Statement
September 2022

Version 2 – FINAL

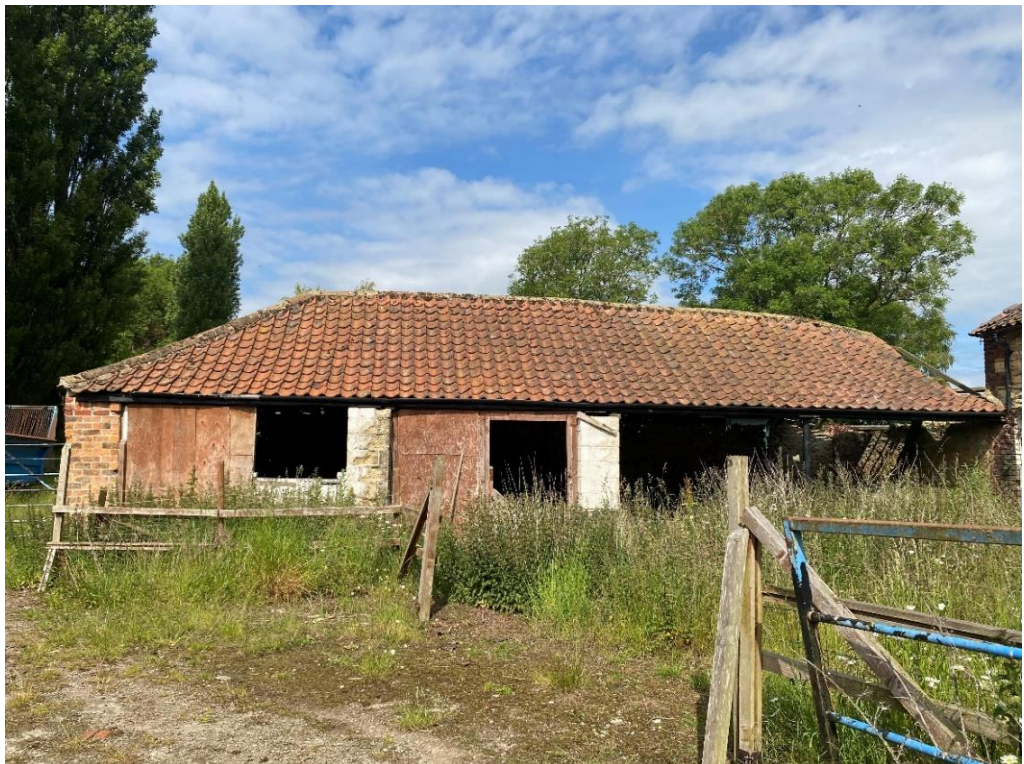
Fig. 20 – Building 1 – east elevation – this building is a mixture of stone, brickwork and modern blockwork wall construction with a hipped pantiled roof on a traditional exposed timber roof construction – partial demolition of this side is recommended within the structural appraisal

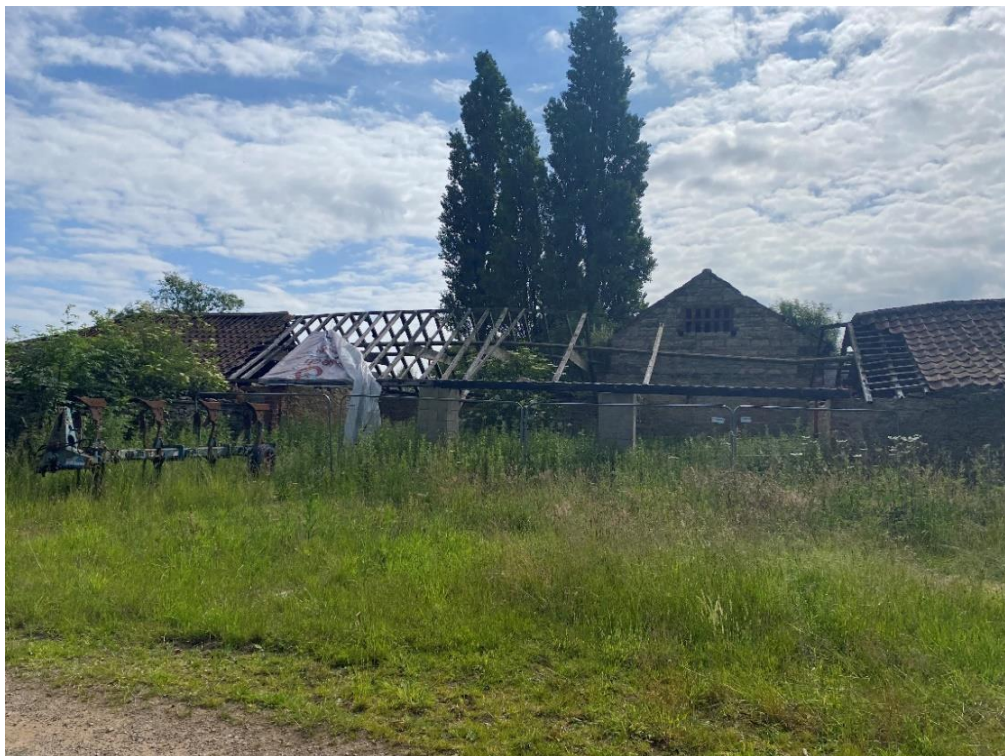
Fig. 24 – Building 2 – west elevation – this building may have been subject to a previous fire – large parts of the roof covering are missing, roof timbers are deformed and there is vegetation growth affecting the built fabric

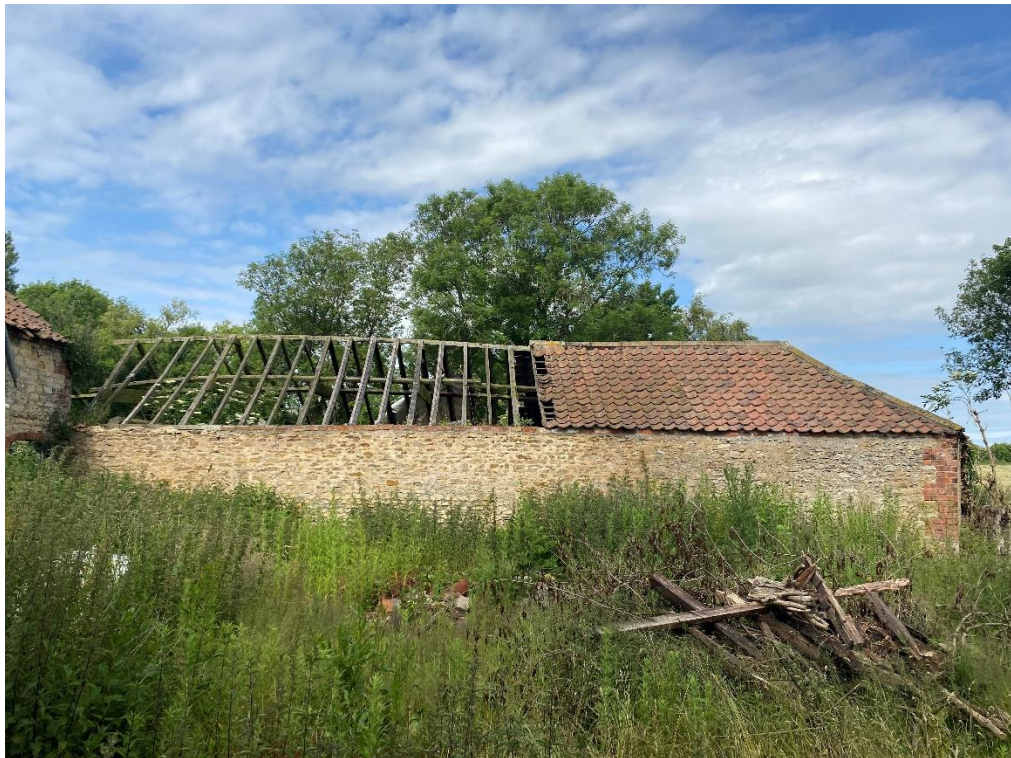
Fig. 26 – Building 2 – eastern elevation – careful demolition and rebuilding of this structure is recommended in the structural appraisal

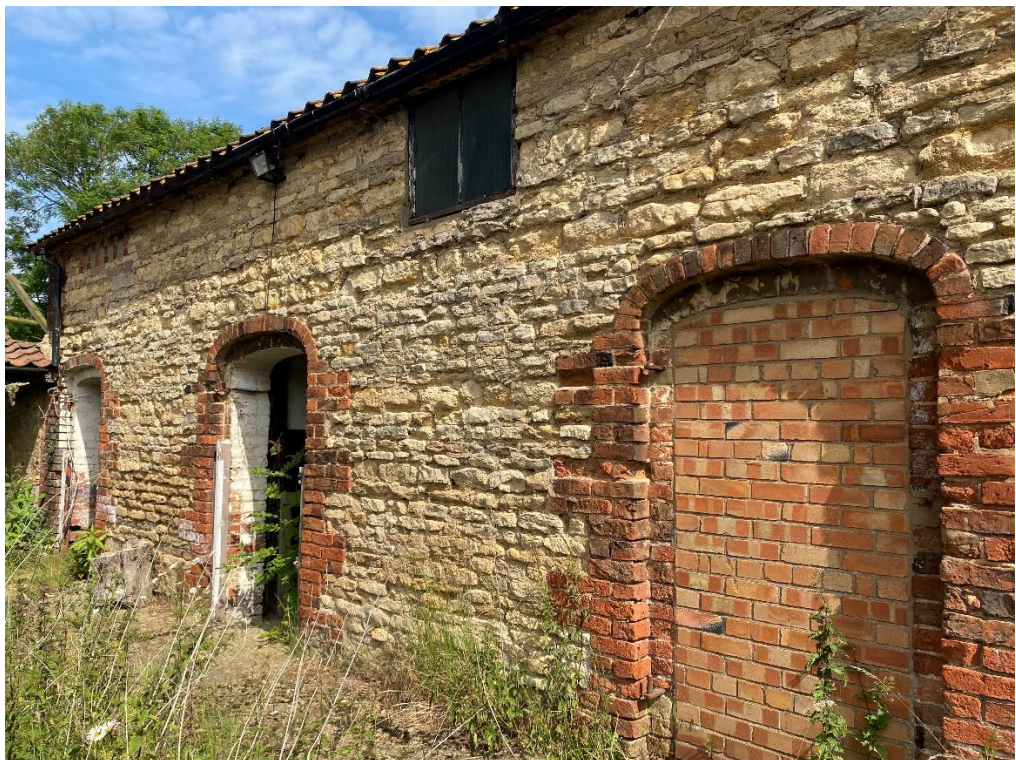
Fig. 28 – Building 3 - part of the south elevation with the arched door openings onto the main enclosed yard and showing a blocked door opening and a boarded first floor window

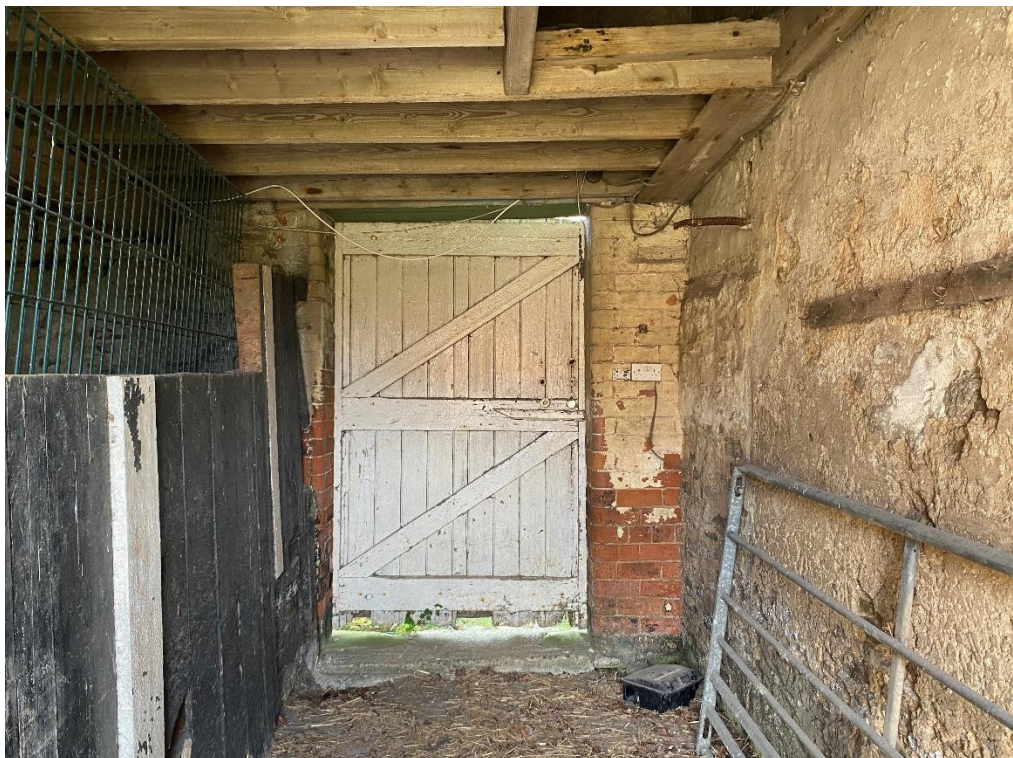
Fig. 30 – Building 3 - a small section of the ground floor is cobbled and the remainder of poor-quality concrete

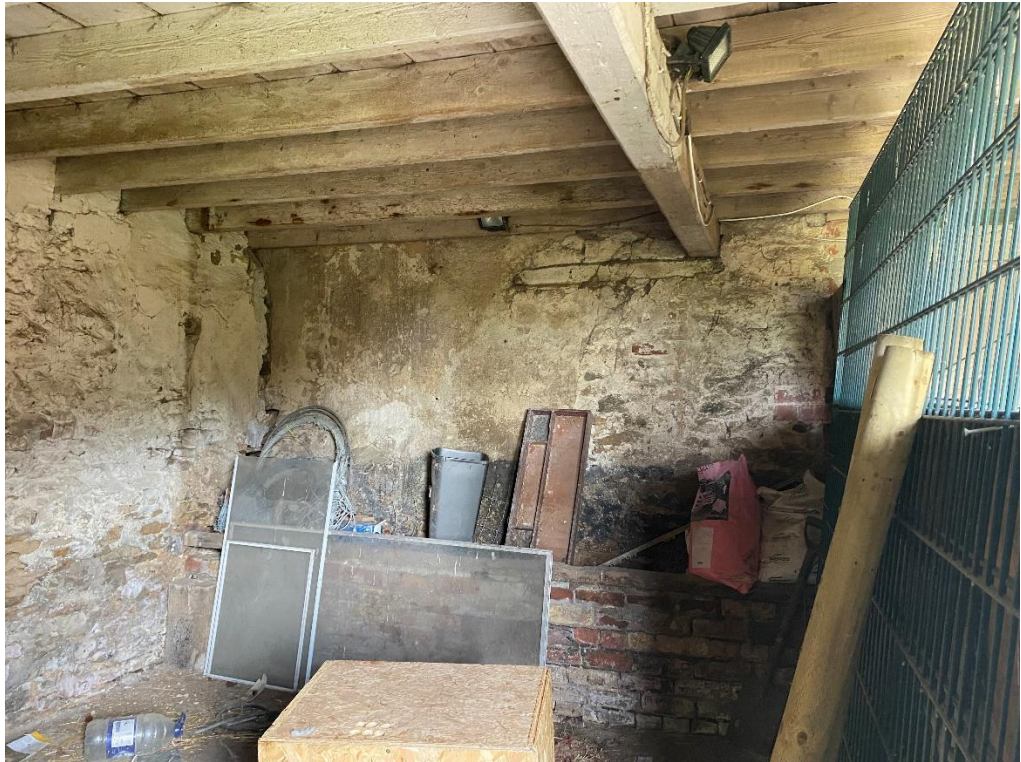
Fig. 31 – Building 3 - renewal of the first-floor construction is recommended in the structural appraisal – this building is sub-divided into 3 bays with a further timber division shown in fig. 30 above – there is a brick-built feeding trough in the easterly bay

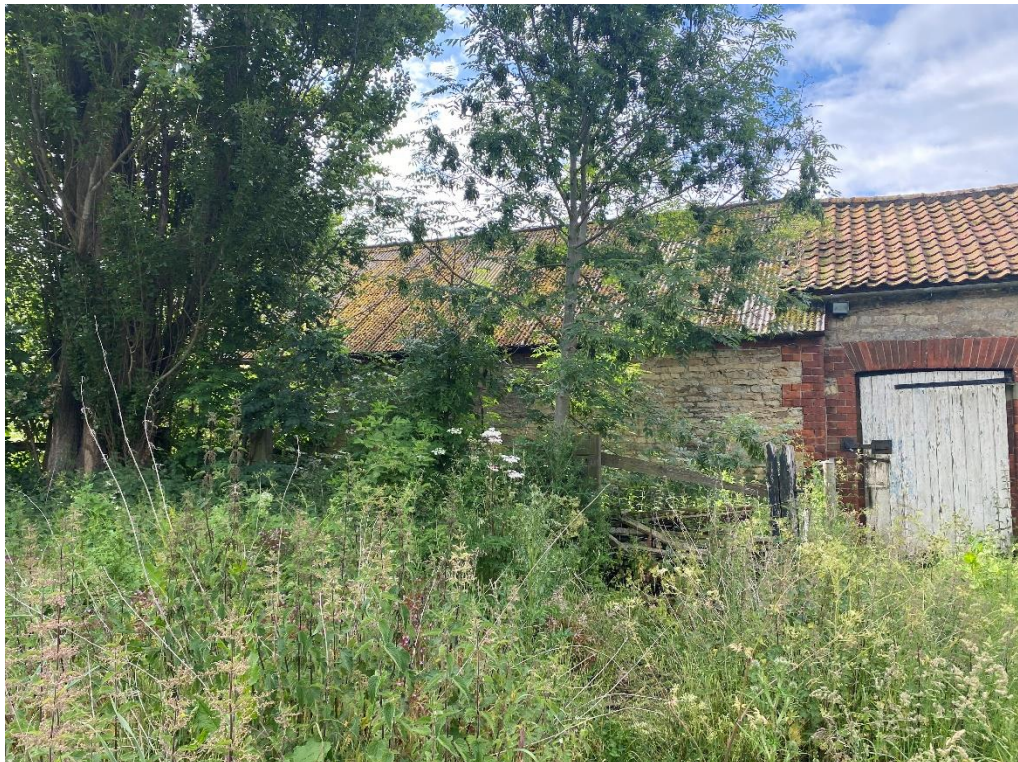
Fig. 34 – Building 4 - much of the north elevation is obscured by vegetation

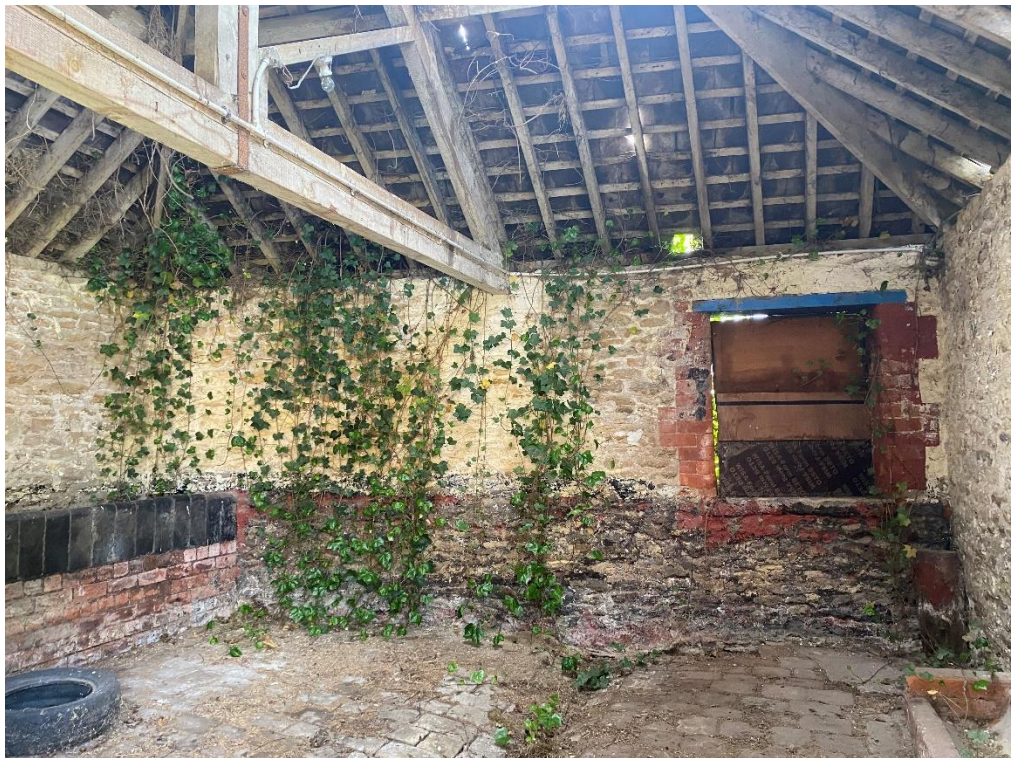
Fig. 40 – Building 5 - the southern bay has a boarded up window opening on its south elevation. The floor has a dished profiled cobbled floor. The roof has a hipped king post roof construction. There is a brick built feeding trough to the internal west side.

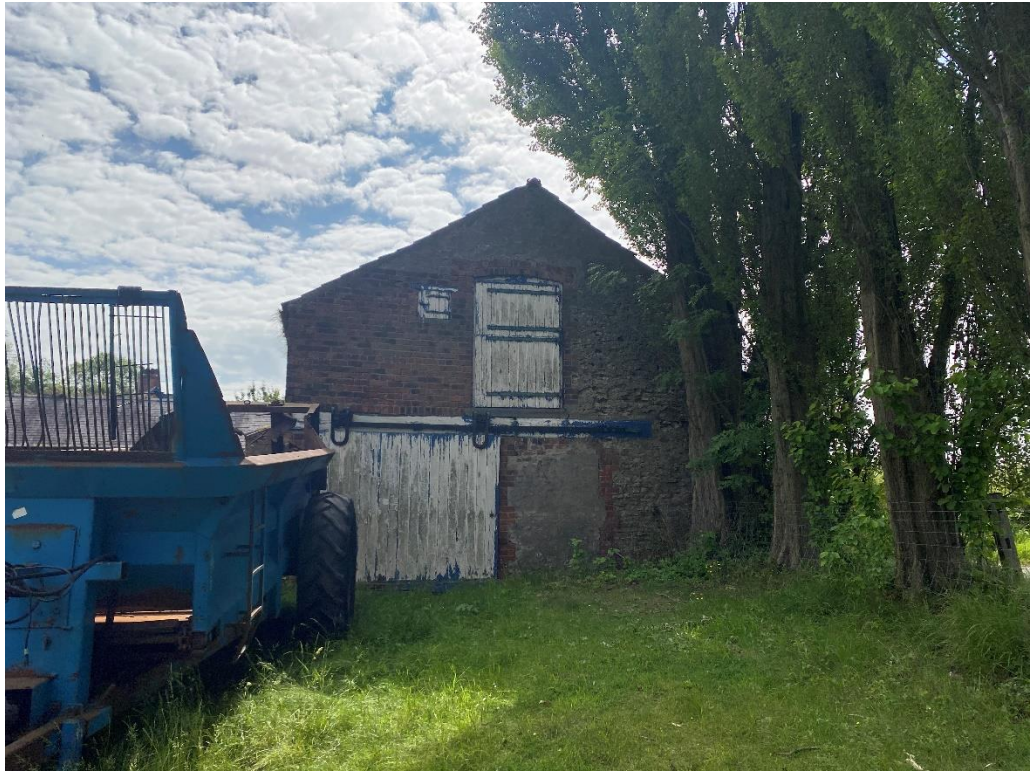
Fig. 49 – Building 6 - the west side which has a first-floor loading door and a timber boarded sliding door - the roadside poplar trees are very close to the south-western corner of this building

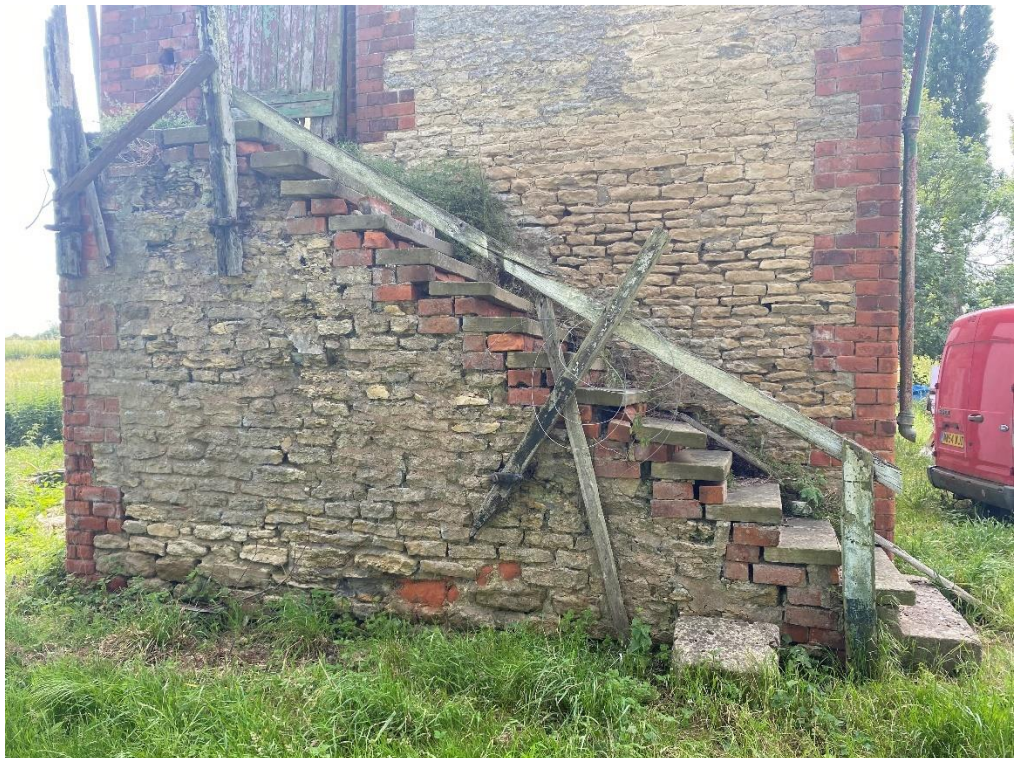
Fig. 54 – Building 7 - the external stair, which is recommended for demolition due to its structural instability
