**WATSON
LINDSEY**
ARBORICULTURE

**Arboricultural
Report to BS
5837:2012**

1 Ferry Rd East
Barrow-upon-Humber
DN19 7AZ

231005

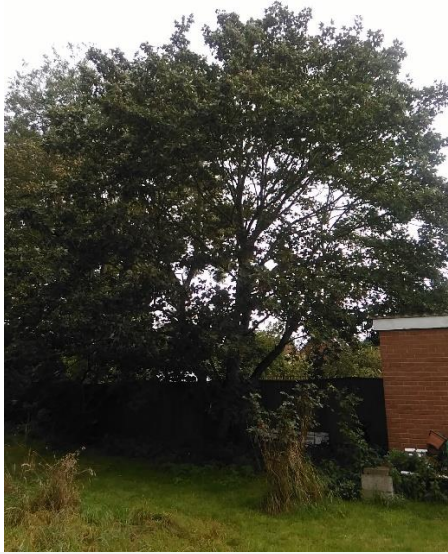
Image 1 – T1

Tree ID	Common Name	Maturity	Height (m)	Stem Diameter (mm)			RPA Radius (m)	Crown Spread (m)				Structural Condition	Retention Category	Life Expectancy	Physiological Condition	Comment	Recommendations
				1	2	3		N	E	S	W						
T1	Sycamore	Semi-mature	12.5	460			5.5	6	6	6	6.5	Good	B1	>40 yrs	Good	A good developing specimen with a spreading habit.	n/a
T2	Orchard Apple	Early-mature	7	350			4.2	3	3	3	4	Fair / Good	B1/2	20 to 40 yrs	Fair / Good	Stem and primary limbs heavily ivy clad preventing detailed inspection. A reasonable specimen.	n/a
T3	Cherry Laurel	Early-mature	9	180 ⁶			5.3	5	4	4	6	Fair / Good	C2	>40 yrs	Good	Multi stemmed from ground level. Congested crown with slender leaders and a bushy spreading habit.	n/a
T4	Sycamore	Semi-mature	13.5	600 [#]			7.2	7.5	7	6	6.5	Good	B1	>40 yrs	Good	Off-site tree, location prevented detailed inspection. Trifurcated from 3m with adequate unions and adjacent minor bleeds on stem. Congested crown structure with multiple slender leaders. A reasonable specimen.	n/a

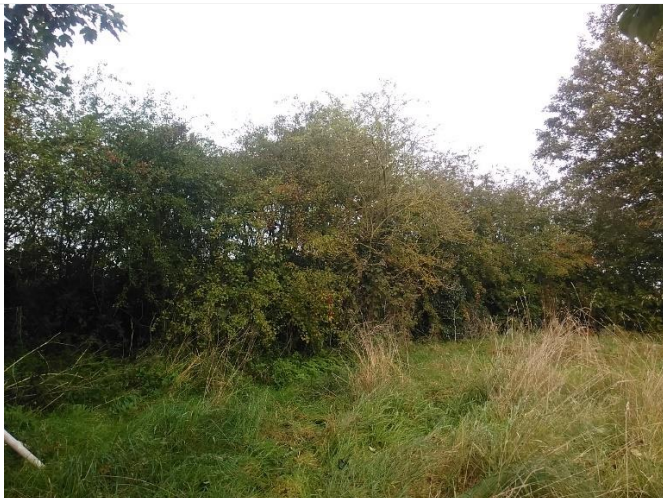
Image 5 – H1

H1	A Hedgerow		5.5					3	3	3	2	Fair	C2			Unmanaged hedge, predominantly hawthorn with elder, wild plum, young elm, and young sycamore. Ivy clad in places.	n/a

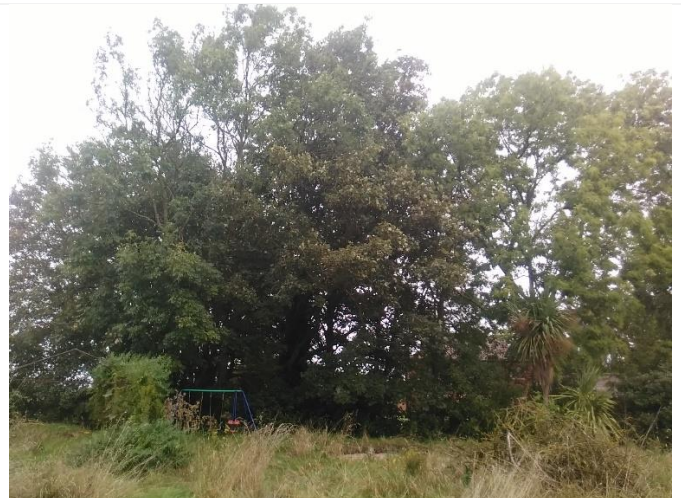
Image 6 – From left to right; T5, G1, T6, T7, & T8

T5	Sycamore	Semi-mature	14	700 [#]			8.4	4	5	5	6.5	Fair	C2	>40 yrs	Fair / Good	Off-site tree, location prevented detailed inspection. Multi stemmed from 2m with acute unions. A congested crown with multiple slender leaders, and suppress by neighbouring trees.	n/a

Tree ID	Common Name	Maturity	Height (m)	Stem Diameter (mm)			RPA Radius (m)	Crown Spread (m)				Structural Condition	Retention Category	Life Expectancy	Physiological Condition	Comment	Recommendations
				1	2	3		N	E	S	W						
T6	Sycamore	Early-mature	18.5	750#			9.0	7.5	8	10.5	9	Good	A1/2	>40 yrs	Good	Off-site tree, location prevented detailed inspection. A good, well established specimen.	n/a
T7	Common Ash	Semi-mature	16.5	470#			5.6	8	7.5	8	7	Good	B1/2	>40 yrs	Good	Off-site tree, location prevented detailed inspection. A good developing specimen free from notable defects.	n/a
T8	Palm	Semi-mature	5	130			1.6	0.5	0.5	0.5	0.5	Good	C1	10 to 20 yrs	Fair	An unremarkable specimen.	n/a
G1	A Group	Semi-mature	15	350	320	150	6.0	5	5	7	6	Fair	C2	>40 yrs		Boundary group containing ash to E and W, with smaller sycamore in centre. All multi stemmed and slender in form due to growing in close competition. W ash with very sparse foliage likely due to Ash Dieback.	n/a
