Barrow Road Barton-upon- Humber – BS 5837:2012 Arboricultural Report, Impact Assessment and Method Statement

Report Title: Barrow Road Barton-upon-Humber – BS 5837:2012
Arboricultural Report, Impact Assessment and Method
Statement

Version: V4.0
Issue Date: August 2023
Report Ref: 19500

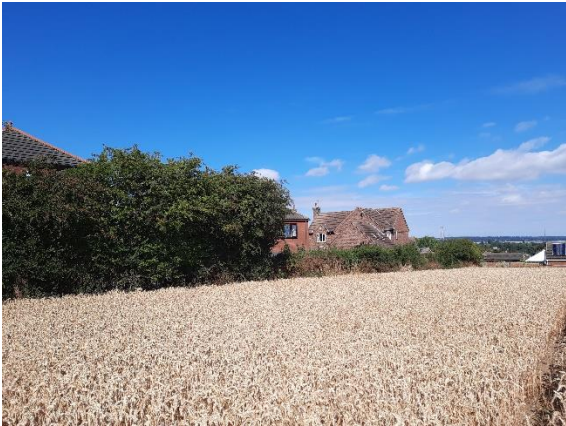
Plate 1: H002, H003 and H004 from the south east

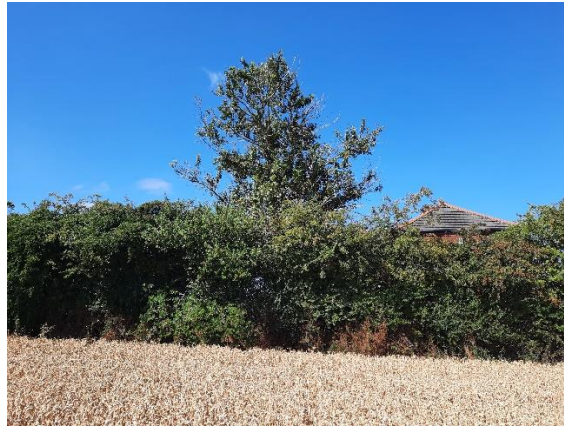
Plate 2: T005 behind H004 from the east

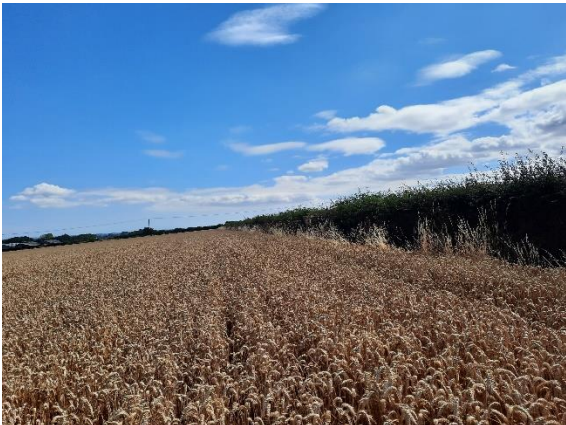
Plate 3: H009 from the west

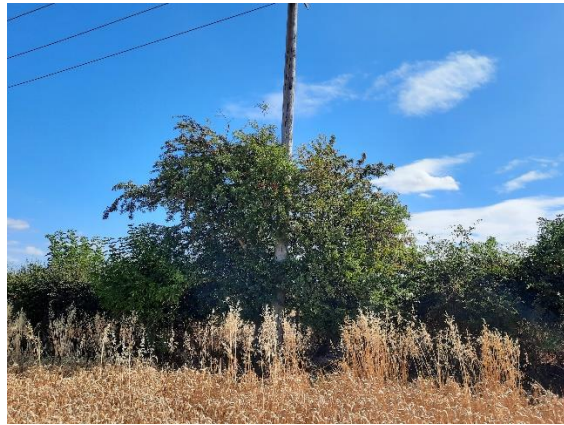
4.5.2 Boundary fencing is proposed within the RPA of several boundary hedgerows and the individual tree T011. The minor pruning required to the hedgerows here will not affect their value or long term prospects. The fencing should be installed following the recommendations in the Arboricultural Method Statement at Appendix 3.

Plate 4: T011 within H010 from the west

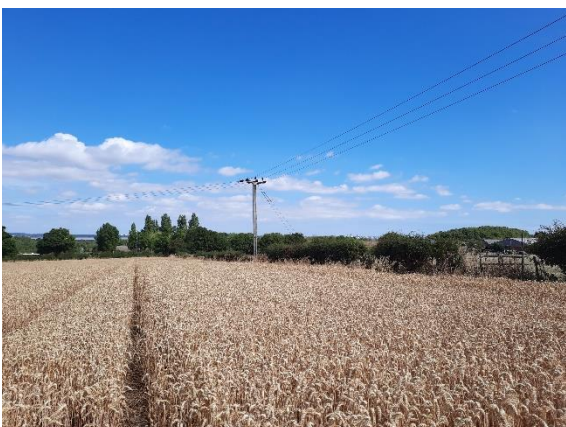
Plate 5: H013, H014, H015 and G016 from the south west

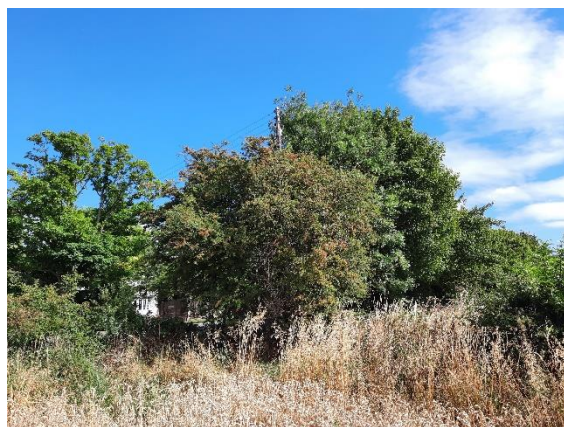
4.3.4 While there will be some particularly minor loss of amenity value from the removal of G016, H020 and sections within H017, this will not detract from the landscape value of the wider site. Any loss can be mitigated through the planting of suitable species throughout the site once construction is complete.

Plate 6: G016 from the south west

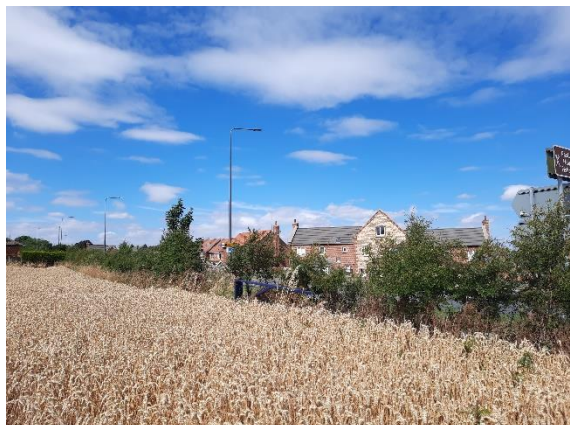
4.3.1 The development proposals indicate that 2 trees (T018 and T020), 1 tree group (G016), 1 hedgerow (H019) and sections of 1 further hedgerow (H017) within the site boundary will need to be removed to facilitate the new development, as they are situated in the footprint of new structures or their retention and protection throughout the development is not suitable.

Plate 7: H017, H019 and T020 from the south east

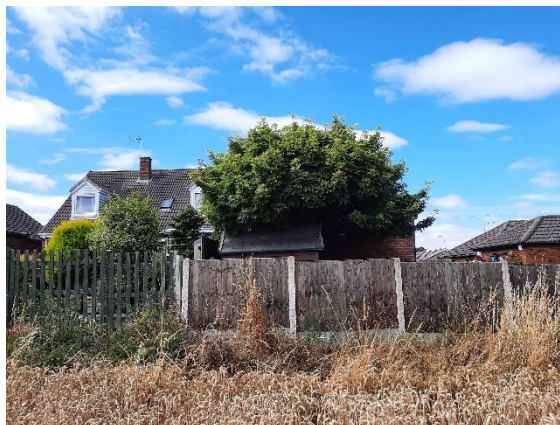
Plate 8: T022 from the east

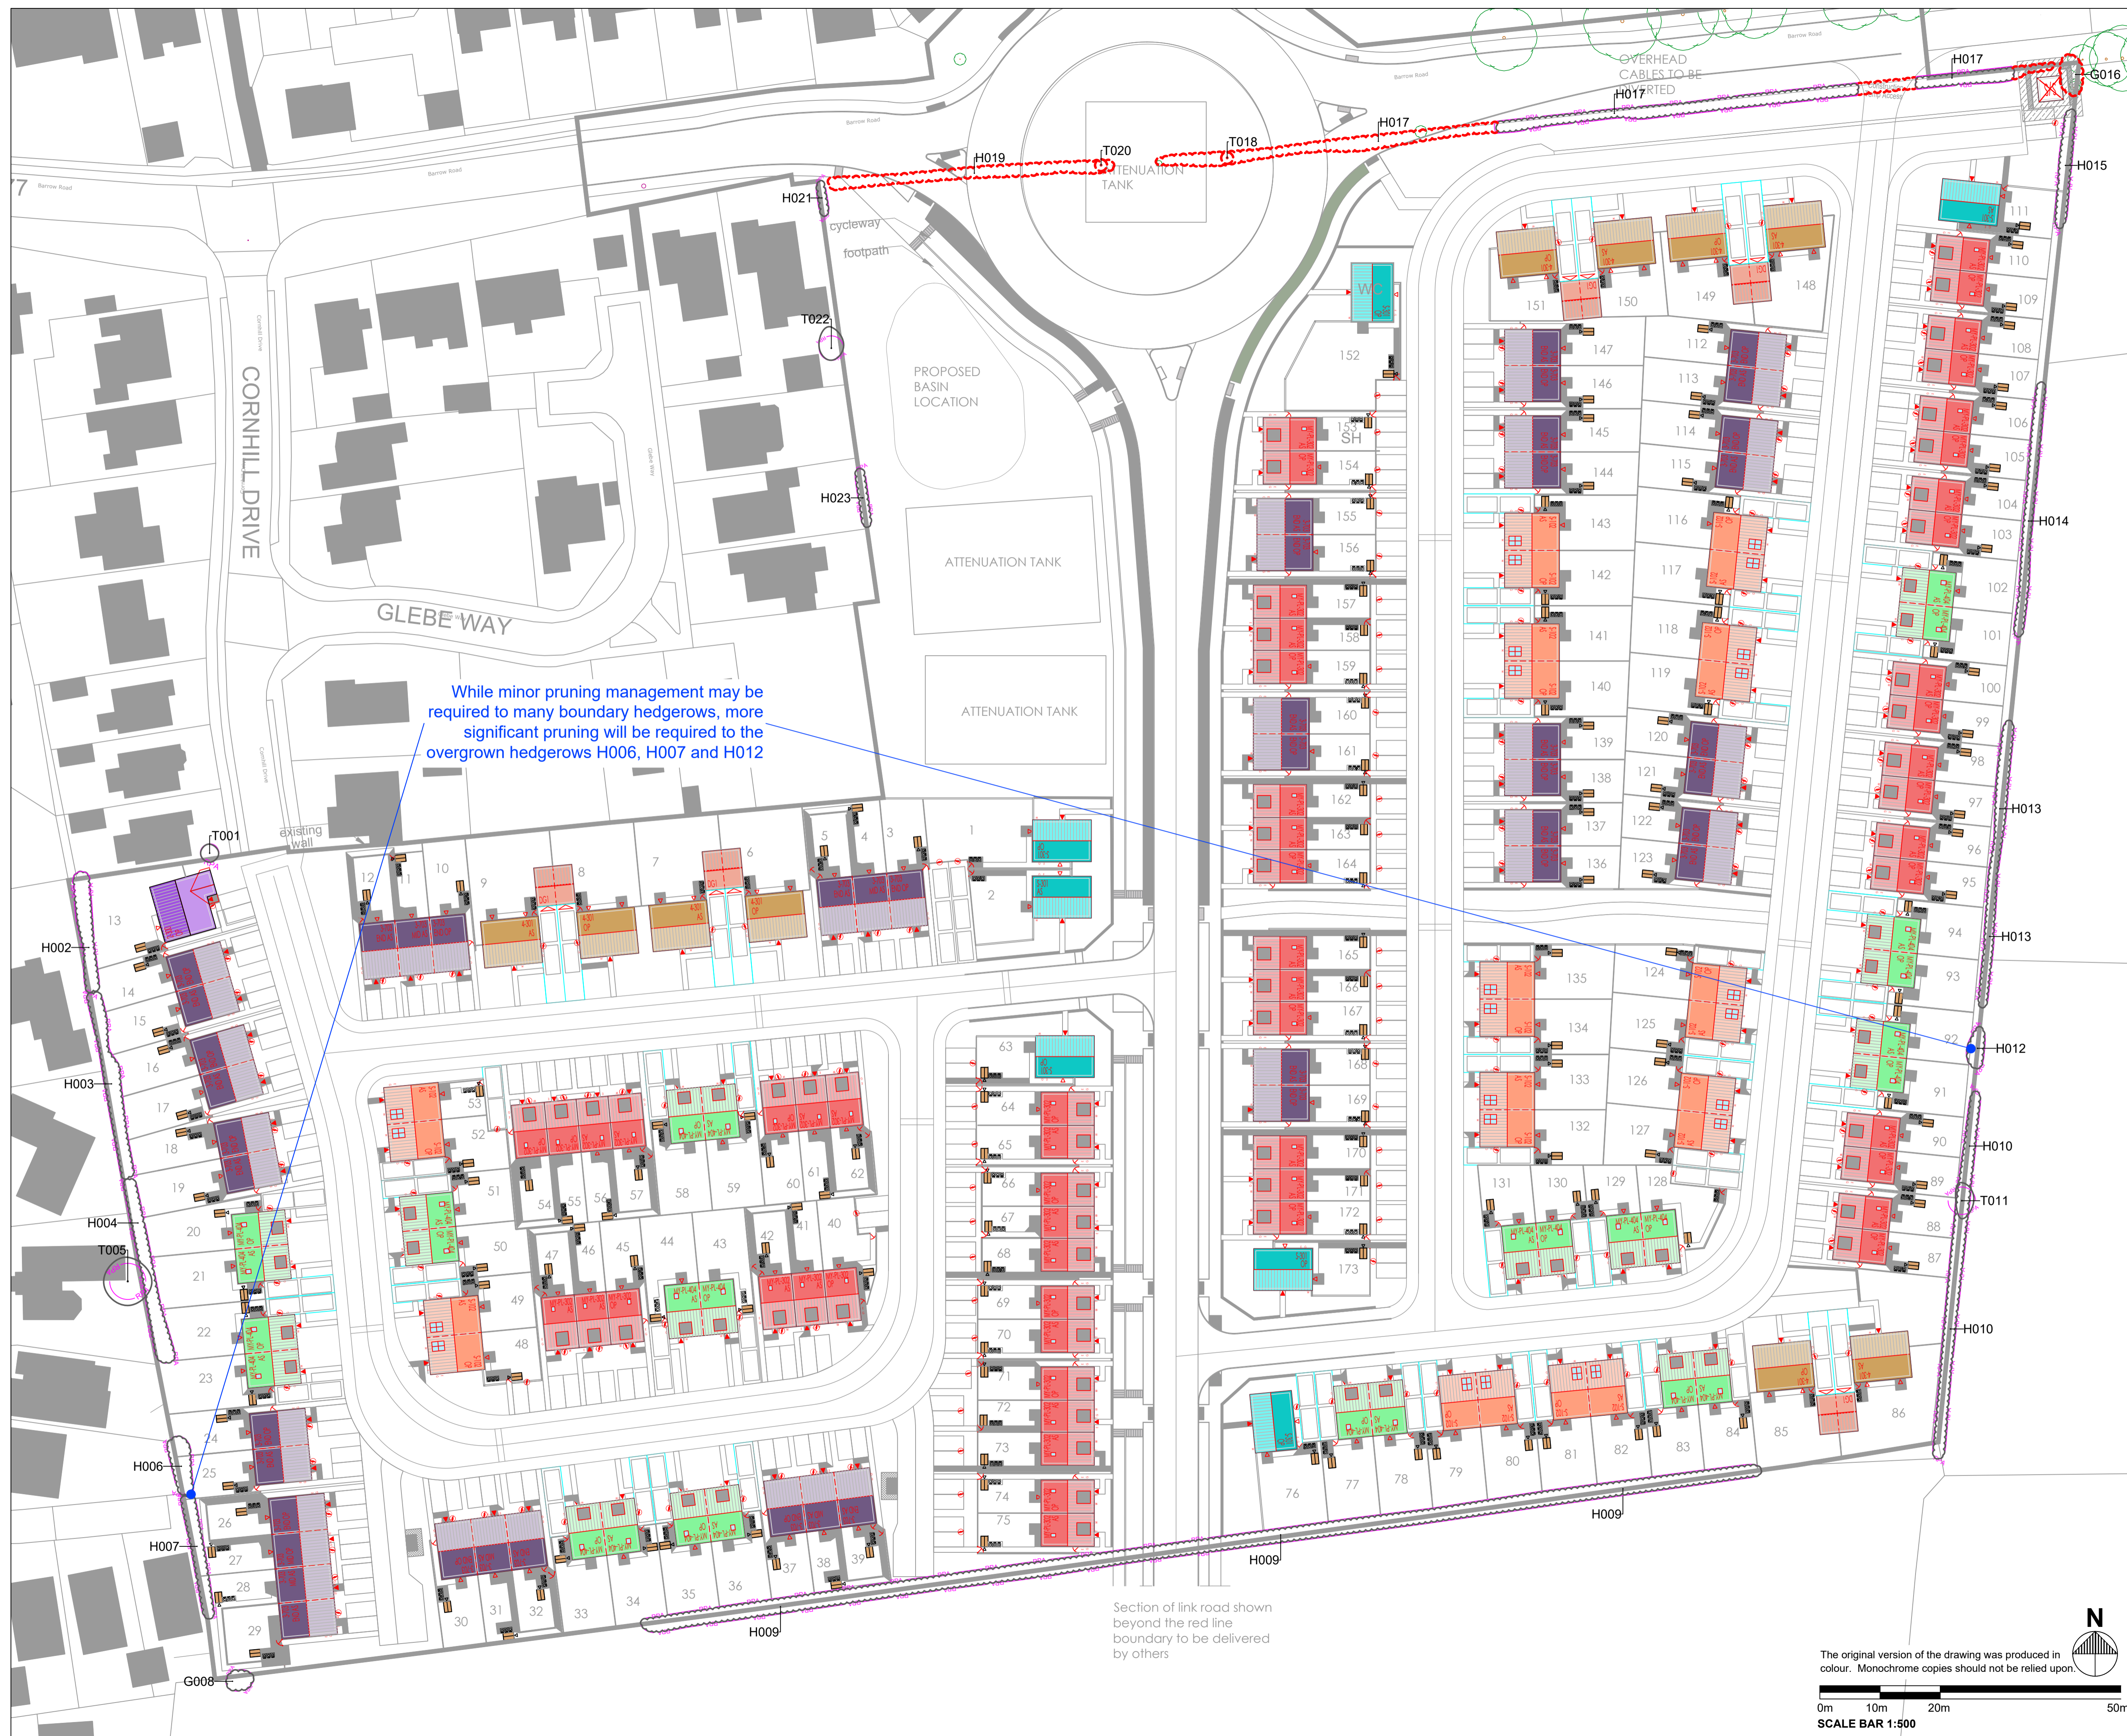
Title
Figure 4 - Tree Impacts Plan

While minor pruning management may be required to many boundary hedgerows, more significant pruning will be required to the overgrown hedgerows H006, H007 and H012
