# Barrow Road, Barton-upon-Humber – BS5837: 2012 Arboricultural Report, Impact Assessment and Method Statement

Date: 07/07/2025  
Prepared by: Stephen Rapin  
Ref: 19500

**Report Title:** Barrow Road Barton-upon-Humber – BS 5837:2012  
Arboricultural Report, Impact Assessment and Method  
Statement

**Version:** V6.0  
**Issue Date:** July 2025  
**Report Ref:** 19500

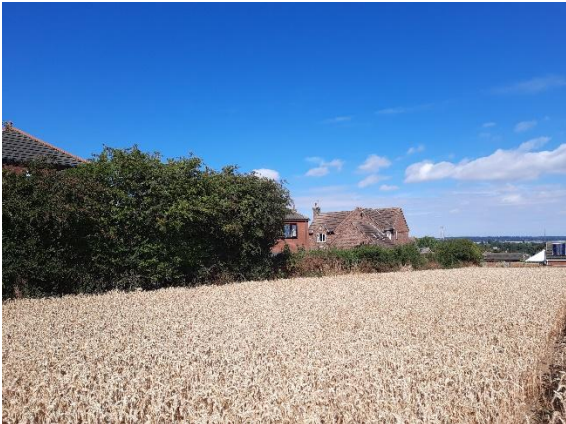
**Plate 1:** H002, H003 and H004 from the south east

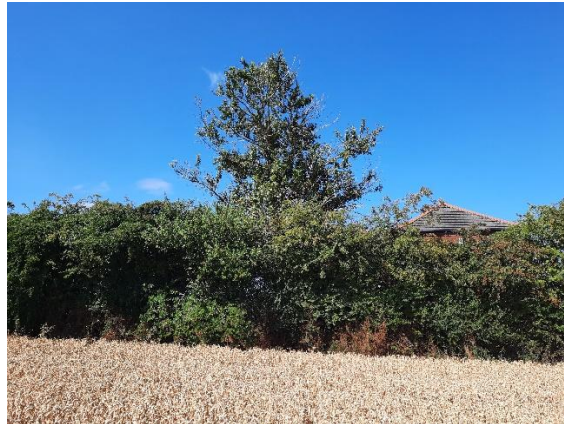
**Plate 2:** T005 behind H004 from the east

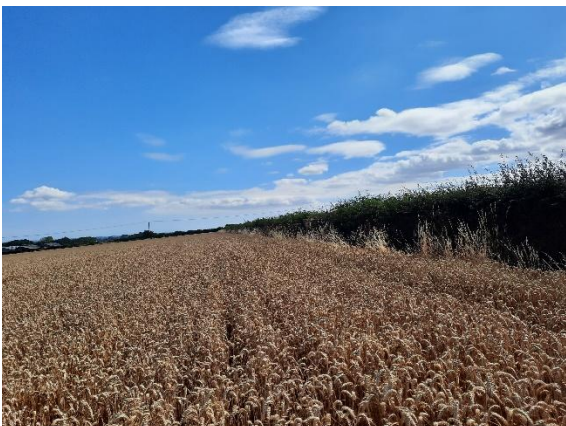
**Plate 3:** H009 from the west

While minor pruning management may be required to many boundary hedgerows, more significant pruning will be required to the overgrown hedgerows H003, H006, H007, H009 and H012

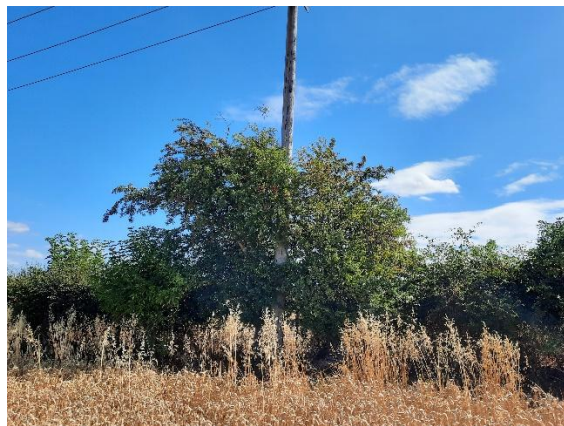
**Plate 4:** T011 within H010 from the west

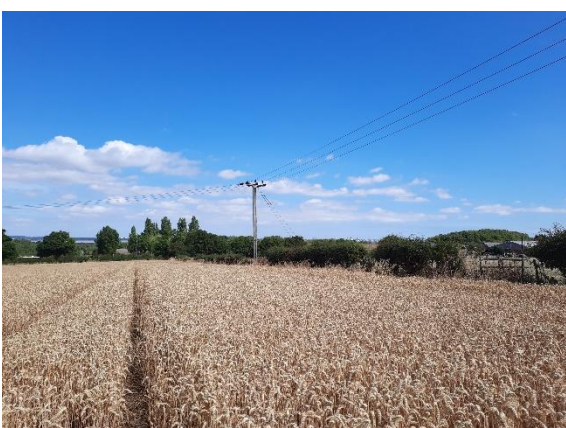
**Plate 5:** H013, H014, H015 and G016 from the south west

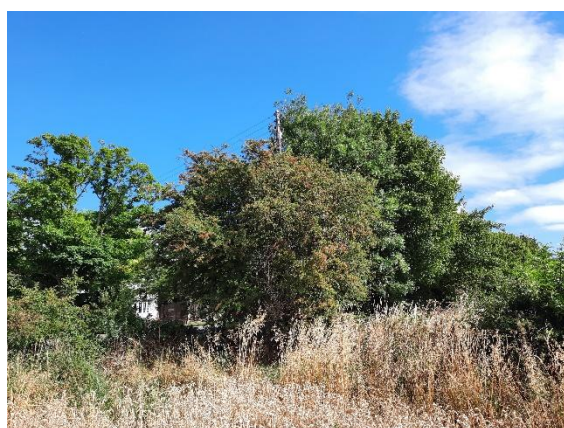
**Plate 6:** G016 from the south west

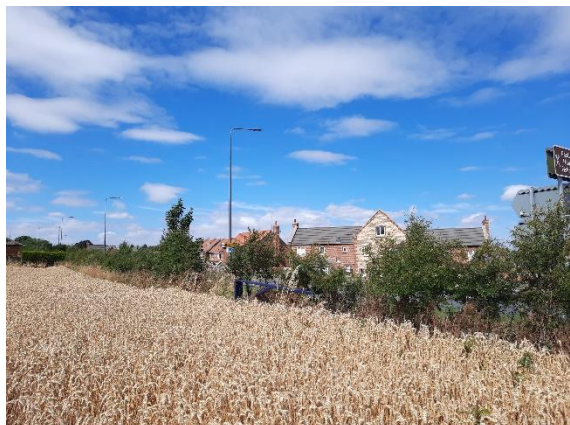
**Plate 7:** H017, H019 and T020 from the south east

4.3.1 The development proposals indicate that 2 trees (T018 and T020), 2 hedgerows (H019 & H017) and sections of 1 further hedgerow (H015) within the site boundary will need to be removed to facilitate the new development, as they are situated in the footprint of new structures or their retention and protection throughout the development is not suitable. H017 has already been granted planning approval for full removal for North Lincolnshire Council to install the link road, ref PA/2023/1981.

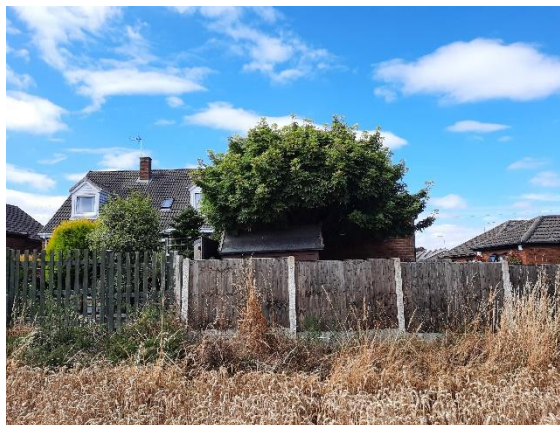
**Plate 8:** T022 from the east
